<b>Inspections Performed for:</b> FMC Technologies Completion	
<b>Inspection Report for:</b> LH0004-C1 - Line Heater Coil 1	
<b>Remaining Life:</b> 0.7 YRS	<b>Date of this Report:</b> 10/25/2016
<b>Rep. Corrosion Rate:</b> 95.0 MPY	<b>Next UT:</b> 10/25/2017 <b>Next VT:</b> 10/25/2017
<b>Manufacturer:</b> Blue Star Welding	<b>Mfg Serial #:</b> BS10K2MM-03A
<b>Date Built:</b> 2005	<b>National Board #:</b> None
<b>Alberta registration #:</b> 514075	<b>Canadian Registration #:</b> ALD-05-001

**FMC Technologies Completion - LH-0004 Line Heater Coil 1**

# API 510 PRESSURE VESSEL EXTERNAL INSPECTION REPORT

**FMC Technologies Completion - LH-0004 Line Heater Coil 2**

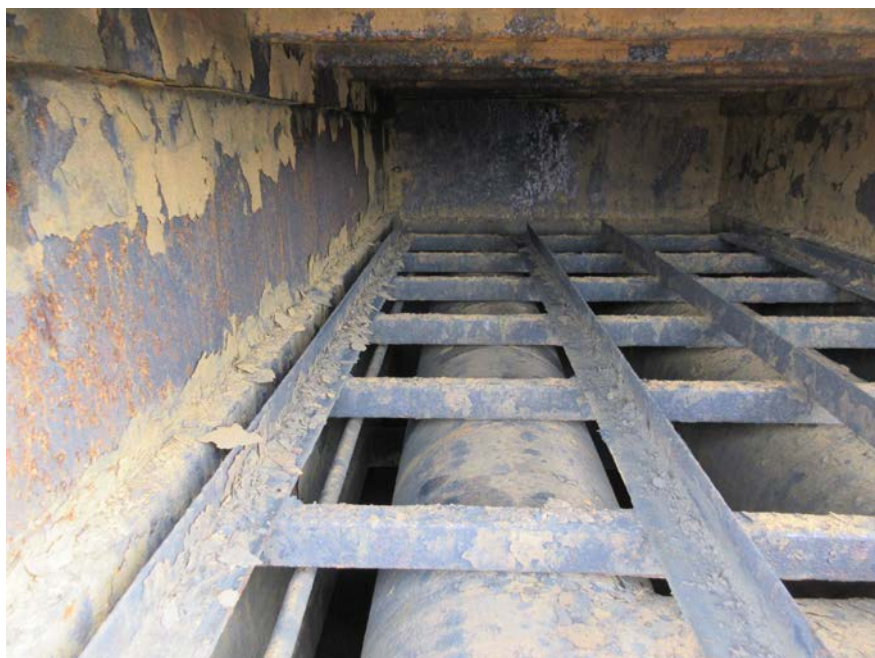
**Condition of Foundation and Anchor Bolts:** Coils pulled out of Line Heater.

**Condition of Paint and/or Insulation:** Front plate has minor chipping with surface corrosion.

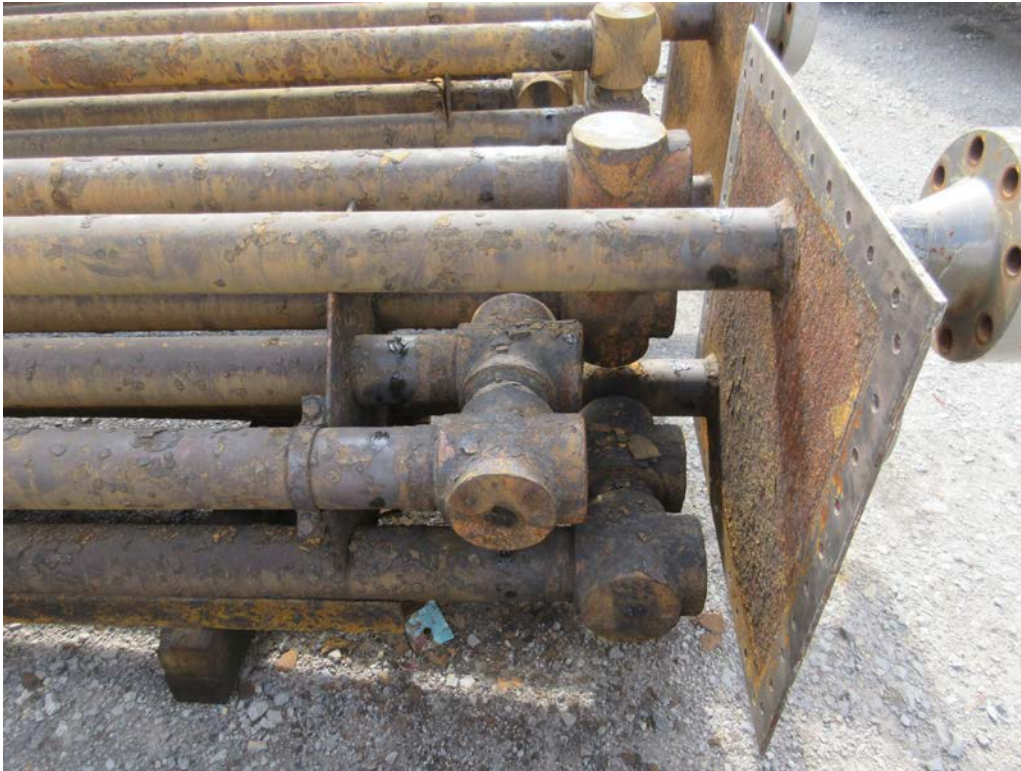
**Condition of Steel Supports, Saddles and Bolting:** (2) vertical plates have heavy surface corrosion and peeling.

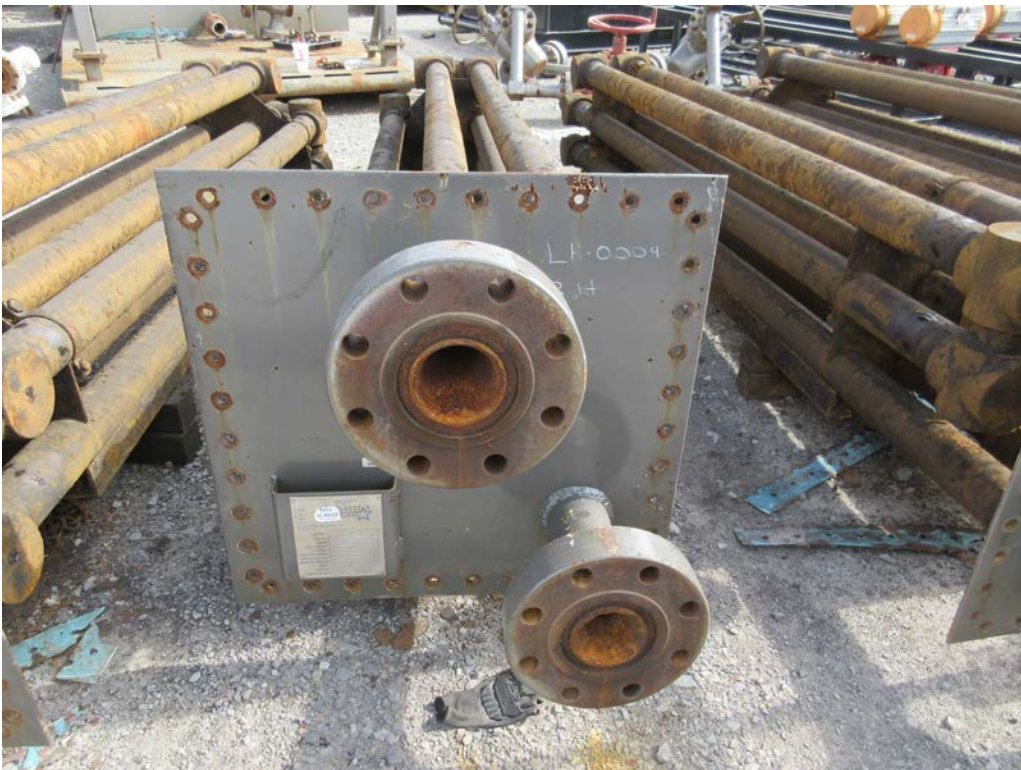
**Condition of Nozzles, Flanges, Repads, and Weepholes:** Nozzles and flanges are in good condition. Coils were pulled out of the Line Heater. There was light chipping on the flanges with minor surface corrosion.

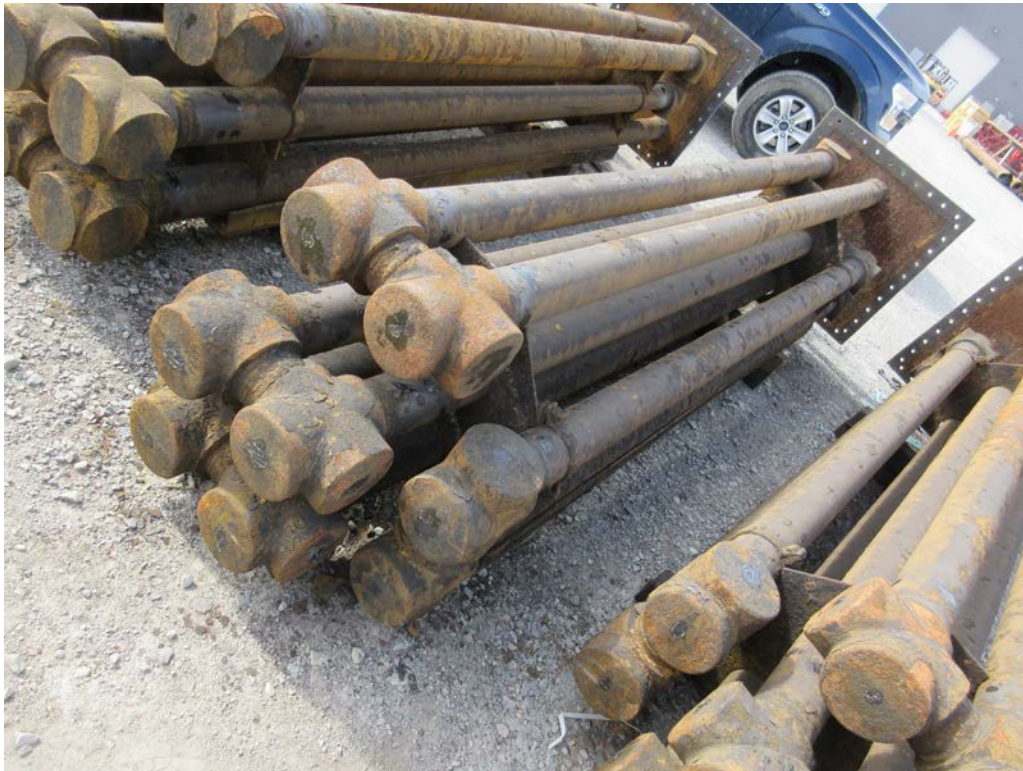
Coils have moderate corrosion with scaling.

**Recommendations:**

None

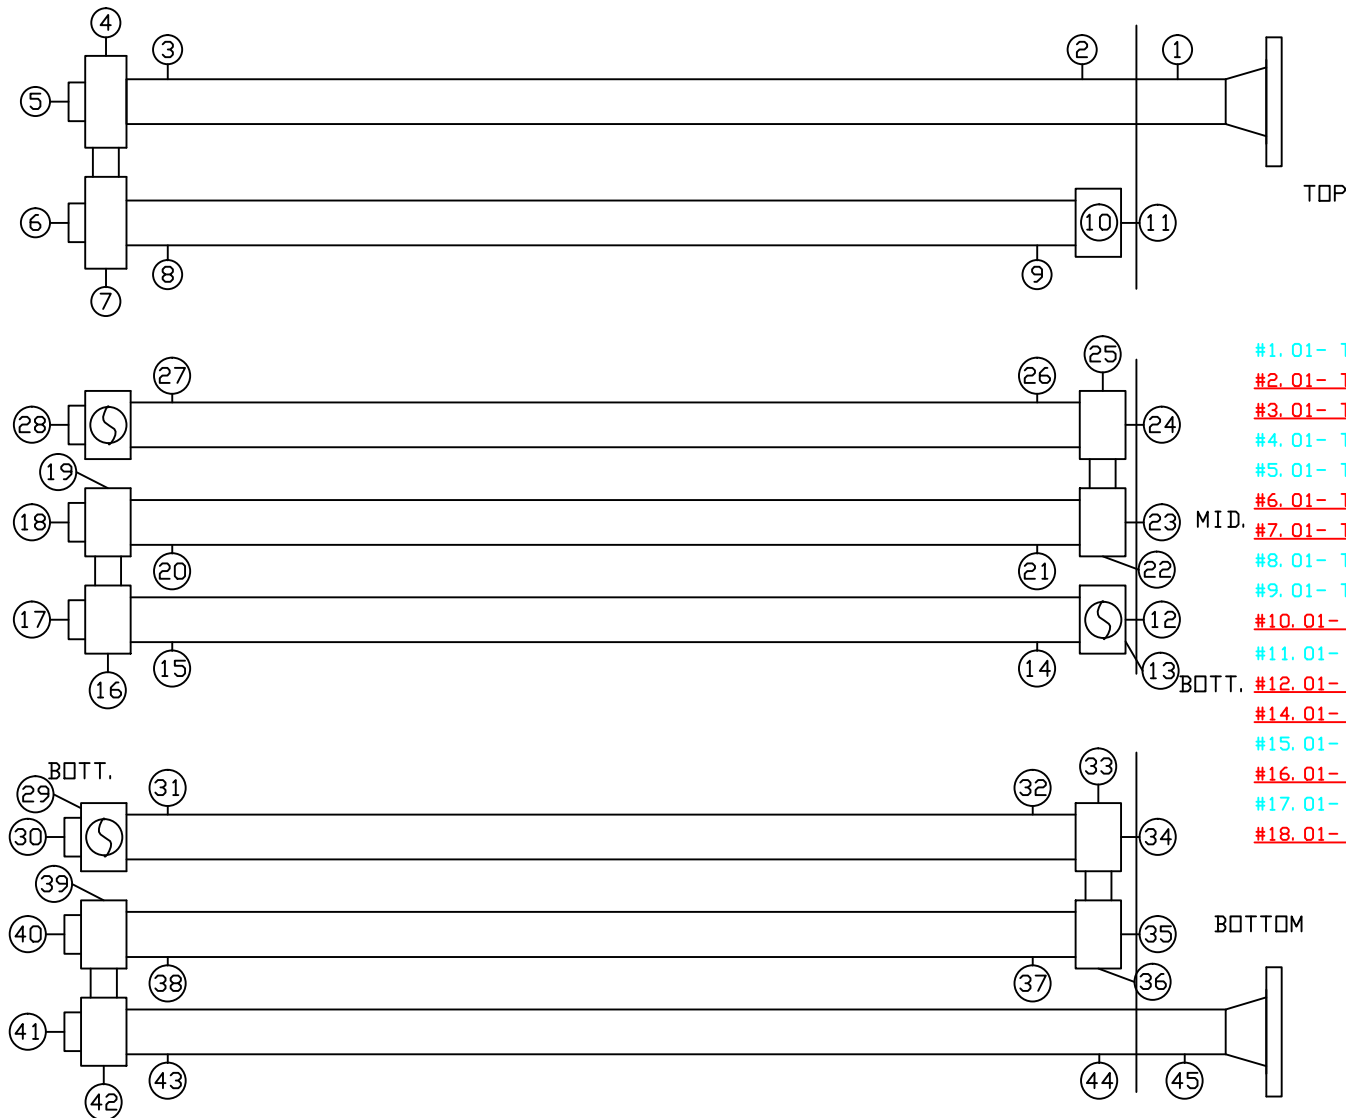
DESC: COIL 1 ON LINE HEATER 1  
DWG#: LH0004-C1-1.01-45.01

#1.01- TOP-T 0.968 TC	#20.01- MID-R 0.972 TC
#2.01- TOP-T 0.912 TC	#21.01- MID-L 0.988 TC
#3.01- TOP-T 0.960 TC	#22.01- MID 0.000 NT
#4.01- TOP 2.708 TC	#23.01- MID 0.000 NT
#5.01- TOP 3.221 TC	#24.01- MID 1.915 TC
#6.01- TOP 2.770 TC	#25.01- MID 2.064 TC
#7.01- TOP 2.095 TC	#26.01- MID-BT 0.952 TC
#8.01- TOP-T 0.979 TC	#27.01- MID-T 0.970 TC
#9.01- TOP-BT 0.968 TC	#31.01- BTM-R 0.930 DC
#10.01- TOP-TURN 0.000 NT	#32.01- BTM-BT 0.960 TC
#11.01- TOP 3.252 TC	#33.01- BTM-TURN 0.000 NT
#12.01- MID 2.442 TC	#37.01- BTM-R 0.981 TC
#14.01- MID-BT 0.968 TC	#38.01- BTM-L 0.934 TC
#15.01- MID-L 0.972 TC	#40.01- TURN 3.240 TC
#16.01- MID-TURN 1.610 TC	#41.01- BTM 2.584 TC
#17.01- MID 3.387 TC	#42.01- BTM-T 2.082 TC
#18.01- MID 2.587 TC	#43.01- BTM-R 0.943
	#44.01- BTM-L 0.977 TC
	#45.01- BTM-BT 0.967 TC

CAL BLK=59°F PIPE=60°F

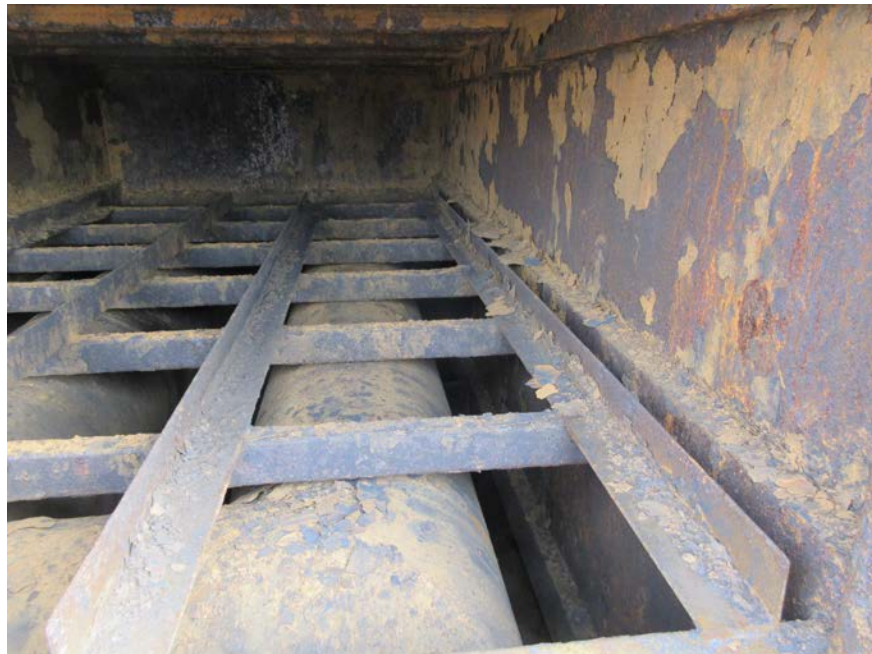
**Condition of Foundation and Anchor Bolts:** Coils pulled out of Line Heater.

**Condition of Steel Supports, Saddles and Bolting:** (2) vertical plates have heavy surface corrosion and peeling.

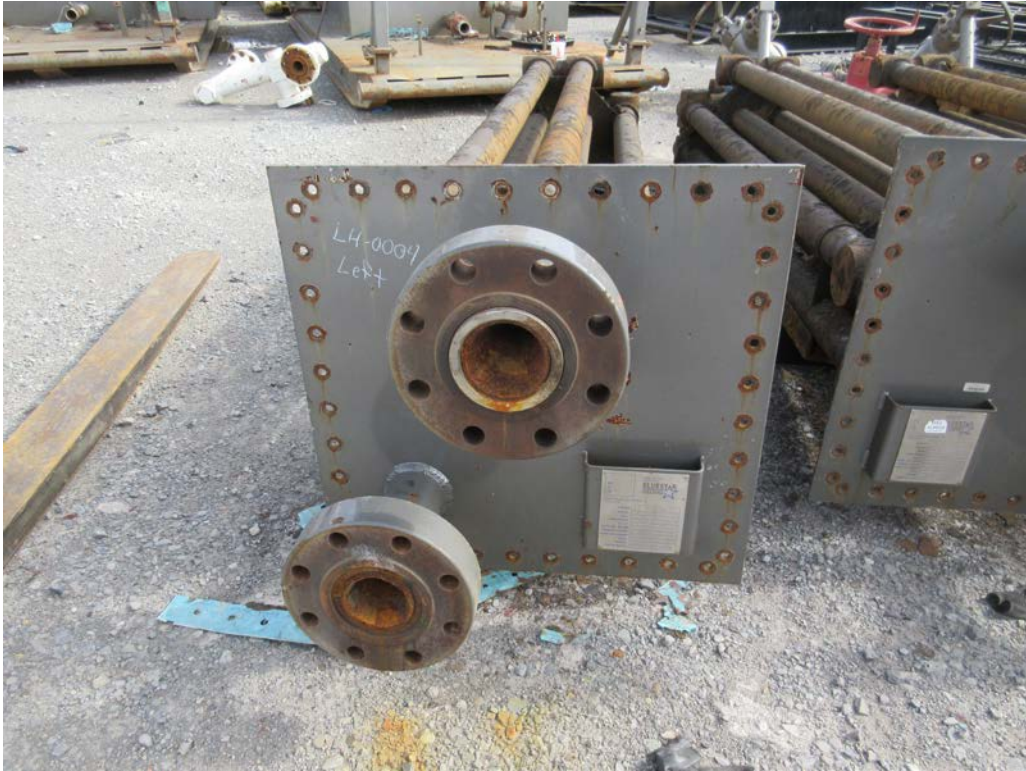
**Condition of Nozzles, Flanges, Repads, and Weepholes:** Nozzles and flanges are in good condition. Coils were pulled out of the Line Heater. There was light chipping on the flanges with minor surface corrosion.

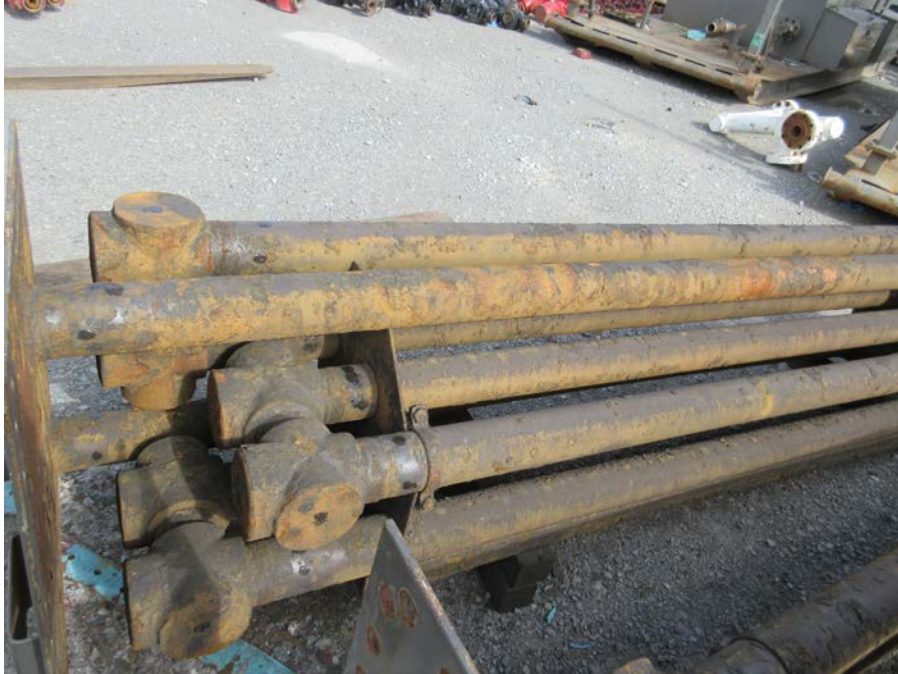
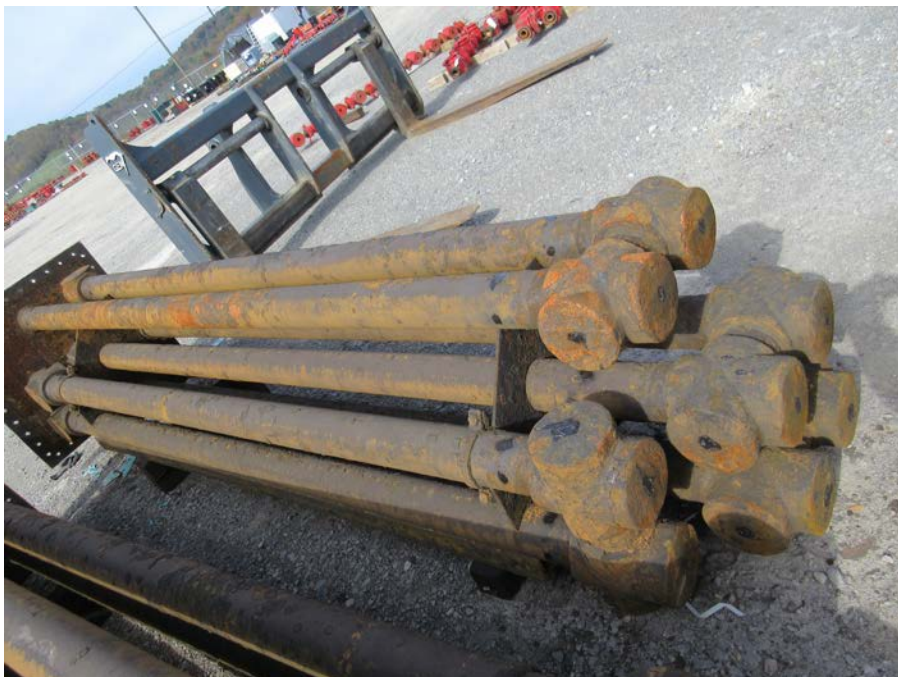
Coils have moderate corrosion with scaling.

**Recommendations:**

None

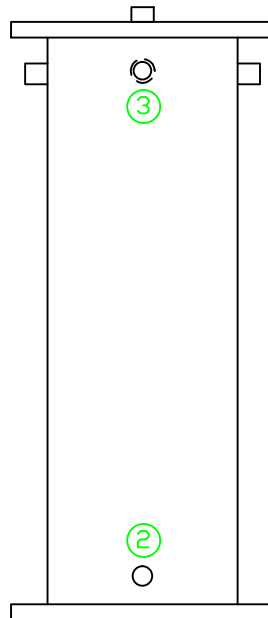
#2.01- BTM SH-FRONT 0.313 TC  
#2.02- BTM SH-LEFT 0.311 TC  
#2.03- BTM SH-BACK 0.317 TC  
#2.04- BTM SH-RIGHT 0.324 TC  
#3.01- TOP SH-FRONT 0.312 TC  
#3.02- TOP SH-LEFT 0.302 TC  
#3.03- TOP SH-BACK 0.307 TC  
#3.04- TOP SH-RIGHT 0.325 TC

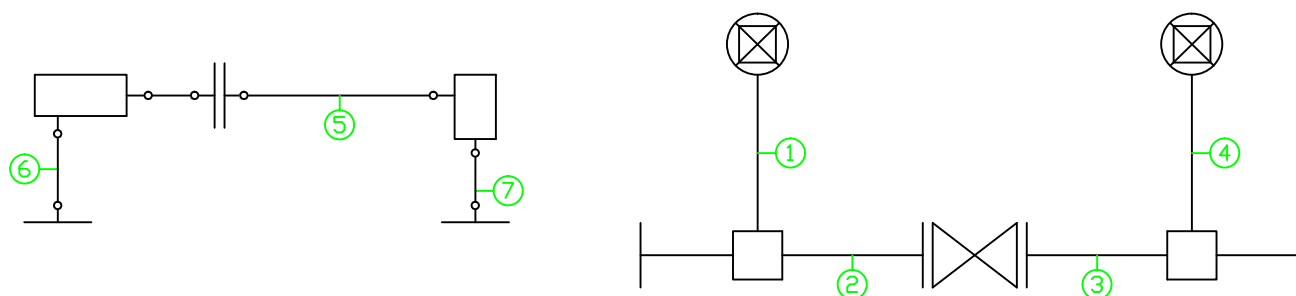
#1. 01- STR-BK 0.725 FH  
#2. 01- STR-BK 0.727 FH  
#3. 01- STR-BK 0.712 FH  
#4. 01- STR-R 0.700 FH  
#5. 01- STR-BT 0.681 FH  
#6. 01- STR-R 0.835 RP  
#7. 01- STR-BT 0.706 FH

CAL BLK=40°F PIPE=37°F
