| <b>Inspection Report for:</b> LH-0004 | |

**FMC Technologies Completion LH-0004 Line Heater**

## API 510 PRESSURE VESSEL EXTERNAL INSPECTION REPORT

**FMC Technologies Completion LH-0004 Line Heater Fuel Gas Scrubber**

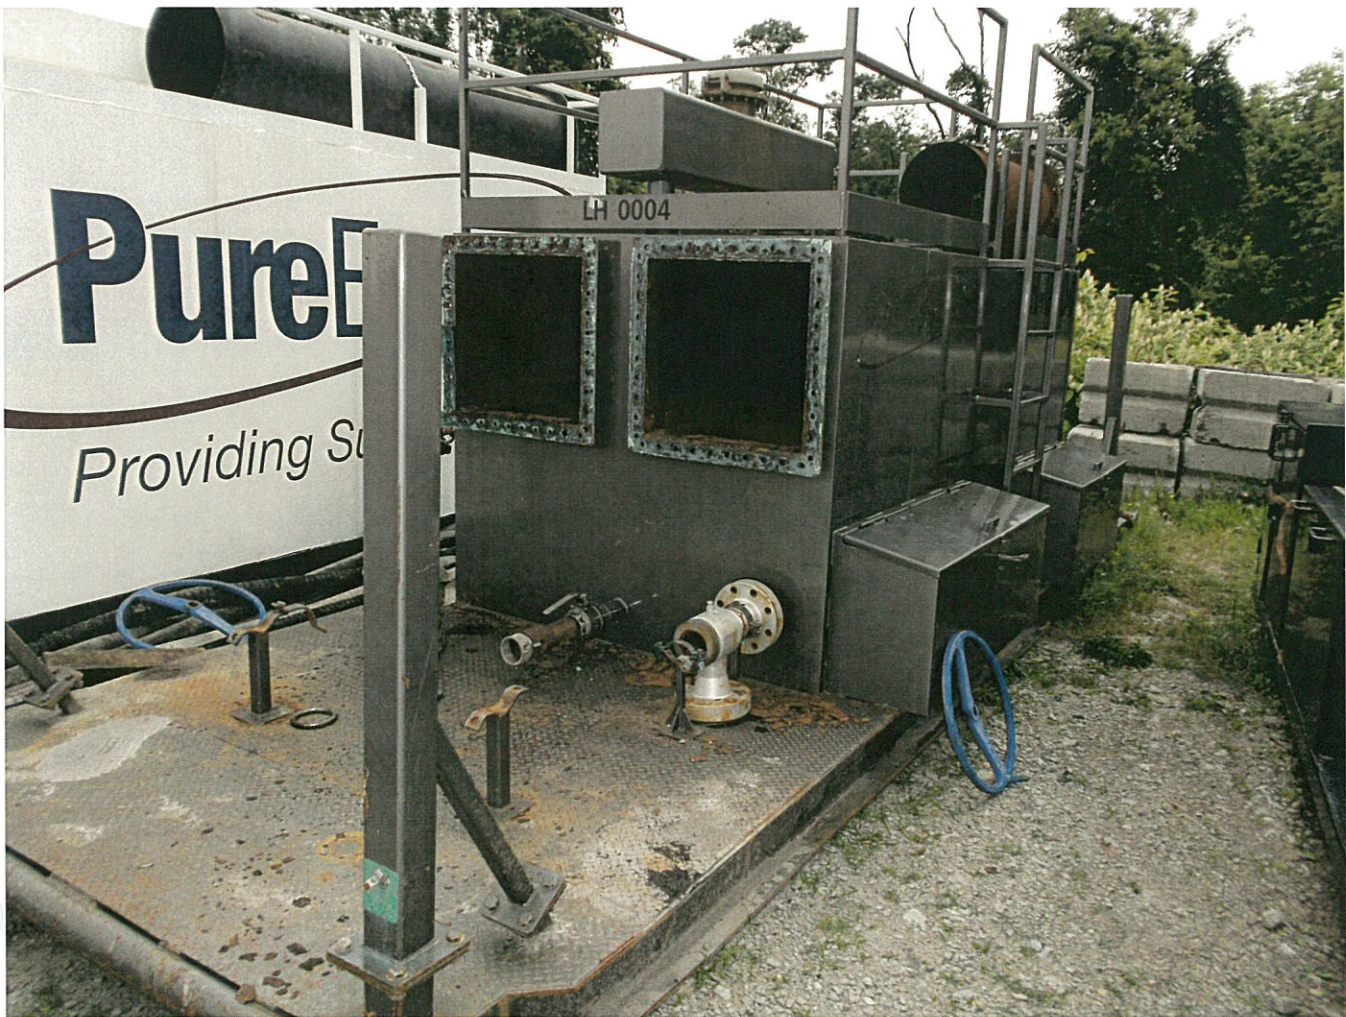
**Condition of Nameplate and/or Bracket:** Nameplate is intact and legible. The nameplate bracket is securely attached. Nameplate and bracket are in acceptable condition.

**Condition of Foundation and Anchor Bolts:** There are no anchor bolts. Line heater is welded directly to the skid attachment welds are smooth with a good weld profile.

**Condition of Paint and/or Insulation:** The paint is in good condition with no chipping or peeling. Heater coating is in acceptable condition.

**Condition of Nozzles, Flanges, Repads, and Weepholes:** Nozzles and flanges are in good condition. All Line Heater flanges are in acceptable condition.

**Condition of Welds; Head and Shell Metal Surfaces:** All (exposed) metal surfaces are painted. There is no distortion or indication of corrosion beneath the paint coating. The pressure boundary welds have no visual weld defects.

Fire tube is in acceptable condition with light surface corrosion present

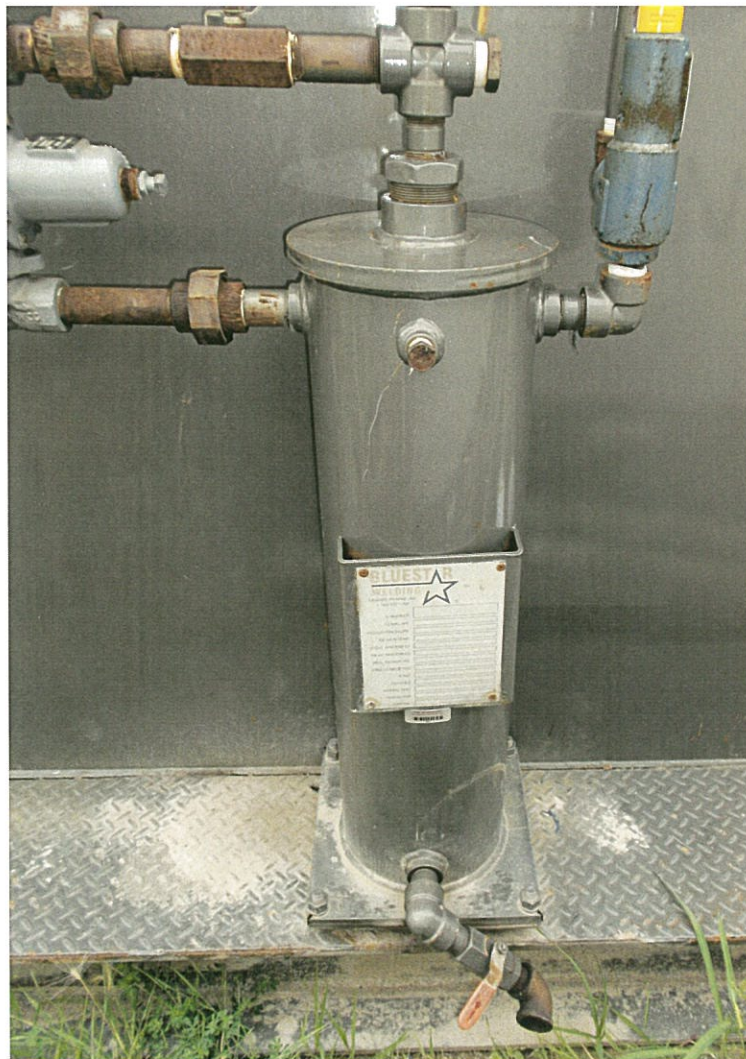
**Condition of Nameplate and/or Bracket:** Nameplate is intact and legible. The nameplate bracket is securely attached. Nameplate is in acceptable condition.

**Condition of Foundation and Anchor Bolts:** Anchor bolts are in place and secure. Vessel has a flat bottom head which also serves as a baseplate anchored to another baseplate welded to the skid. All Attachment welds appear sound.

**Condition of Steel Supports, Saddles, and Bolting:** The vessel baseplate/ flat bottom head has light surface corrosion but free from distortion.

**Condition of Paint and/or Insulation:** The paint is in good condition with no chipping or peeling. Vessel coating is in acceptable condition.

**Condition of Nozzles, Flanges, Repads, and Weepholes:** All threaded connection. Threaded coupling attachment welds appear sound.

**Condition of Welds; Head and Shell Metal Surfaces:** All (exposed) metal surfaces are painted. There is no distortion or indication of corrosion beneath the paint coating. The pressure boundary welds have no visual weld defects.
