| <b>Inspection Report for:</b> LH-0004 C1-C2 | |

**FMC Technologies Completion LH-0004 Line Heater**

| <b>Inspection Report for:</b> LH-0004 Fuel Gas Scrubber | |

**FMC Technologies Completion LH-0004 Line Heater Fuel Gas Scrubber**

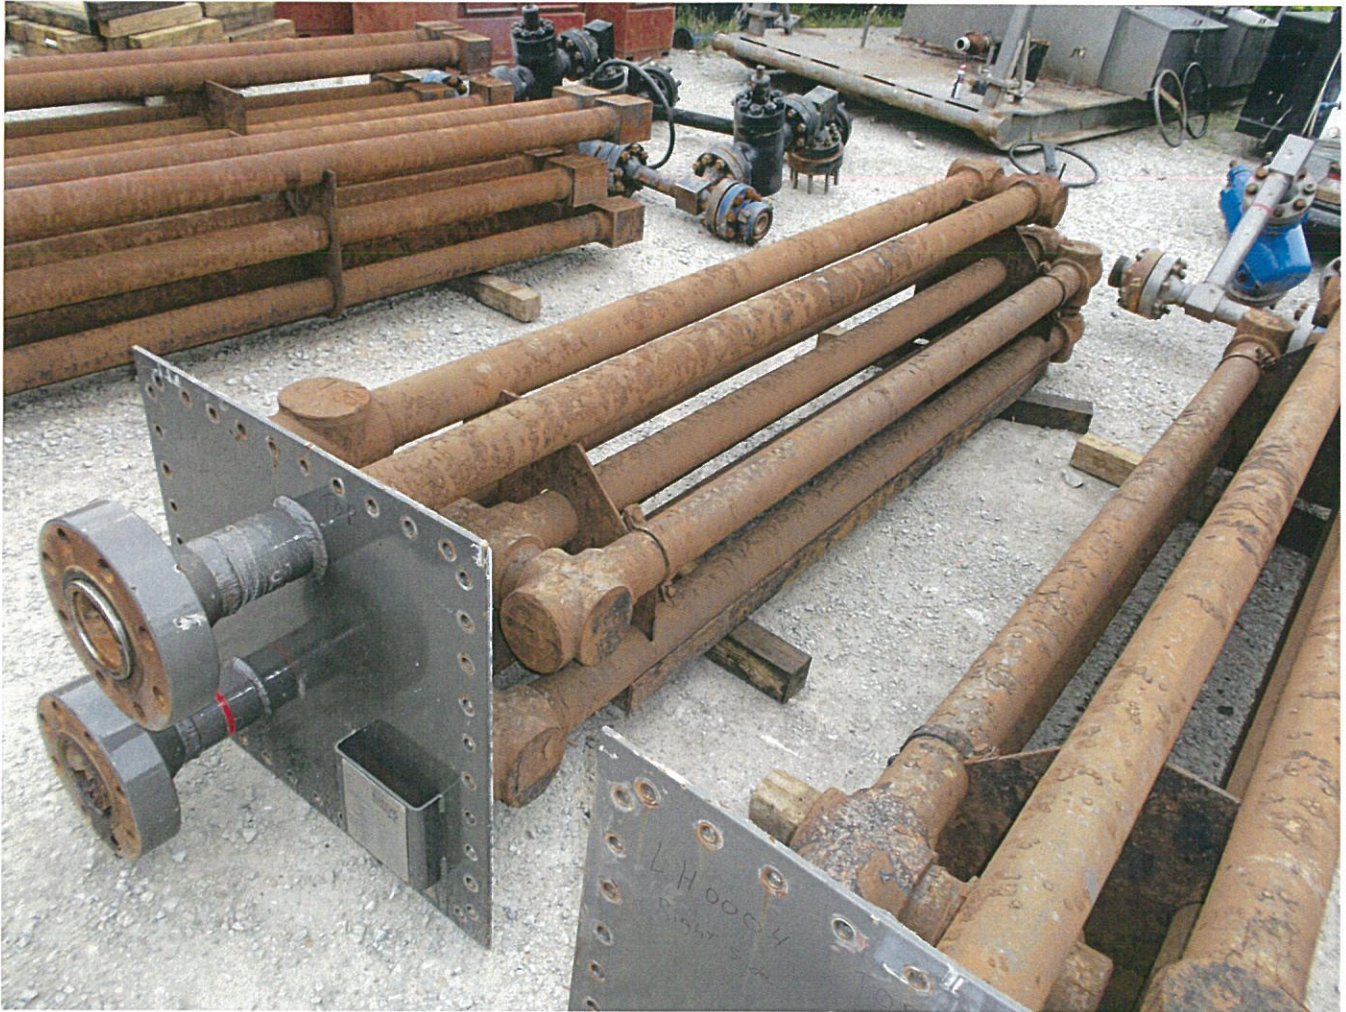
Coil #1

| Coating Condition: | Comments: |
|---|---|
| <input type="checkbox"/> Good<br><input checked="" type="checkbox"/> Fair, Some Blistering/Peeling<br><input checked="" type="checkbox"/> Corrosion Present (Describe)<br><input checked="" type="checkbox"/> Other<br><input checked="" type="checkbox"/> No Issues | Coils have no coating with minor corrosion and scaling present. |

| Condition of Welds: | Comments: |
|---|---|
| <input checked="" type="checkbox"/> Welds Are Full, Smooth and Well Profiled<br><input type="checkbox"/> Incomplete Fusion/Penetration<br><input type="checkbox"/> Crack Located Near Weld Seam<br><input type="checkbox"/> Weld Does Not Appear to Be Original<br><input type="checkbox"/> Joints-Misaligned<br><input type="checkbox"/> Undercut<br><input checked="" type="checkbox"/> Other<br><input checked="" type="checkbox"/> No Issues | Welds could not fully be observed due to scale build up, but are in overall good condition. |
