| <b>Inspection Report for:</b> LH-0004 C1-C2 | |

**FMC Technologies Completion - LH-0004 Line Heater**

## Corrosion Monitoring Eq/Circ ID Analysis Report

**FMC Technologies Completion - LH-0004 Line Heater Fuel Gas Scrubber**

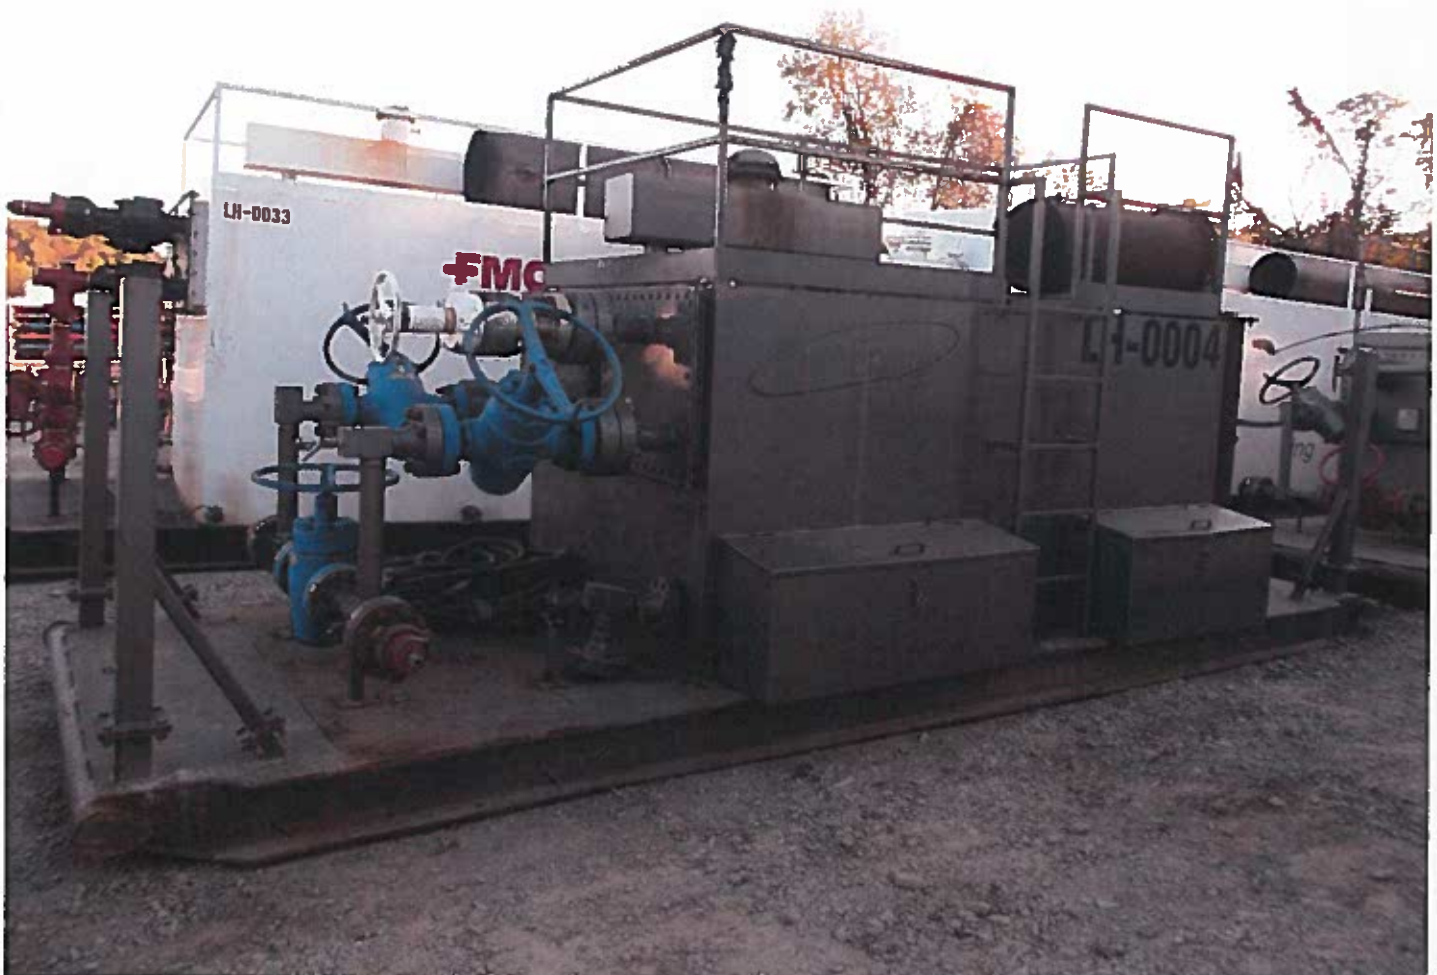
| <b>Remaining Life:</b> 1.3 YRS (Coil 1); 2.4 YRS (Coil 2) | <b>Date of this Report:</b> 08/22/2015 |
| <b>Rep. Corrosion Rate:</b> 71.4 MPY (Coil 1); 93.1 MPY (Coil 2) | <b>Next Inspection Due Date:</b> 08/22/2016 |

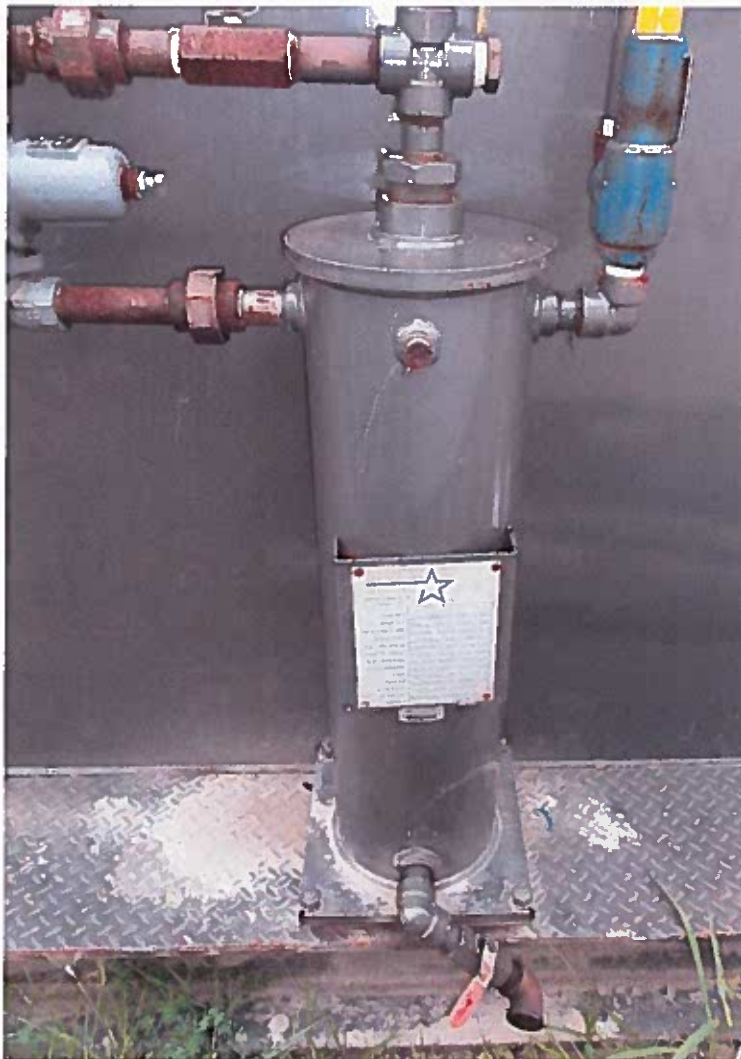
**Condition of Nameplate and/or Bracket:** Nameplate is intact and legible. The nameplate bracket is securely attached. There are signs of moderate corrosion beneath attachment area of nameplate-to-shell.

**Condition of Foundation and Anchor Bolts:** Anchor bolts are in place and secure. Vessel has a flat bottom head which also serves as a baseplate anchored to another baseplate welded to the skid. All (4) anchor bolt nuts are in place and secure.

**Condition of Paint and/or Insulation:** The paint is in acceptable condition with minor localized chipping and peeling. Vessel coating is in acceptable condition.

**Condition of Welds; Head and Shell Metal Surfaces:** All (exposed) metal surfaces are painted. There is no distortion or indication of corrosion beneath the paint coating. The pressure boundary welds have no visual weld defects.
