| <b>Inspection Report for:</b> LH-0004 Fuel Gas Scrubber | |

**FMC Technologies Completion - LH-0004 Line Heater Fuel Gas Scrubber**

**FMC Technologies Completion - LH-0004 Line Heater Coil 1**

**FMC Technologies Completion - LH-0004 Line Heater Coil 2**

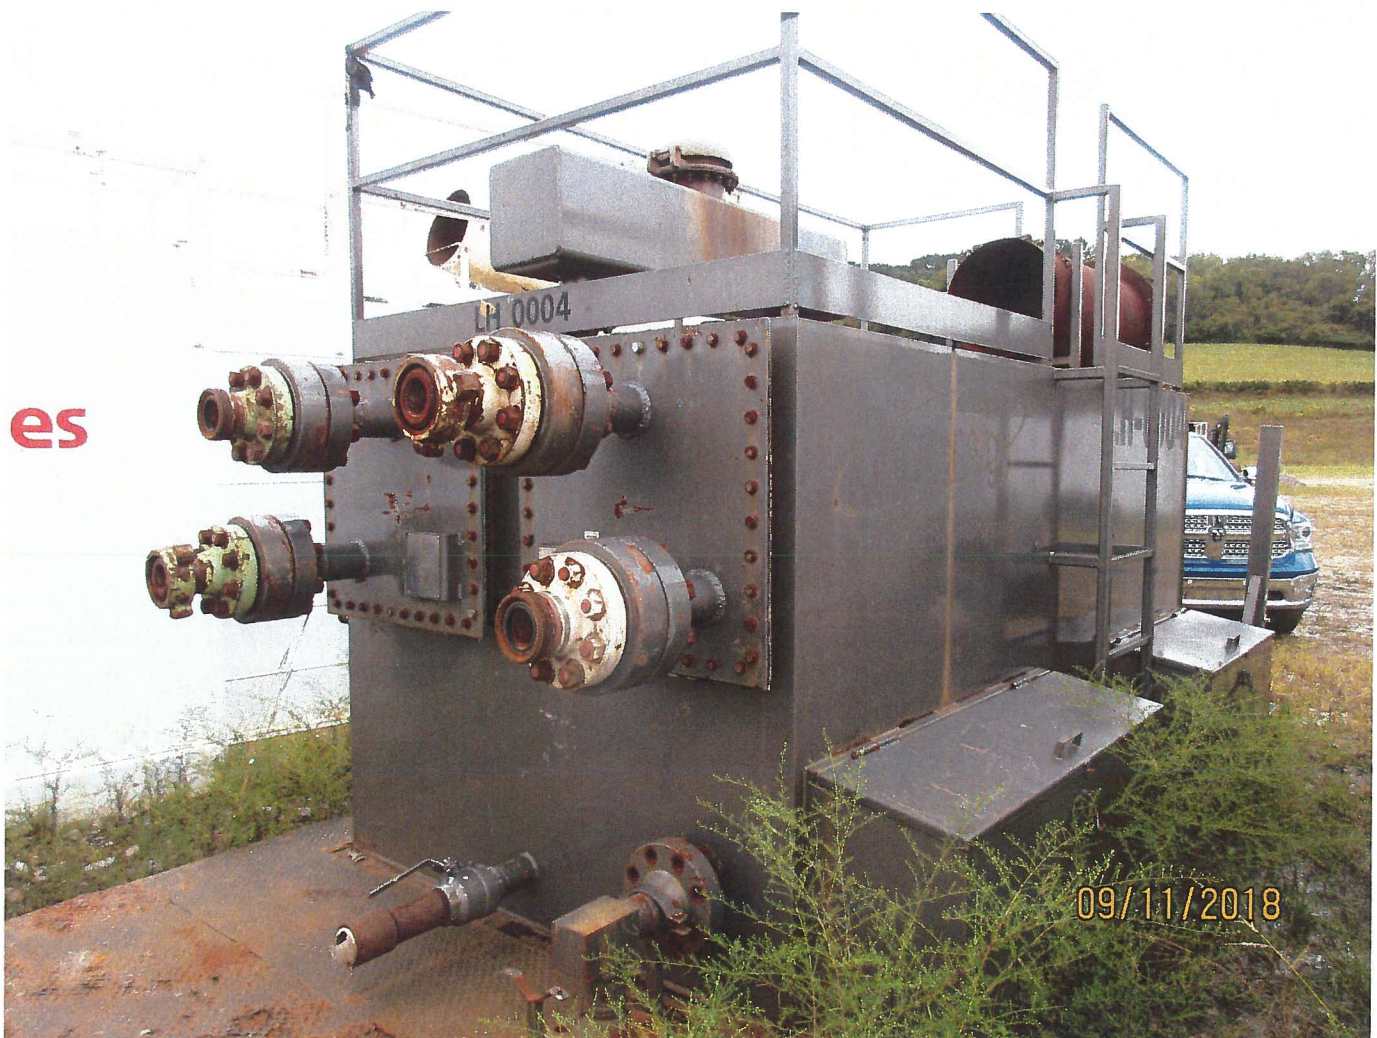
**Condition of Foundation and Anchor Bolts:** Bundle removed from heater. Front plate in acceptable condition.

**Condition of Steel Supports, Saddles and Bolting:** Angle iron supports have heavy corrosion/scaling buildup.

**Condition of Paint and/or Insulation:** Front plate has minor chipping with surface corrosion.

**Condition of Nozzles, Flanges, Repads, and Weepholes:** Nozzles and flanges are in good condition. Coils were pulled out of the Line Heater. There was no piping bolted.

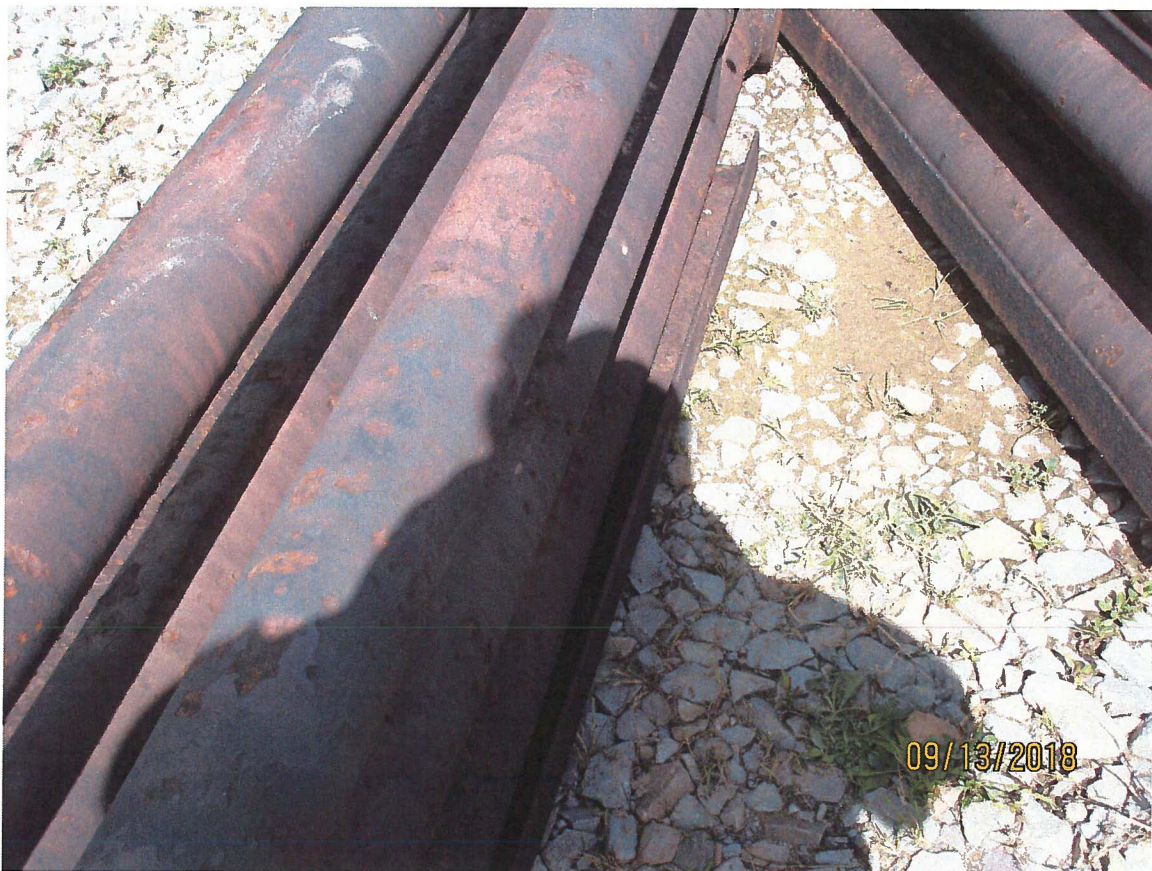
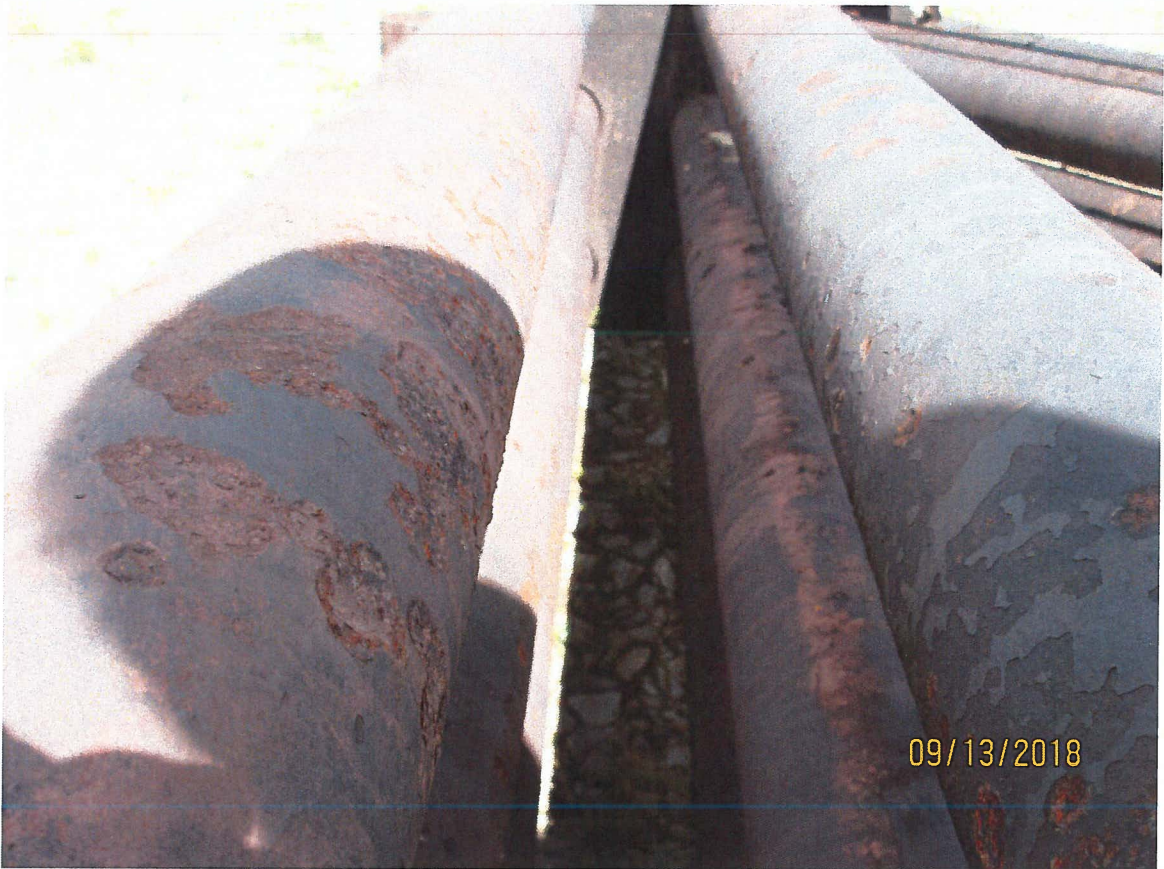
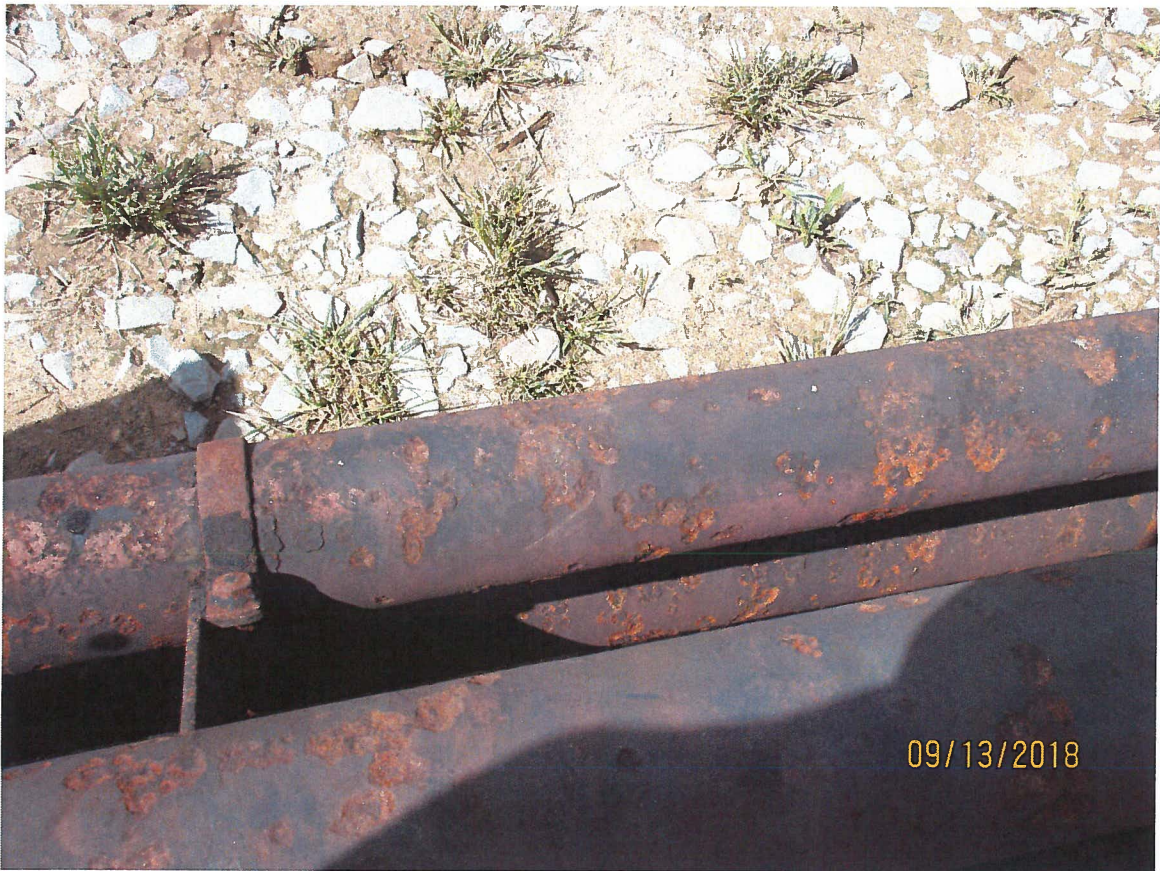
Coils have heavy corrosion with scaling. Pitting as deep at 1/16". Angle iron under tubes has come loose.

Repair angle iron under tube bundle.

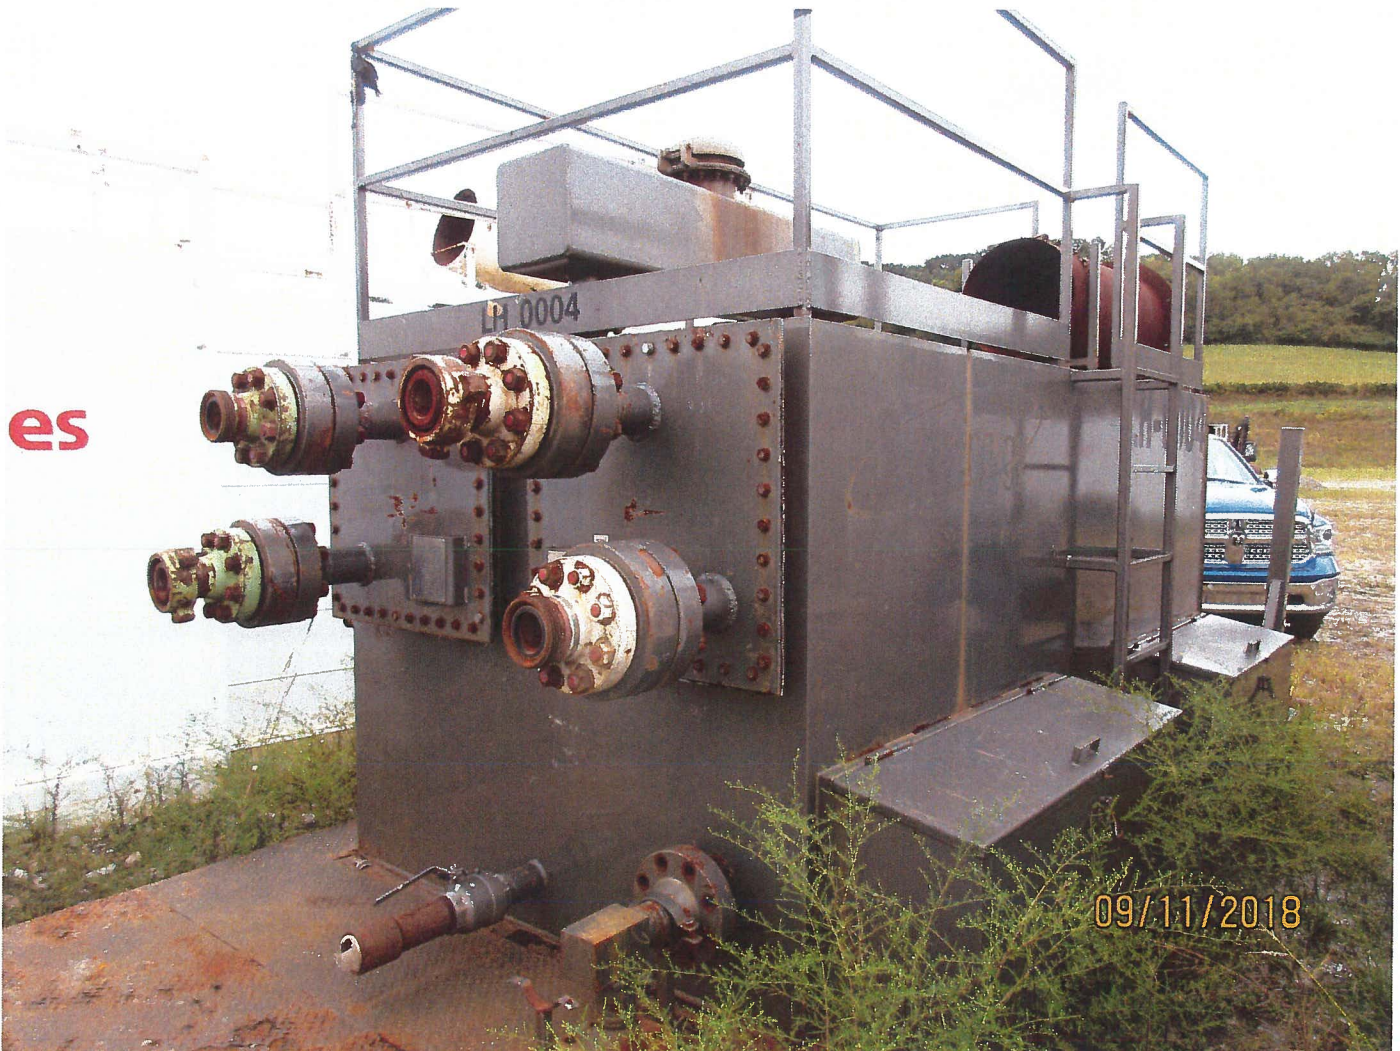
**Condition of Foundation and Anchor Bolts:** The bundle was removed from the heater. Front plate is inacceptable condition.

**Condition of Steel Supports, Saddles and Bolting:** Angle iron supports have heavy surface corrosion/scale buildup.

**Condition of Paint and/or Insulation:** The paint is in acceptable condition with minor localized chipping and peeling. Coils have heavy corrosion with scaling.

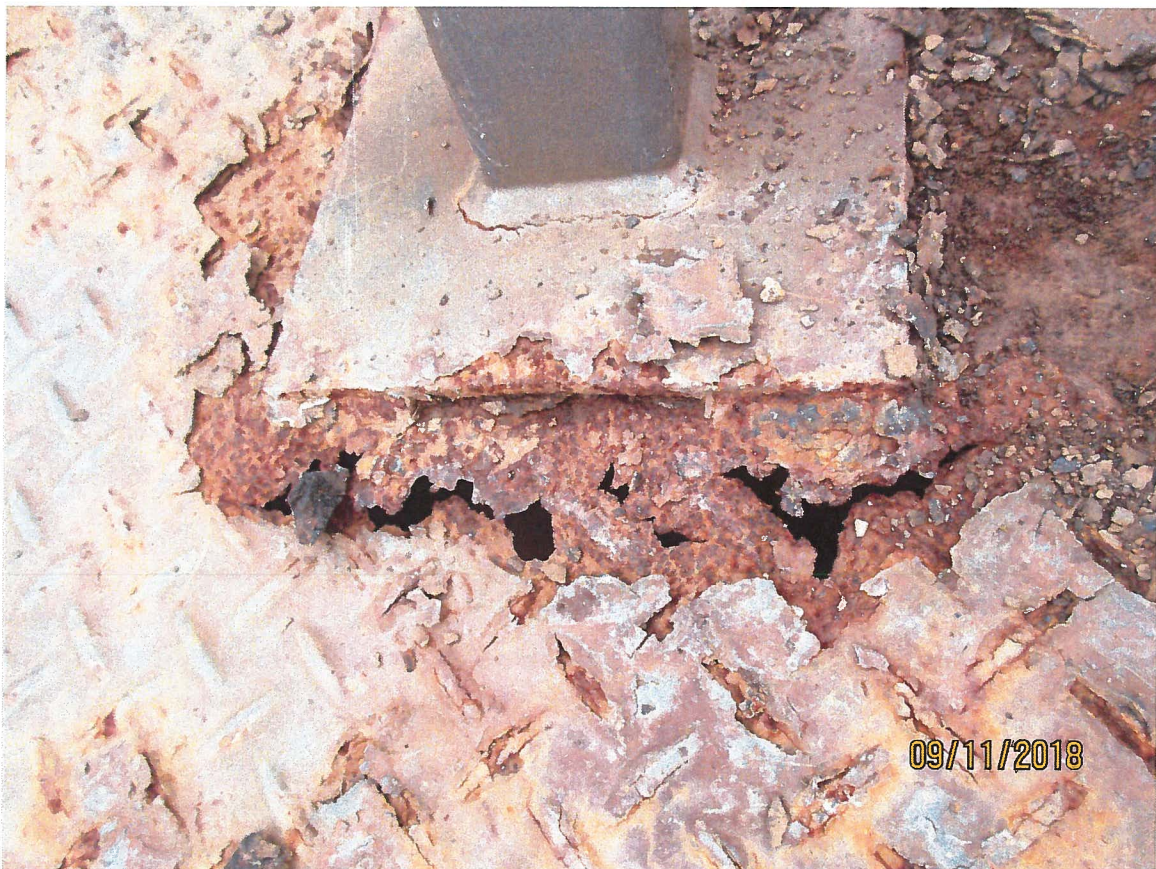
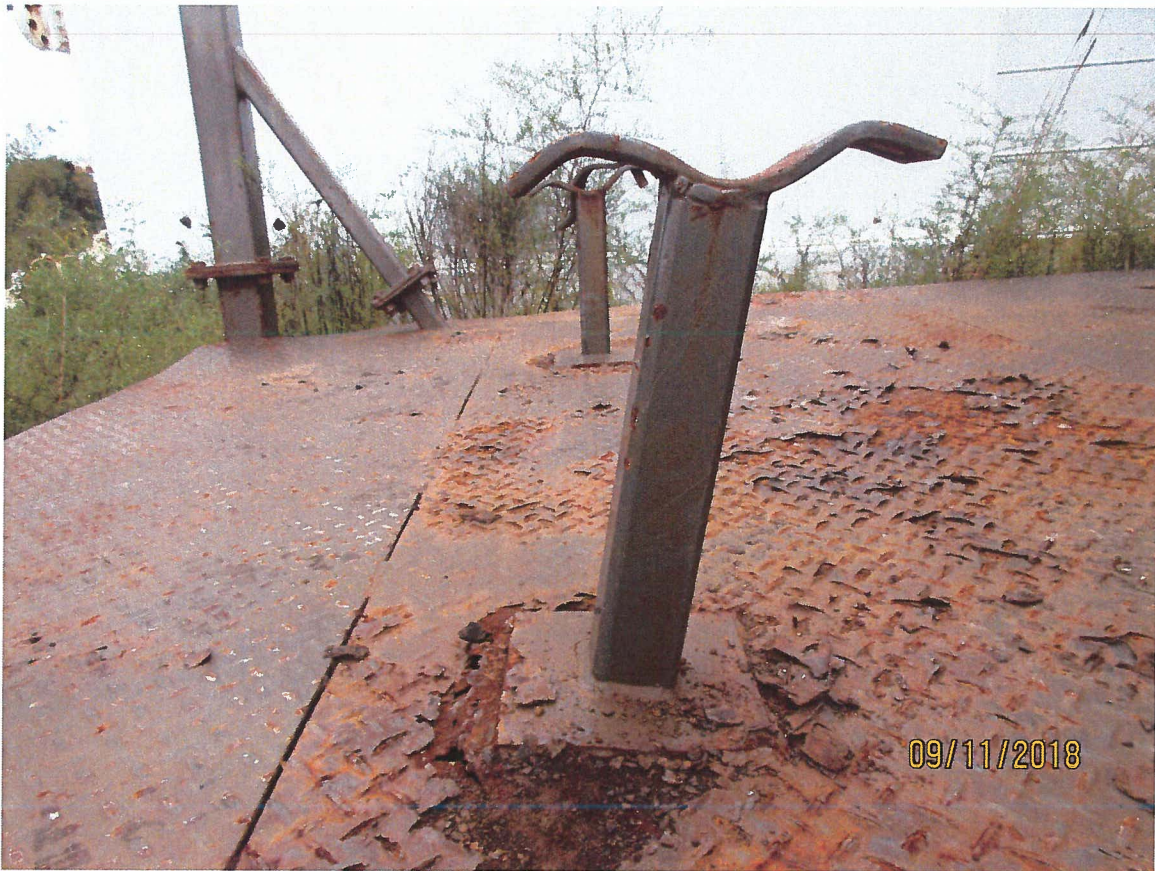
Coils have heavy corrosion with scaling.

Pipe support on skid is rotted out and bent.

Repair pipe support and drain fitting as well as the angle iron shoe on the coil.

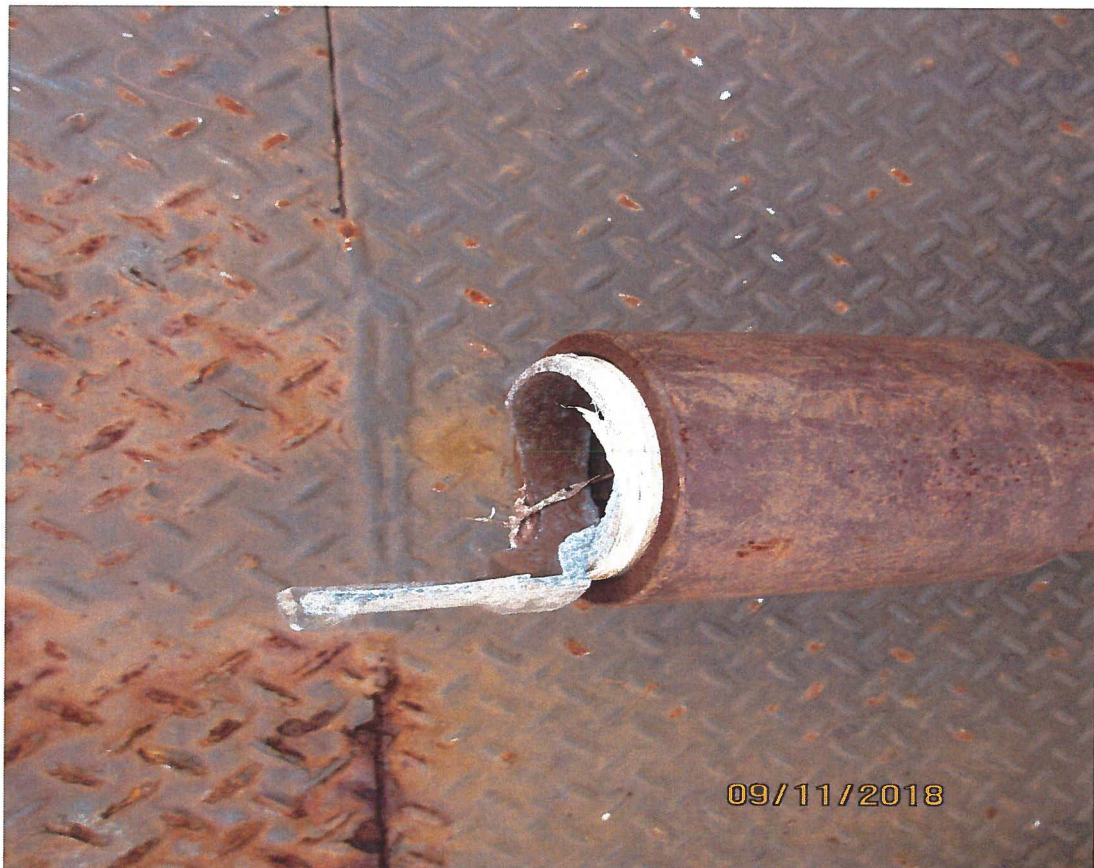
Drain has broken fitting.

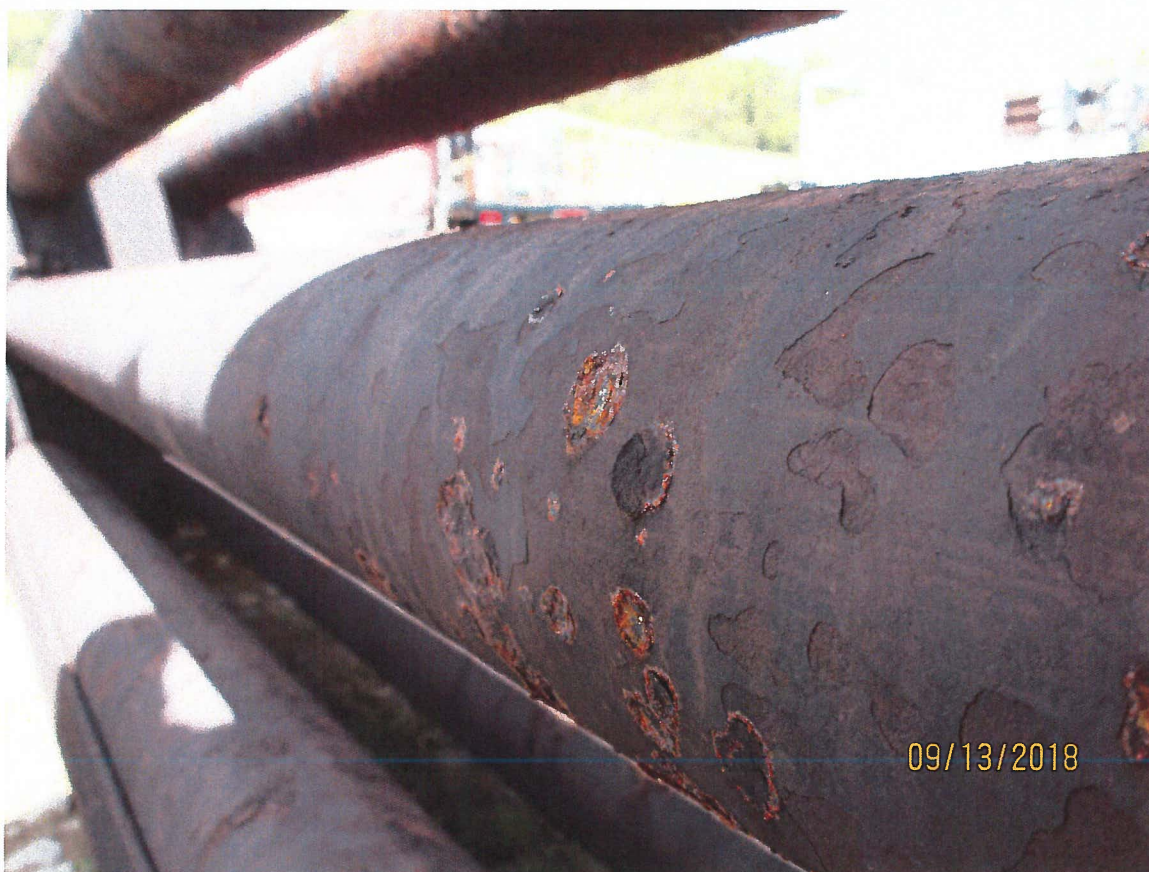
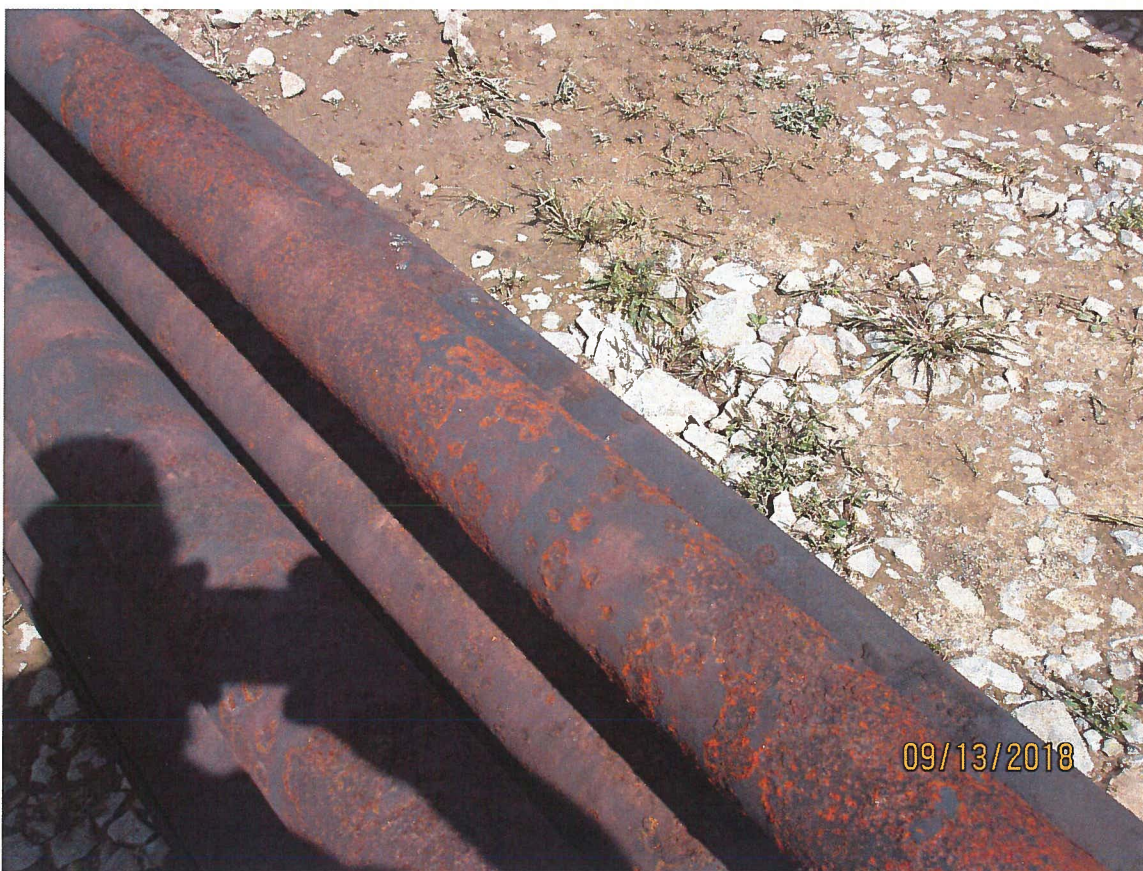
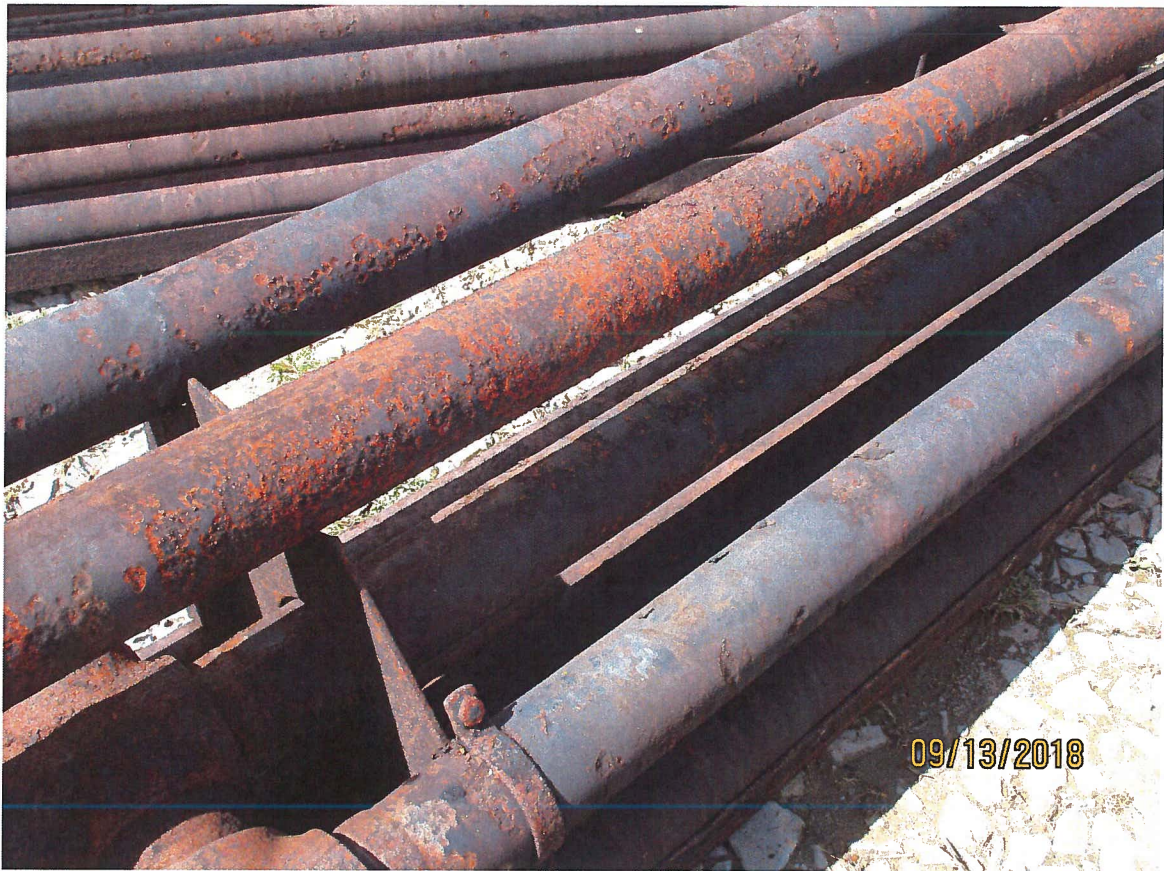
Pitting as deep as 1/16" found.
