| <b>Inspections Performed for:</b> FMC Technologies Completion | |
| <b>Inspection Report for:</b> LH-0010 Line Heater (Does Not Include The Coils) | |
| <b>Date of this Report:</b> 03/10/2014 | <b>Next Inspection Due Date:</b> 03/10/2015 |

## LINE HEATER EXTERNAL INSPECTION REPORT

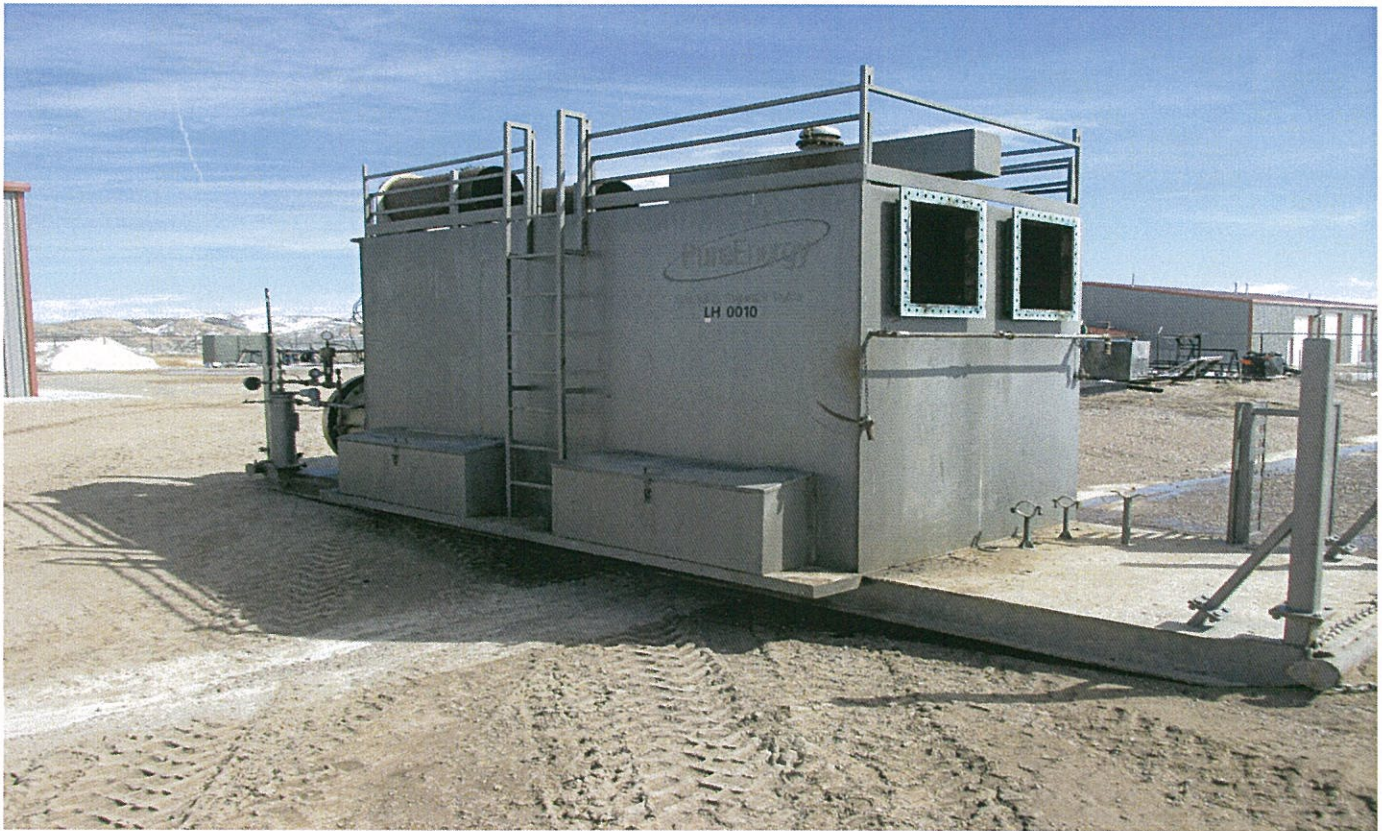
**Flame Arrested Burner:** Is in good overall condition with no surface corrosion present.

**Top Reservoir Tank:** Is in good overall condition with no corrosion present.

**Shell:** Shell to shell attachment welds appear sound.

**Threaded coupling:** Attachment welds appear sound.

**Flanged Head:** Gasket is free from pitting or surface corrosion. Coating is in good condition.

**Ladder:** Access ladder attachment welds appear sound and the ladder is in good overall condition.

**Skid Decking:** Skid Decking to heater attachment welds appear sound and overall is in good condition.

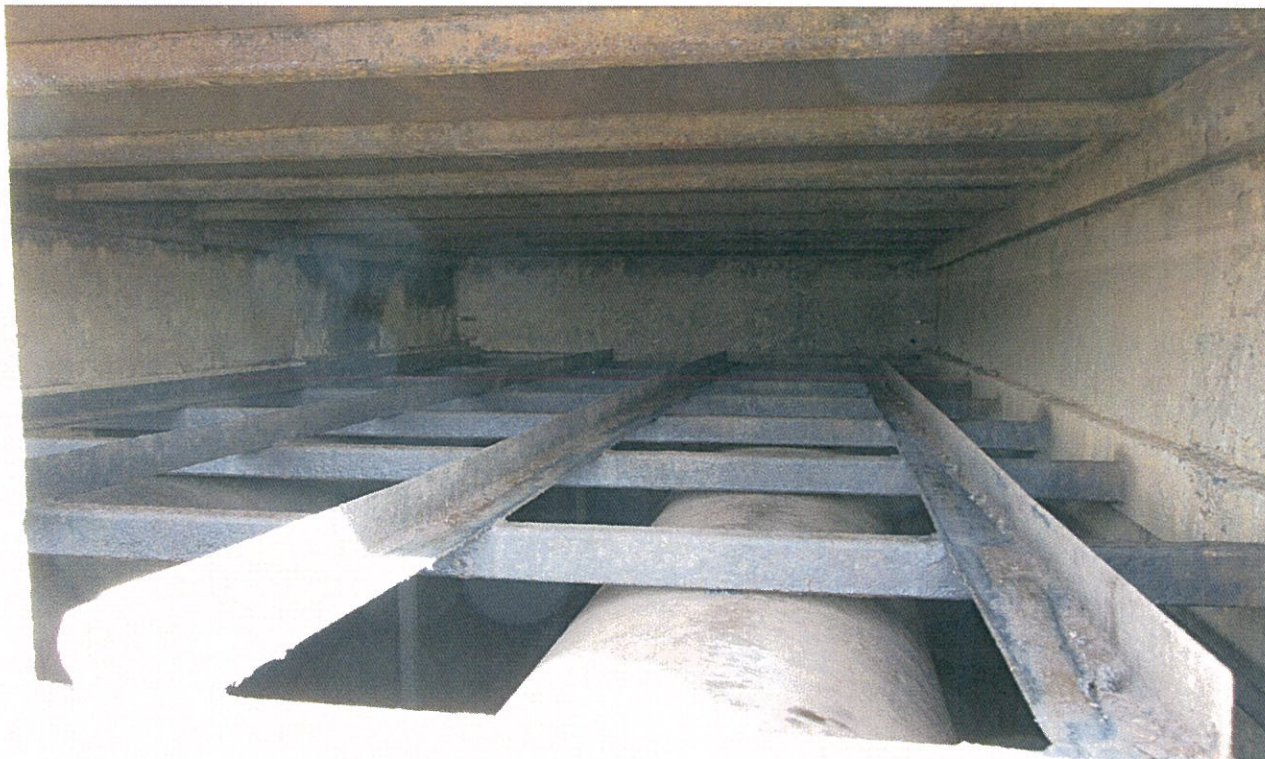
**Internal:** Internal supports appear to be in good condition with no reformation. There is light surface corrosion present. Welds not observed.

**Fire tube:** Appears to be in good condition (no access). Welds not observed. Moderate surface corrosion and scale present.

**Shell Internal:** Has minor scale build up as well as light surface corrosion.

**Comments:** Per Scott they have introduced a corrosion inhibitor into the glycol mixture to help mitigate against surface corrosion/scale build up.

**Recommendations:** None

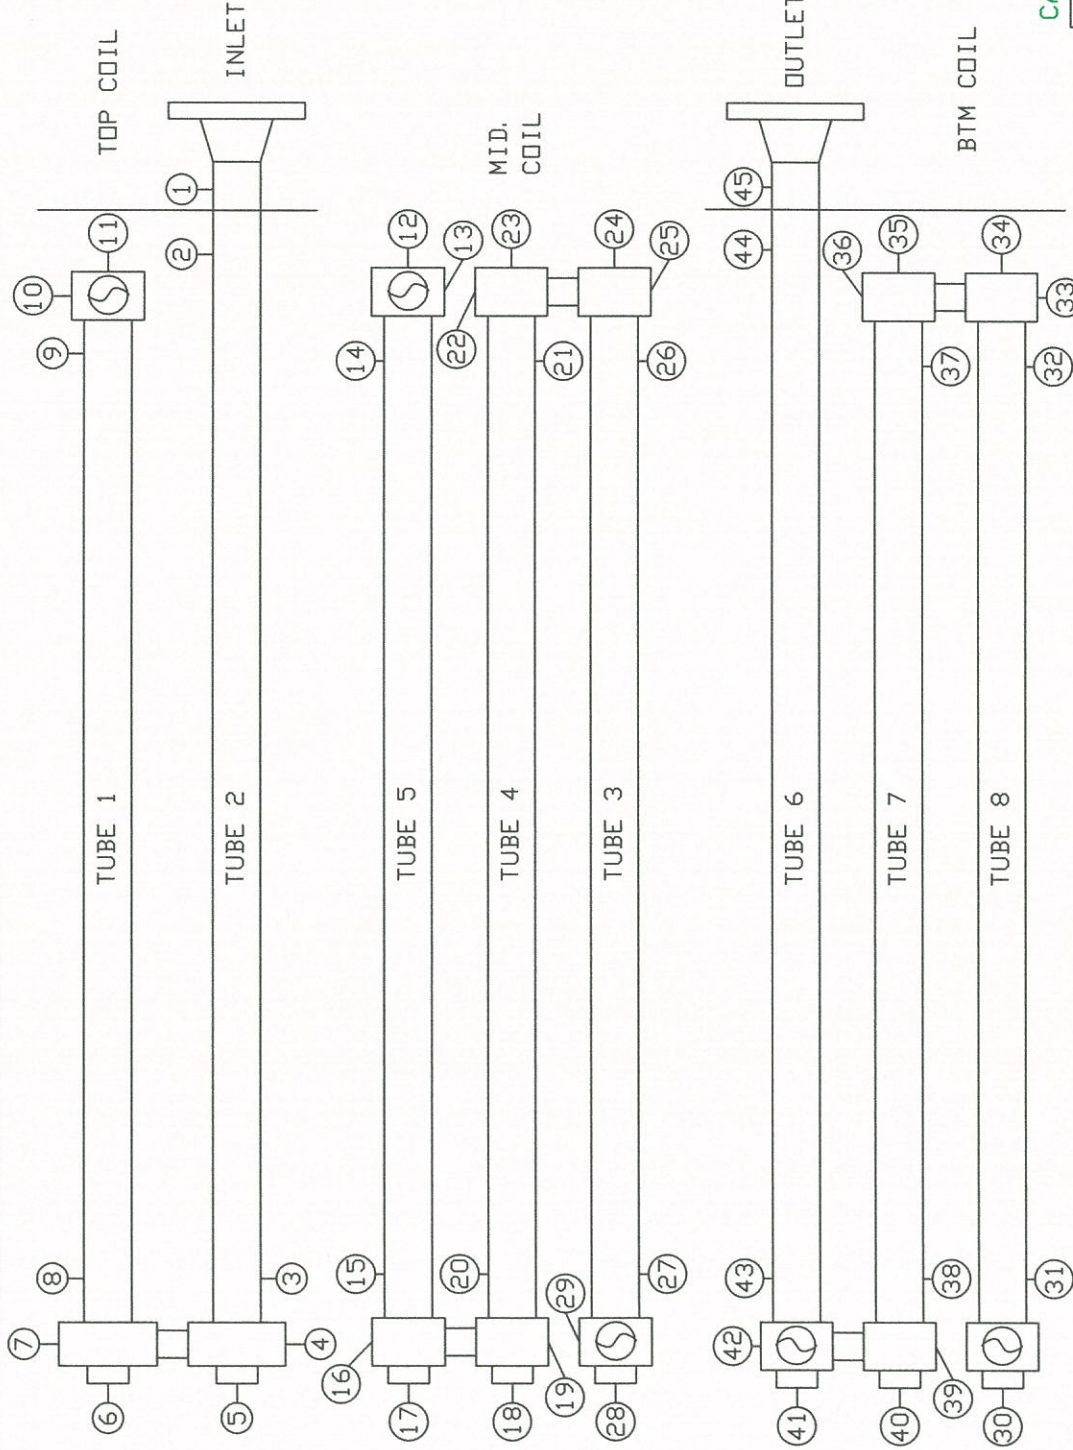
| NAMEPLATE INFO | |
| MFG | BLUESTAR WELDING |

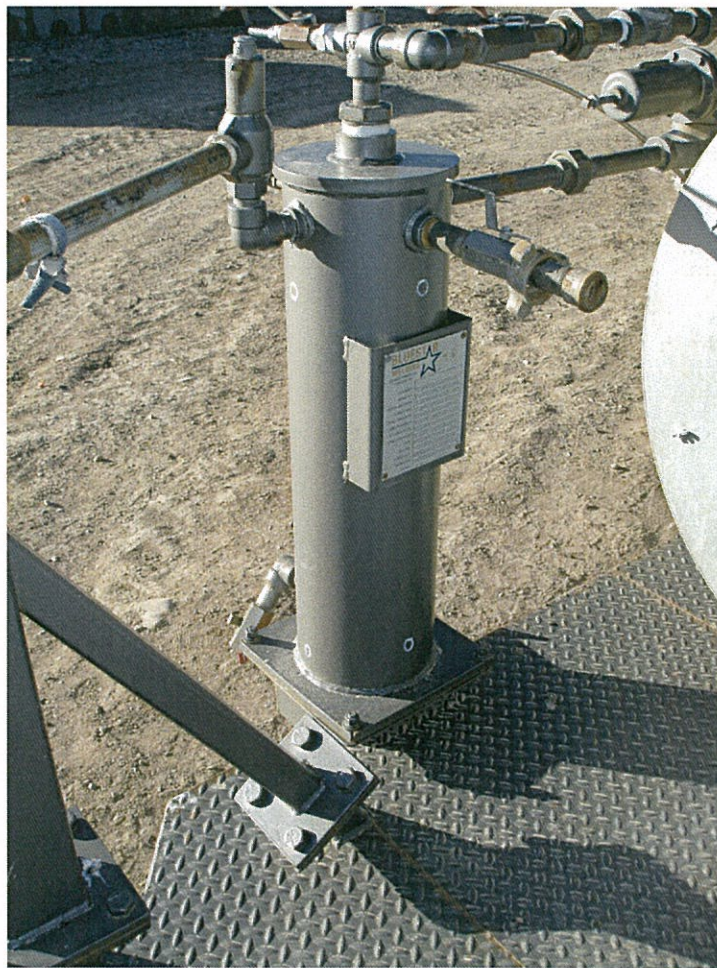
**FMC Technologies Completion LH-0010-FGS-1 Fuel Gas Scrubber**

**Condition of Nameplate and/or Bracket:** Nameplate is intact and legible. The nameplate bracket is securely attached.

**Condition of Foundation and Anchor Bolts:** Anchor bolts are in place and secure. The vessel is anchored to the heater skid. All (4) anchor bolt nuts are in place and secure.

**Condition of Steel Supports, Saddles, and Bolting:** All support structural welds appear sound.

**Condition of Paint and/or Insulation:** The paint is in good condition.

**Condition of Nozzles, Flanges, Repads, and Weepholes:** All threaded couplings. The threaded coupling attachment welds appear sound. There is no evidence of leaks at any of the threaded connections.

**Condition of Welds; Head and Shell Metal Surfaces:** All (exposed) metal surfaces are painted. There is no distortion or indication of corrosion beneath the paint coating. The pressure boundary welds have no visual weld defects.

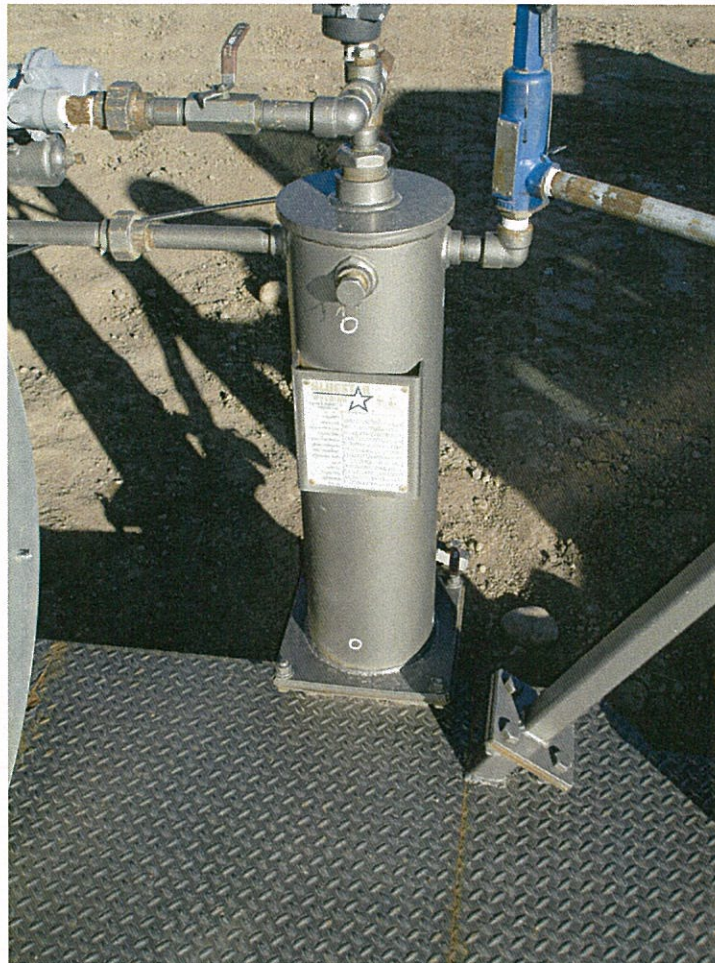
**FMC Technologies Completion LH-0010-FGS-2 Fuel Gas Scrubber**

**Condition of Nameplate and/or Bracket:** Nameplate is intact and legible. The nameplate bracket is securely attached.

**Condition of Foundation and Anchor Bolts:** Anchor bolts are in place and secure. The vessel is anchored to the heater skid. All (4) anchor bolt nuts are in place and secure.

**Condition of Steel Supports, Saddles, and Bolting:** All support structural welds appear sound.

**Condition of Paint and/or Insulation:** The paint is in good condition with no chipping or peeling.

**Condition of Nozzles, Flanges, Repads, and Weepholes:** All threaded couplings. The threaded coupling attachment welds appear sound. There is no evidence of leaks at any of the threaded connections.

**Condition of Welds; Head and Shell Metal Surfaces:** All (exposed) metal surfaces are painted. There is no distortion or indication of corrosion beneath the paint coating. The pressure boundary welds have no visual weld defects.

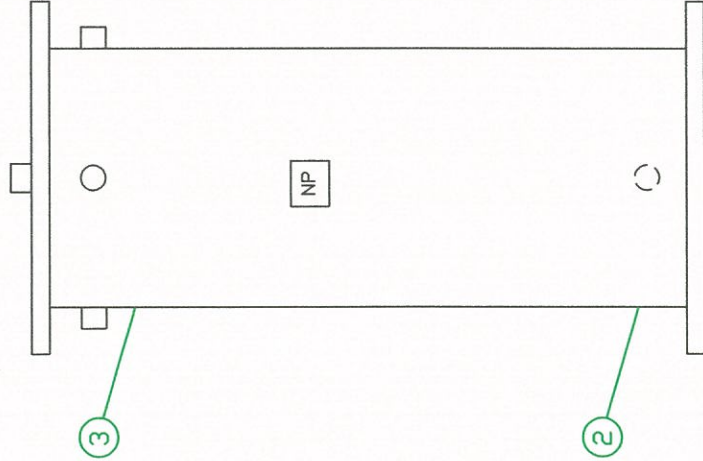
- #2. 01- SH-FRONT 0. 319 TC
- #2. 02- SH-LEFT 0. 302 TC
- #2. 03- SH-BACK 0. 304 TC
- #2. 04- SH-RIGHT 0. 315 TC
- #3. 01- SH-FRONT 0. 317 TC
- #3. 02- SH-LEFT 0. 317 TC
- #3. 03- SH-BACK 0. 315 TC
- #3. 04- SH-RIGHT 0. 319 TC
