| <b>Inspection Report for:</b> LH0034-C1 Line Heater | <b>Date Last Inspected:</b> 11/12/2017 |

**FMC Technologies Completion LH0034-C1 (Coil 1)**

# API 510 PRESSURE VESSEL EXTERNAL INSPECTION REPORT

**FMC Technologies Completion LH-0034 Fuel Gas Scrubber**

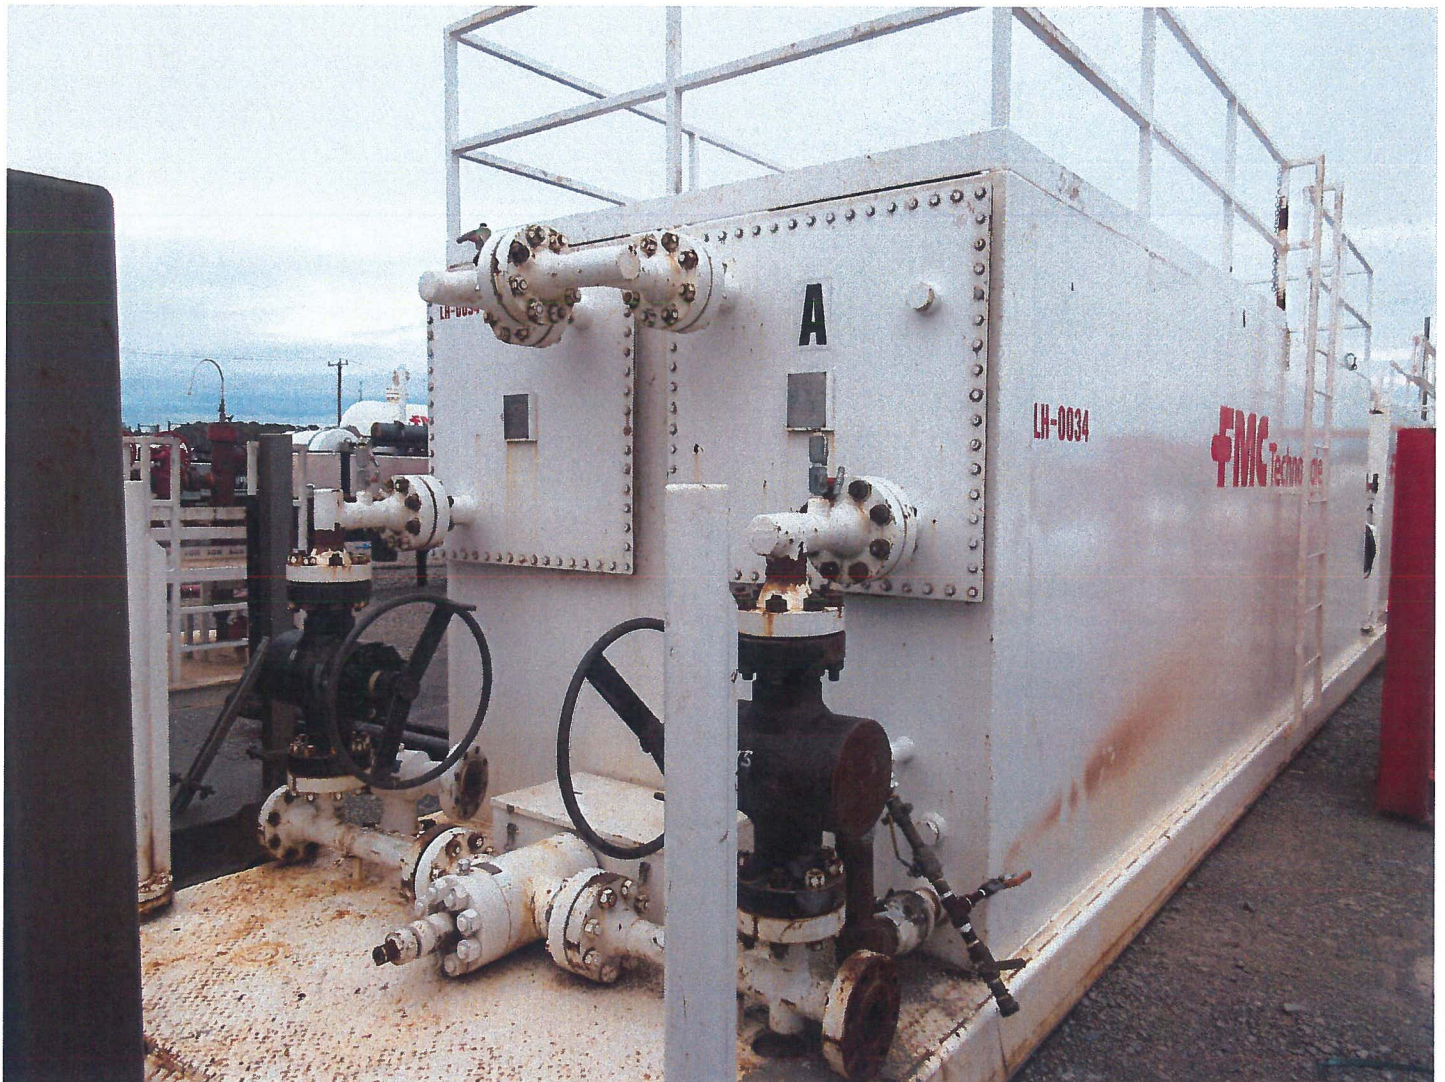
**Condition of Paint and/or Insulation:** The paint is in acceptable condition with minor localized chipping and peeling. There is moderate surface corrosion on the Coils.

Fired tubes on this until were hammer tested and no areas of concern were found. Coils have moderate corrosion.

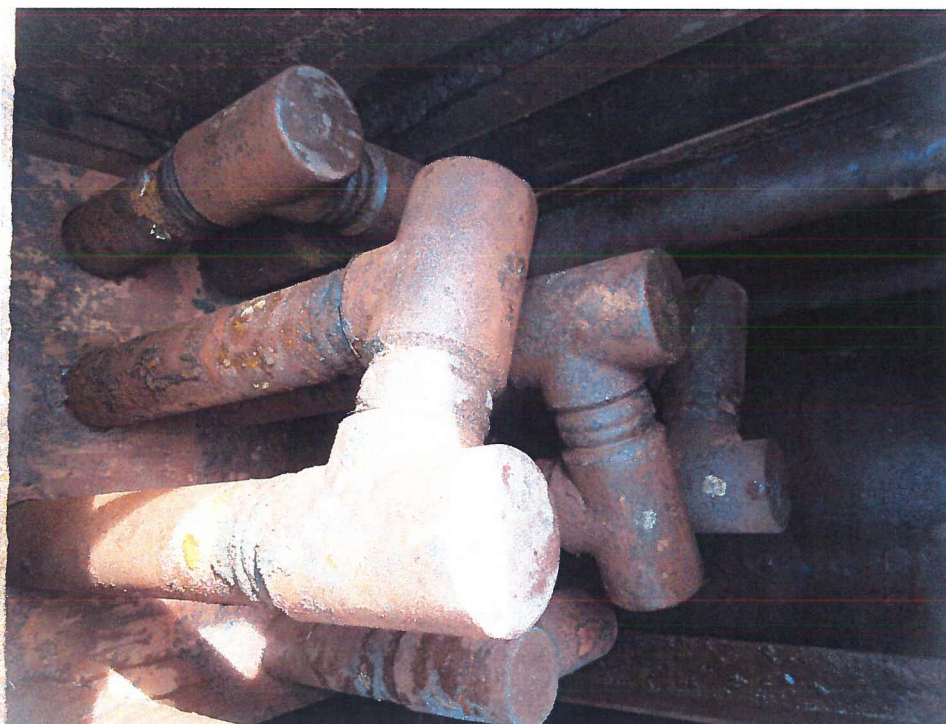
**Condition of Paint and/or Insulation:** The paint is in acceptable condition with minor localized chipping and peeling. Coils have moderate corrosion with scaling.

Coils have moderate corrosion.

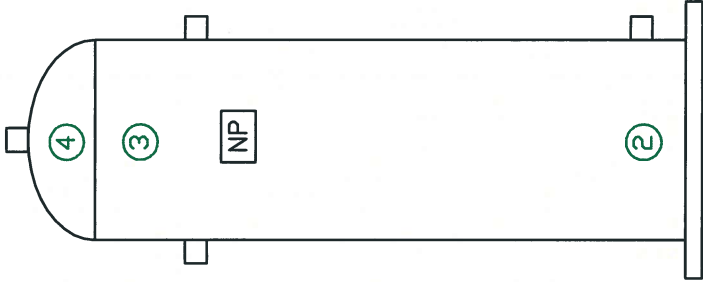
TC-560

- #2. 01- BTM SHELL-F 0. 310 TC
- #2. 02- BTM SHELL-L 0. 313 TC
- #2. 03- BTM SHELL-BK 0. 302 TC
- #2. 04- BTM SHELL-R 0. 316 TC
- #3. 01- TOP SHELL-F 0. 318 TC
- #3. 02- TOP SHELL-L 0. 316 TC
- #3. 03- TOP SHELL-BK 0. 321 TC
- #3. 04- TOP SHELL-R 0. 324 TC
- #4. 01- TOP HEAD-F 0. 292 TC
- #4. 02- TOP HEAD-L 0. 300 TC
- #4. 03- TOP HEAD-BK 0. 291 TC
- #4. 04- TOP HEAD-R 0. 299 TC
