11-28-013-20W4M
Fuel gas scrubber
251994
REPORT # 251994__28FEB2025_UT_VE_GRADYINSPECTIONLTD

DATE 2025-02-28
CLIENT OSL

Ultrasonic Report

External Inspection - (Vessel)		Date	2025-02-28	403-793-7697

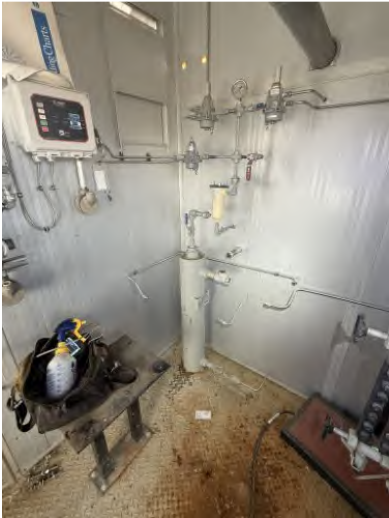
Overview

Fit For Service:	Fit For Service.
Inspection Summary:	Pre-purchase inspection of vessel, out of service in storage yard. Vessel is in good visual condition and is suitable for service. PSV not installed and is overdue for service

Recommendations:	Service PSV
-------------------------	-------------
