## Ultrasonic Inspection Report

**UT\_SN 10154B\_Flare Knockout\_aug2025**

Client: <b>Fuelled</b>	Facility: <b>n/a</b>	Date: <b>Aug 22, 2025</b>
LSD: <b>n/a</b>	Item(s) Inspected: <b>Flare Knockout Drum</b>	Job #: <b>13752</b>
Material: <b>Carbon Steel / Stainless Steel</b>	Thickness Range: <b>0 to 75mm</b>	WO #: <b>n/a</b>
Procedure: <b>UT-01 Rev. 9</b>	Ref. Code: <b>ASME VIII &amp; ASME B31.3</b>	Surf. Temp: <b>-20° to 20° C</b>
UT Equipment: <b>Asset# FD-15 Olympus Epoch XT</b>	Serial Number: <b>070057201</b>	Cal. Due: <b>Dec. 16, 2025</b>
Transducer 1: <b>Asset# T-243 Technisonic Research</b>	0° Dual 5MHz Diam. 6.35mm	Serial #: <b>25952</b>
Transducer 2: <b>Asset# T-54 Olympus D-790-SM</b>	Hot Probe 0° 5MHz Diam. 6.35mm	Serial #: <b>858220</b>
Transducer 3: <b>Asset# T-255 Olympus P/E</b>	0° 5MHz Diameter 12.7mm	Serial Number: <b>1412290</b>
Cal. Block 1: <b>Asset# CB-80 (1018) Carbon Steel</b>	6-step wedge	Serial Number: <b>62196</b>
Cal. Block 2: <b>Asset# CB-75 Stainless Steel</b>	Step Wedge 2.5 -12.5mm	Serial Number: <b>52747</b>

**Job Scope:** To perform a baseline ultrasonic thickness survey on the requested vessel located at 06-03-69-06 w6m in the Wapiti Field.

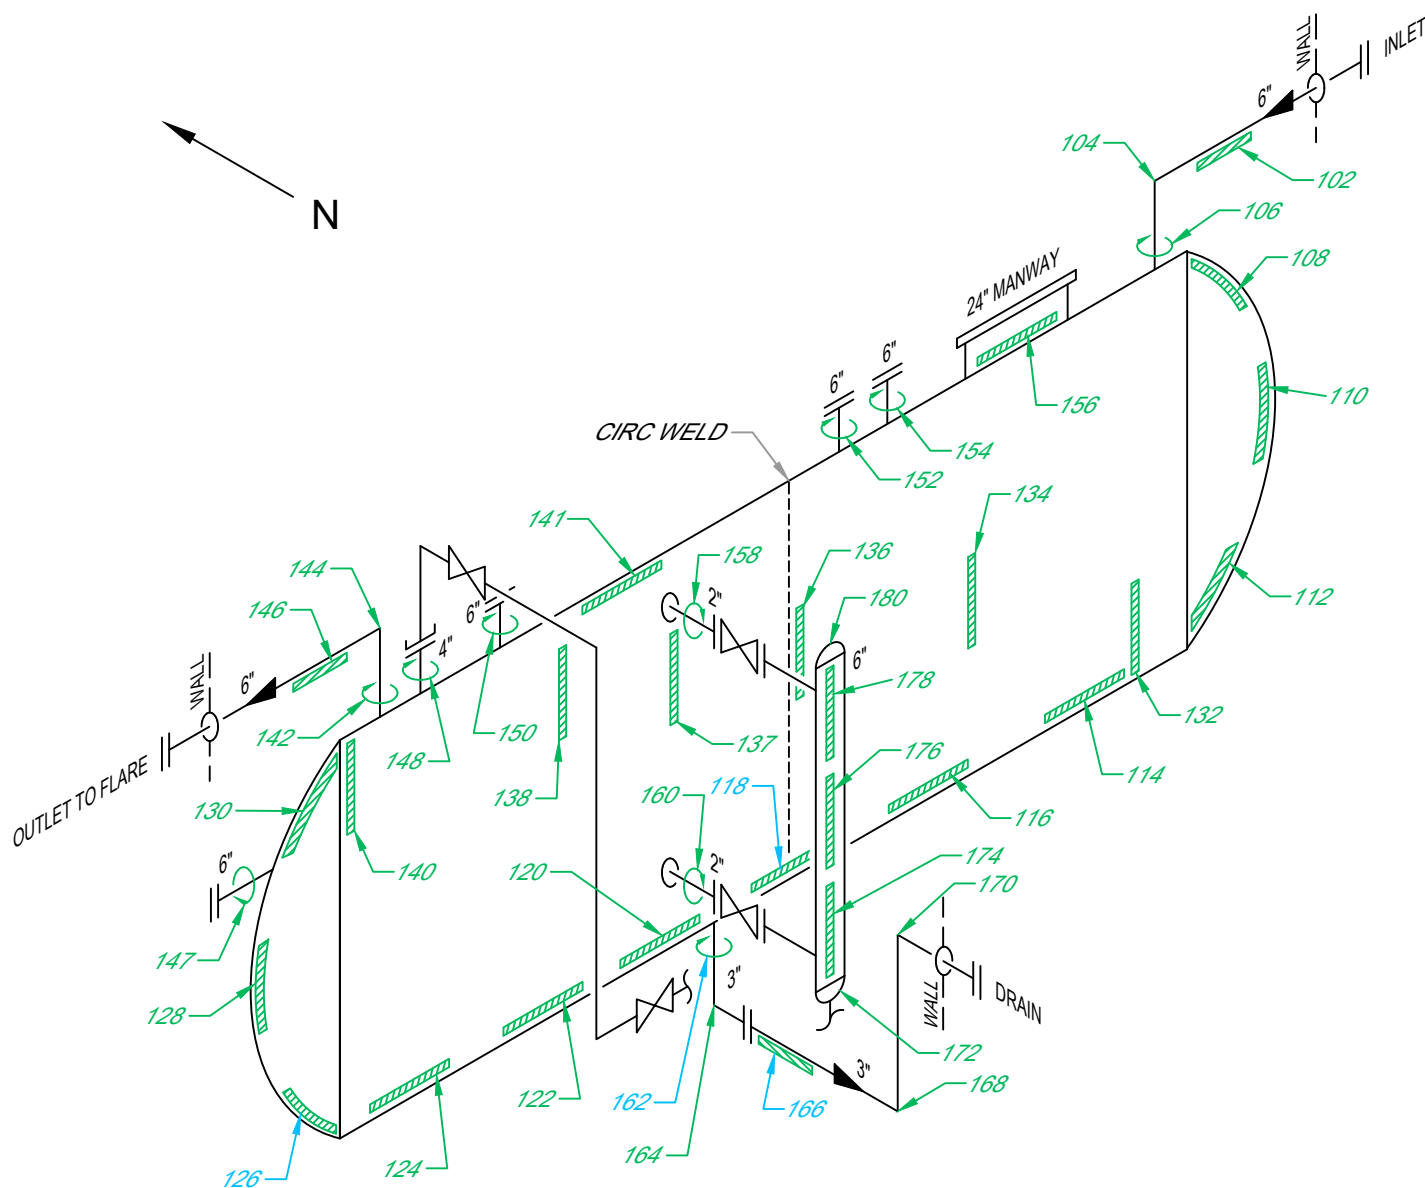
Customer: FUELLEDDescription: FLARE KNOCKOUT DRUMFacility: N/ALocation: N/AReg A#: N/ASerial #: 10154BDrawing#: 1CRN #: N/AManufacturer: PRISM INTEGRATEDUnit #: C84179Year Built: 2014Shell MAWP: 103 kPaShell MAWT: N/AShell Material: N/SNominal: 9.5mmCA: N/S

NOTE: VESSEL IS INTERNALLY COATED. ALL NOZZLE FLANGES HAVE A 150 lb RATING.

AUG 2025\_LOCATED ON CNRL SITE 06-03-69-06 W6M AT TIME OF INSPECTION.
