ALTEC INSPECTION LTD.

GENERAL INSPECTION FORM						
Company Name: Fuelled Family of Companies				Inspection Date: September 17 th , 2025		
Facility: N/A				Location (LSD): CNRL FSJ Meek's Boneyard		
Vessel Name & Equipment Number: Flare Knockout Drum						
Orientation: Horizontal <input checked="" type="checkbox"/> or Vertical <input type="checkbox"/>				Status: operating <input type="checkbox"/> or shut-in <input checked="" type="checkbox"/>		
External Inspection <input checked="" type="checkbox"/>				Commissioning Inspection <input type="checkbox"/> or Corporate Inspection <input checked="" type="checkbox"/>		
NON-CODE VESSEL NAMEPLATE DATA						
"A" or BC Registration Number: N/A				Company Tag # (if applicable):		
CRN Number: N/A				Associated PSV Tag # (if applicable):		
Vessel serial number: C7407 V1				Size (diameter x length- estimate if necessary): 100" OD x 20'0" S/S (Approx.)		
Shell thickness: 0.375" (Assumed)				Shell material: SA-516-70 (ASSUMED)

EQUIPMENT EXTERNAL PICTURES: Page 3

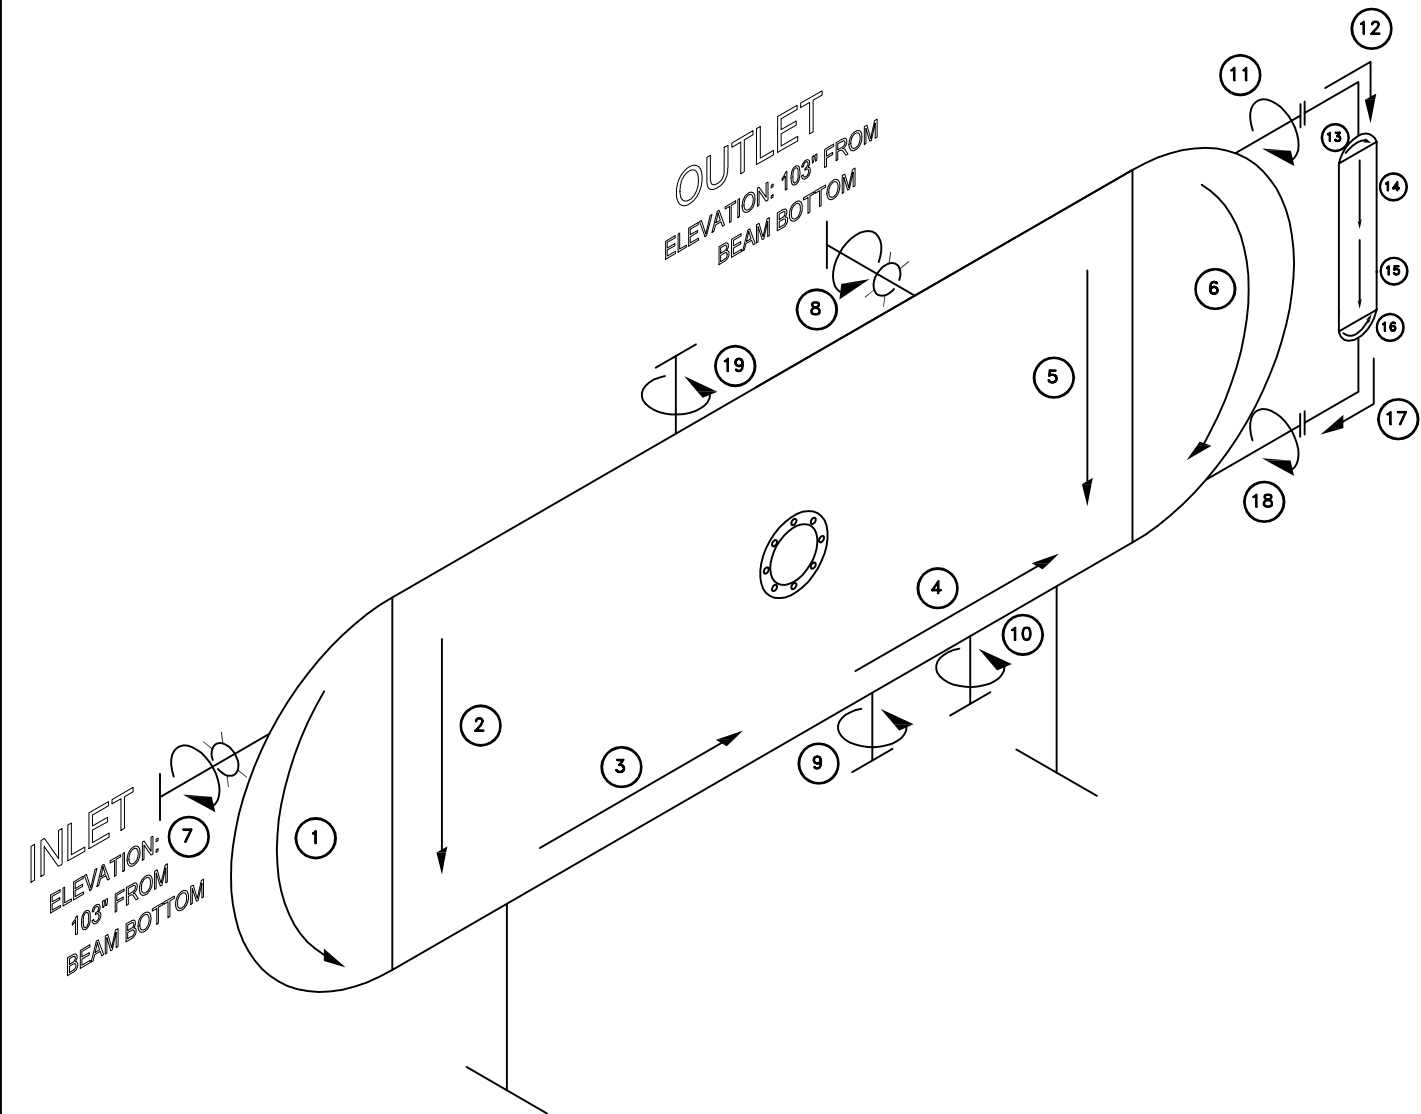
ALTEC INSPECTION LTD.	FLARE KNOCKOUT DRUM	
	CNRL MEEK'S BONEYARD	
BY: T.NINAN	DATE: SEPTEMBER 17th, 2025	COMPANY: FUELLED FAMILY OF COMPANIES
DRAWN: 13020 BEATON PARK ROAD, BOX 283, CHARLIE LAKE, B.C. V0C 1H0 (250)785 6295	DRAWING NUMBER: FLARE KNOCKOUT DRUM

Band #'s	Size	Sch	Nom.	Sept. 17th, 2025		T _{min}	% Below Nom.	Change from last survey
Flare Knockout Drum								
Band #1	HEAD		0.375	0.369		0.369	1.6	N/A
Band #2	SHELL		0.375	0.380		0.380	N/A	N/A
Band #3	BOTTOM SHELL		0.375	0.387		0.387	N/A	N/A
Band #4	BOTTOM SHELL		0.375	0.382		0.382	N/A	N/A
Band #5	SHELL		0.375	0.383		0.383	N/A	N/A
Band #6	HEAD		0.375	0.369		0.369	1.6	N/A
Band #7	10" INLET NOZZLE CIRC.	40	0.365	0.354		0.354	3.0	N/A
Band #8	10" OUTLET NOZZLE CIRC.	40	0.365	0.356		0.356	2.5	N/A
Band #9	3" BOTTOM NOZZLE CIRC.	STD	0.216	0.213		0.213	1.4	N/A
Band #10	3" BOTTOM NOZZLE CIRC.	STD	0.216	0.216		0.216	N/A	N/A
Band #11	2" NOZZLE (BRIDLE) CIRC.	XS	0.218	0.208		0.208	4.6	N/A
Band #12	2"-90°	XS	0.218	0.221		0.221	N/A	N/A
Band #13	6" BRIDLE TOP HEAD	40	0.280	0.279		0.279	0.4	N/A
Band #14	6" BRIDLE SHELL	40	0.280	0.265		0.265	5.4	N/A
Band #15	6" BRIDLE SHELL	40	0.280	0.263		0.263	6.1	N/A
Band #16	6" BRIDLE BOTTOM HEAD	40	0.280	0.279		0.279	0.4	N/A

EQUIPMENT DATA:	
MAKE:	TORNADO TECHNOLOGIES INC.
SER. NO.:	-
CRN NO.:	-
B.C. NO.:	-
ALTA. NO.:	-
MFG. DATE:	-
MAWP:	-
"t" SHELL:	-
"t" HEAD:	-
SIZE:	100" OD x 240" S/S (APPROX.)
CORR. ALLOW.:	-
XRAY/STRESS REL.:	-
