District: Clairmont Facility/Area: Surface Location: 01-09-073-05W6M Report #:   
 Equipment #: Equipment Name: Inlet Gas Separator MFR Serial #: 1563   
 Provincial Reg #: A0441017 CRN: N9540.2 National Board #:   
 Tag Number: Skid Number: Operating Status: In Service : Yes

**Inspection Results**

**Assessment Summary**

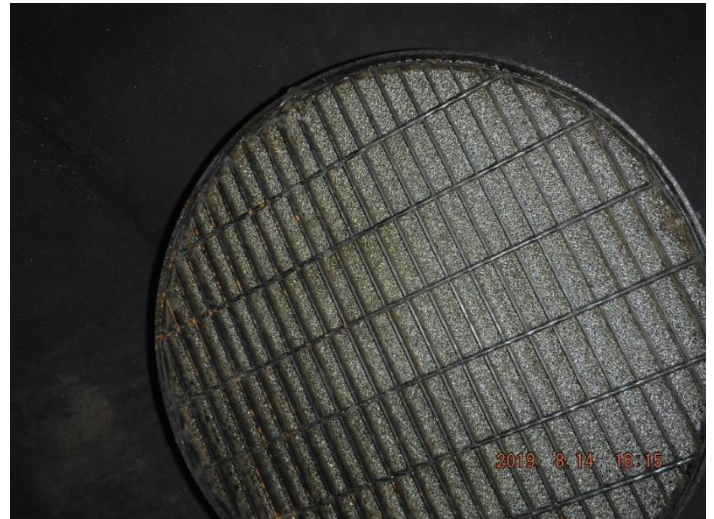
**Demister**

Non-conformance Summary	None to Report
Recommendation Summary	None at this time.
Additional Inspection Comments	All welds proud No signs of any Erosion, Corrosion, or Pitting No Deformations noted Demister was clear No access to upper shell at demister, as demister pads were not removed Internal Weirs (3) were secure Vortex Breakers (2) were secure and no washing at the nozzles was noted
