<b>Inspections Performed for:</b> FMC Technologies Completion – Grand Junction	
<b>Inspection Report for:</b> HS-0026 Separator	
<b>Remaining Life:</b> 19 YRS	<b>Date Last Inspected:</b> 09/25/2018
<b>Representative Corrosion Rate:</b> 8.3 MPY	<b>Next UT:</b> 09/25/2019 <b>Next VT:</b> 09/25/2019
<b>Manufacturer:</b> Micoda Process Systems	<b>Manufacturer Serial #:</b> 1182
<b>Year Built:</b> 2005	<b>National Board #:</b> 6
<b>Alberta Registration #:</b> 524558	<b>Canadian Registration #:</b> R9975.2

**HS-0026 Separator**

<b>Inspections Performed for:</b> FMC Technologies Completion – Grand Junction	
<b>Inspection Report for:</b> HS-0026 Fuel Gas Scrubber	
<b>Remaining Life:</b> 20+ YRS	<b>Date Last Inspected:</b> 09/25/2018
<b>Representative Corrosion Rate:</b> 1.0 MPY	<b>Next UT:</b> 09/25/2019 <b>Next VT:</b> 09/25/2019
<b>Manufacturer:</b> Micoda Process Systems	<b>Manufacturer Serial #:</b> 1226
<b>Year Built:</b> 2005	<b>National Board #:</b> N/A
<b>Alberta Registration #:</b> None	<b>Canadian Registration #:</b> OH-4873.2

**HS-0026 Fuel Gas Scrubber**

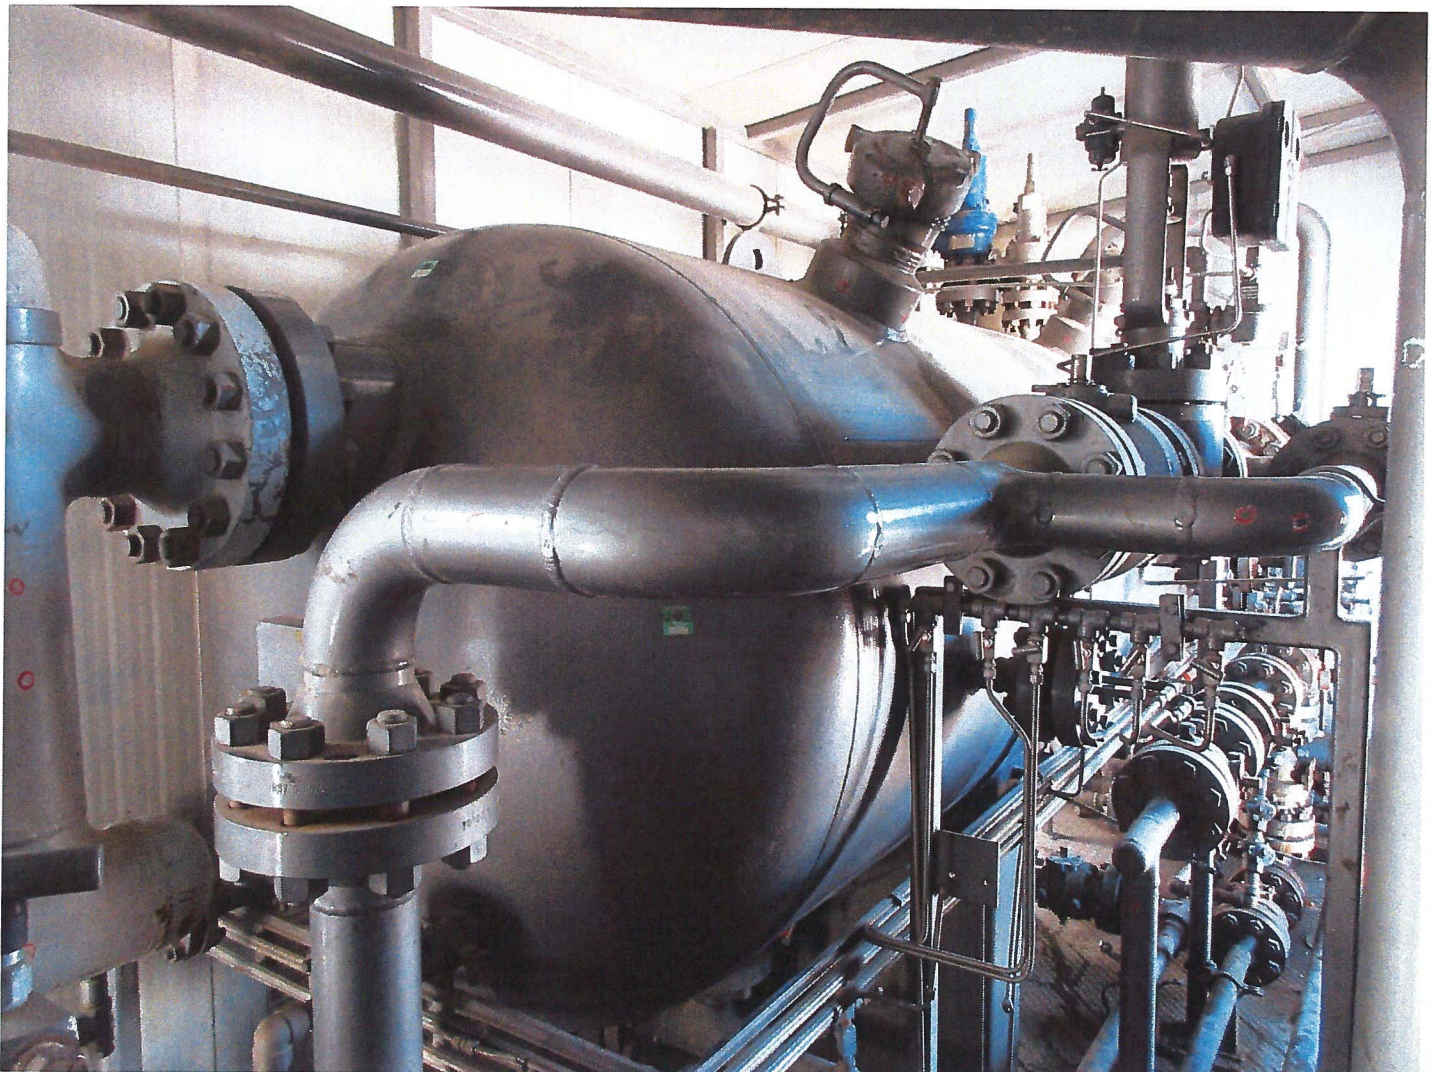
**Condition of Foundation and Anchor Bolts:** There are no anchor bolts. The (2) vertical support baseplates are welded to the skid/trailer. Baseplate-to-deck/frame attachment welds appear sound. (2) support saddles are welded to skid and deck plate.

**Condition of Steel Supports, Saddles, and Bolting:** The support structural welds appear sound. The accessible support saddle-to-shell attachment welds have no visual weld defects. All welds appear full and uniform. There is light chipping and peeling on (2) saddles.

**Condition of Paint and/or Insulation:** The paint is in acceptable condition with minor localized chipping and peeling. There is no insulation.

**Condition of Nozzles, Flanges, Repads, and Weepholes:** Nozzles and flanges are in good condition. All flange bolting is in place and secure. Light chipping and peeling on multiple flanges and nozzles. There are no threaded connections. Vessel is not in service. There is light surface corrosion on the bolts.

**Condition of Welds; Head and Shell Metal Surfaces:** All (exposed) metal surfaces are painted. There is no indication of corrosion beneath the paint coating. The pressure boundary welds have no visual weld defects. Paint has minor chipping.

The vessel appears to be in acceptable condition.

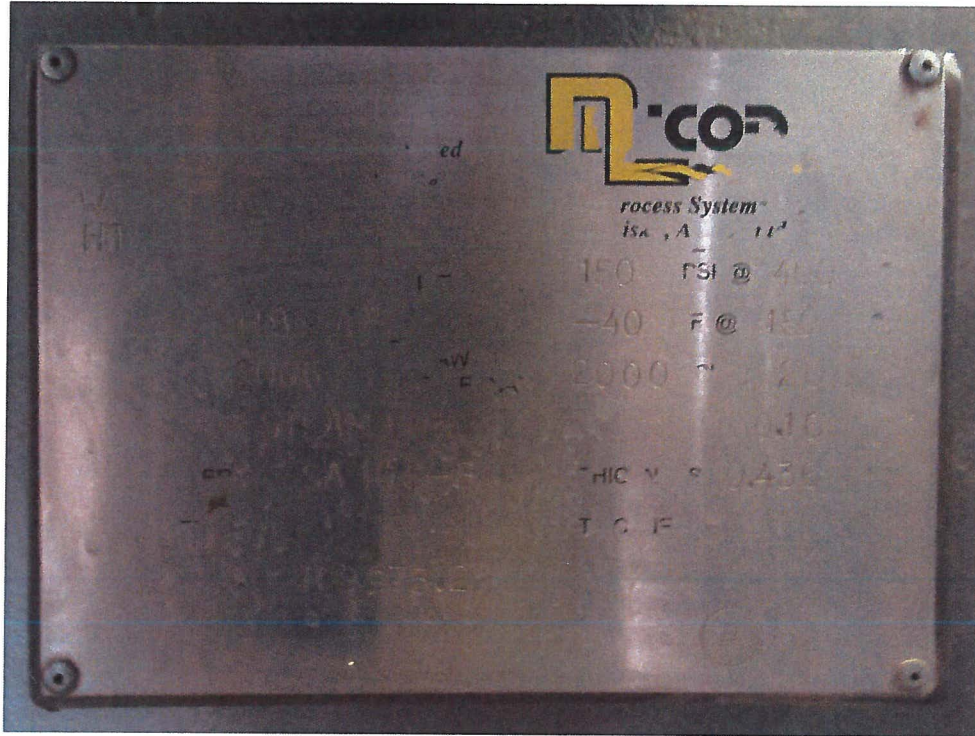
**Coil Nameplate**

**Condition of Nameplate and/or Bracket:** The nameplate is intact. Nameplate bracket is securely attached. The stamping is legible but the painted wording has completely worn off.

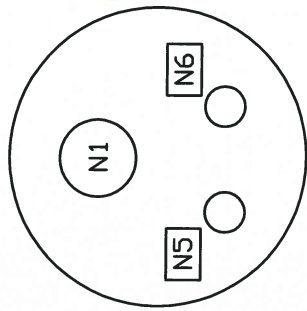
LEFT HEAD

- #1. 01- NZ END-FRONT 2. 970 TC #3. 01- SHELL-FRONT 3. 013 TC #5. 01- SHELL-FRONT 3. 013 TC
- #1. 02- NZ END-BOTTOM 2. 969 TC #3. 02- SHELL-BOTTOM 3. 010 TC #5. 02- SHELL-BOTTOM 3. 024 TC
- #1. 03- NZ-END-BACK 2. 959 TC #3. 03- SHELL-BACK 3. 016 TC #5. 04- SHELL-TOP 3. 000 TC
- #1. 04- NZ-END-TOP 3. 007 TC #3. 04- SHELL-TOP 3. 020 TC #6. 01- END-FRONT 2. 959 TC
- #2. 01- SHELL-FRONT 3. 014 TC #4. 01- SHELL-FRONT 3. 020 TC #6. 02- END-BOTTOM 2. 984 TC
- #2. 02- SHELL-BOTTOM 3. 023 TC #4. 02- SHELL-BOTTOM 3. 017 TC #6. 03- END-BACK 2. 972 TC
- #2. 03- SHELL-BACK 3. 020 TC #4. 03- SHELL-BACK 3. 020 TC #6. 04- END-TOP 2. 950 TC
- #2. 04- SHELL-TOP 3. 034 TC #4. 04- SHELL-TOP 3. 011 TC

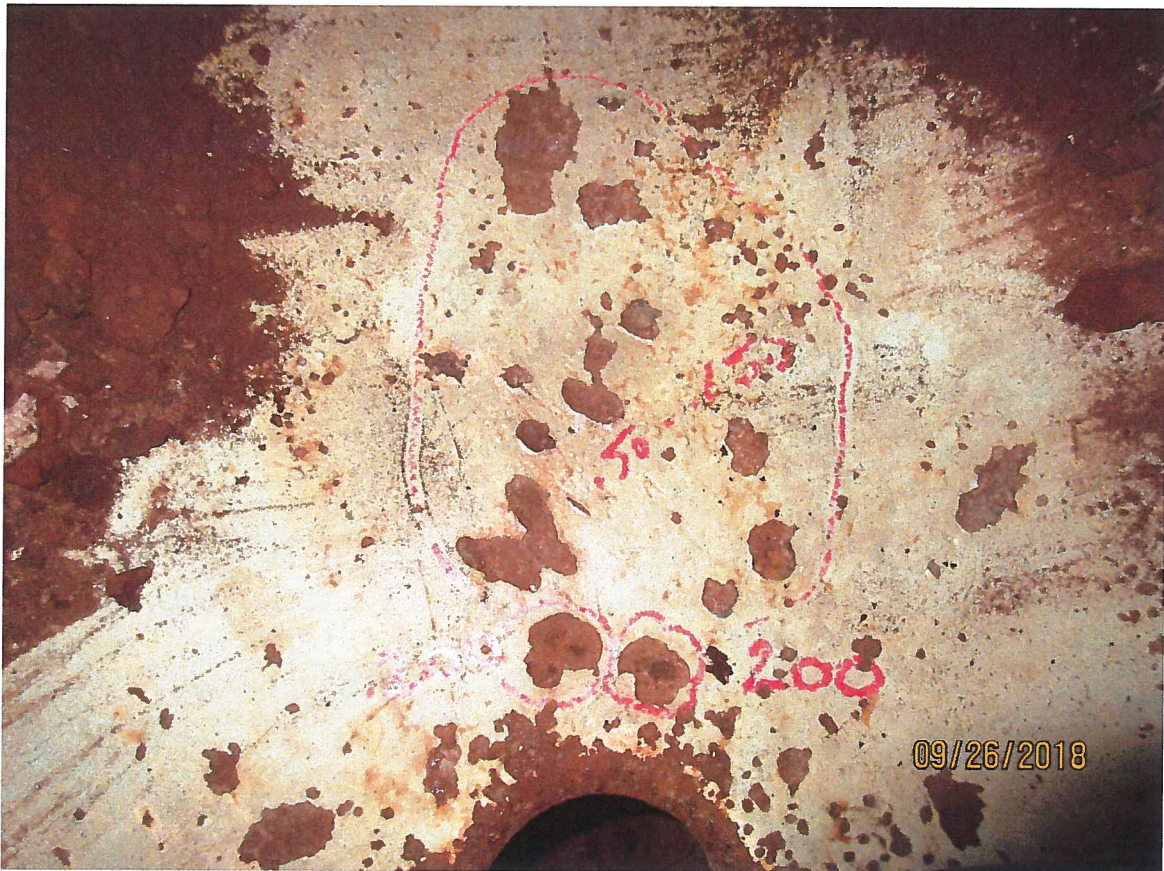
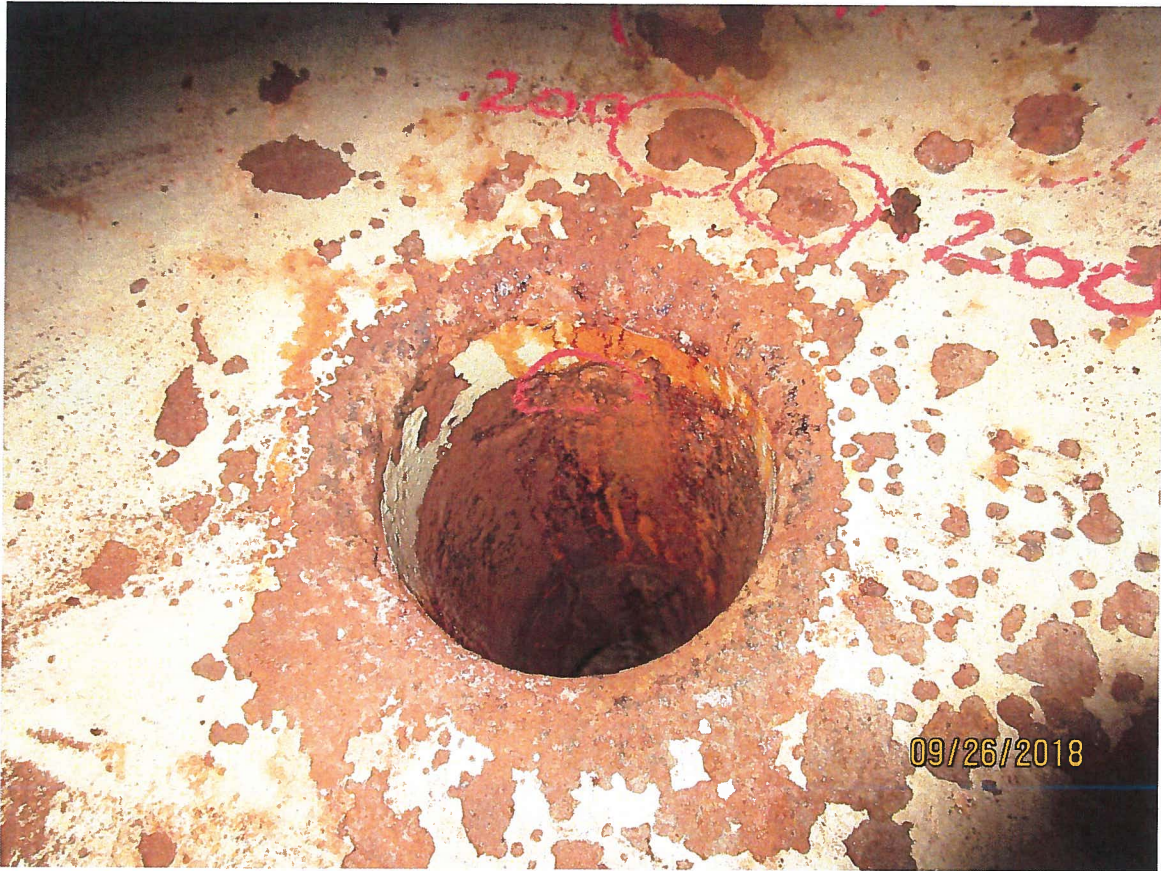
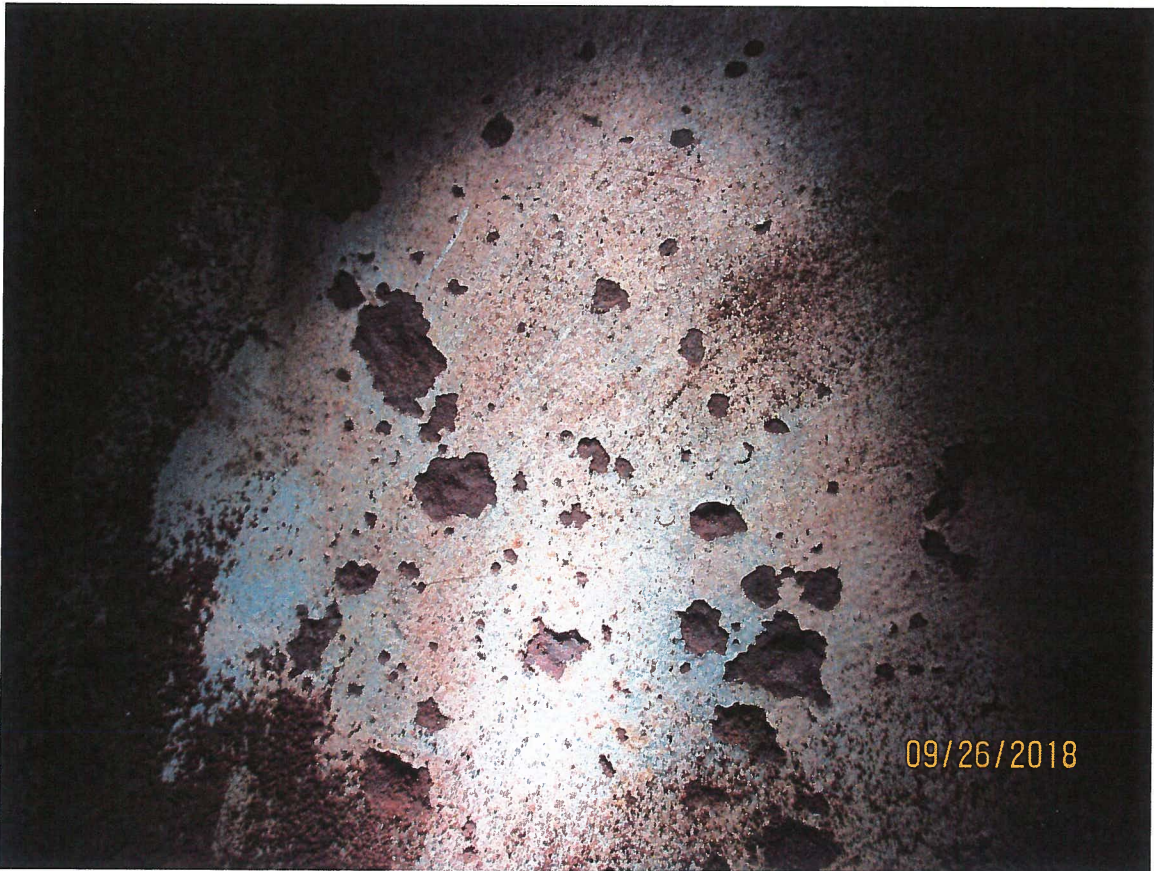
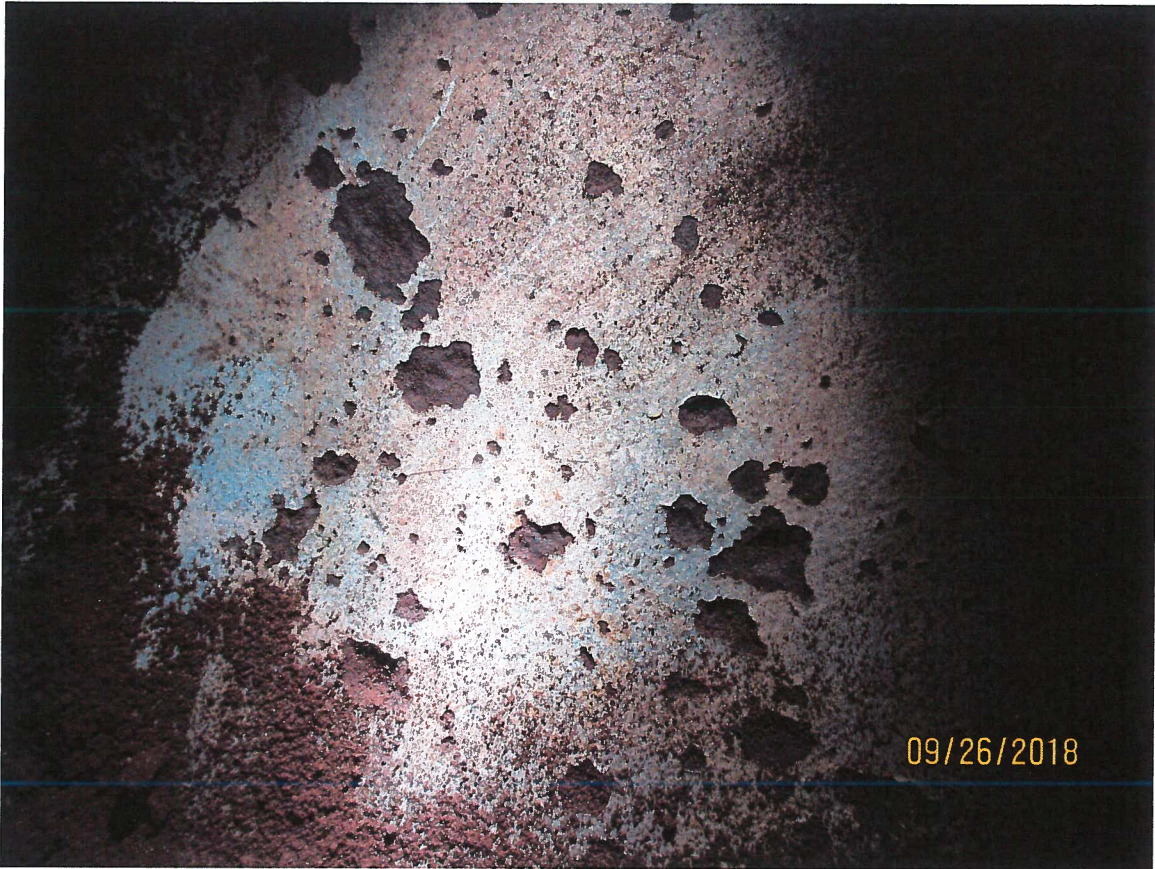
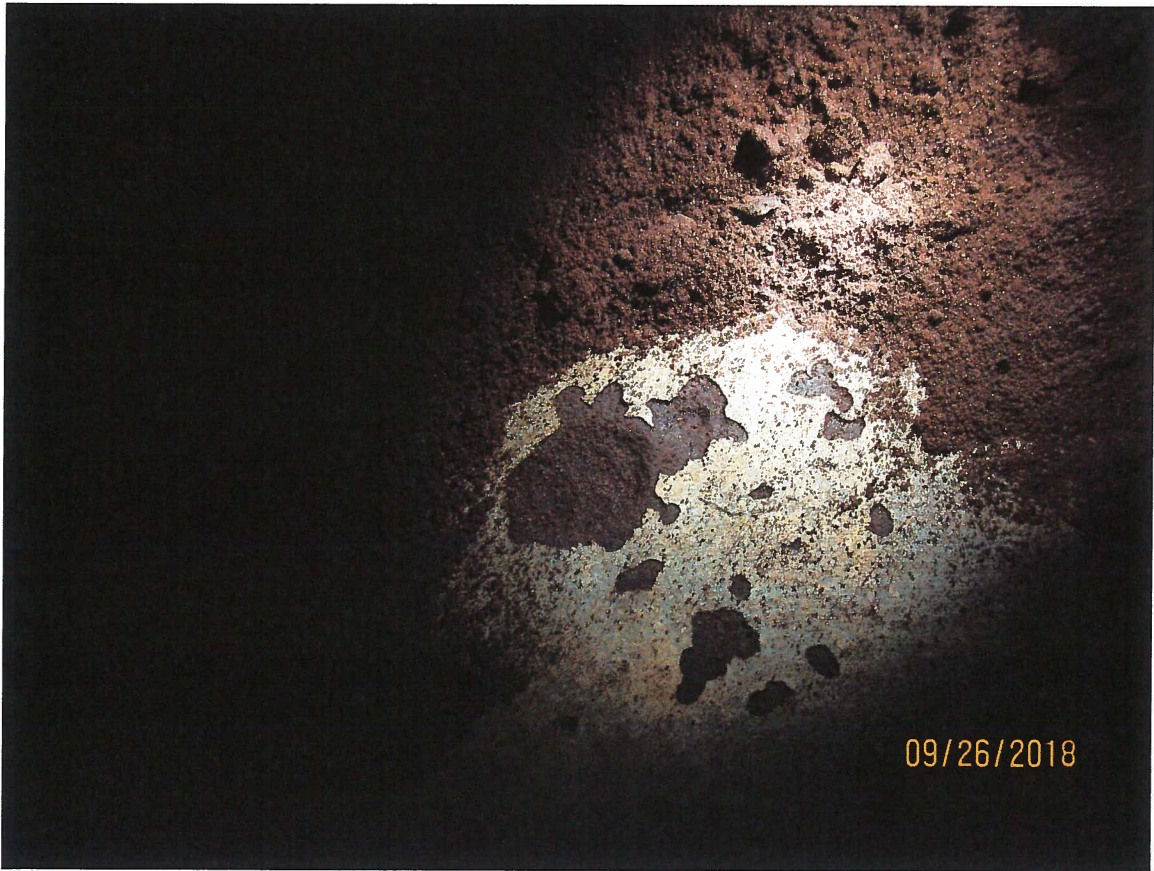
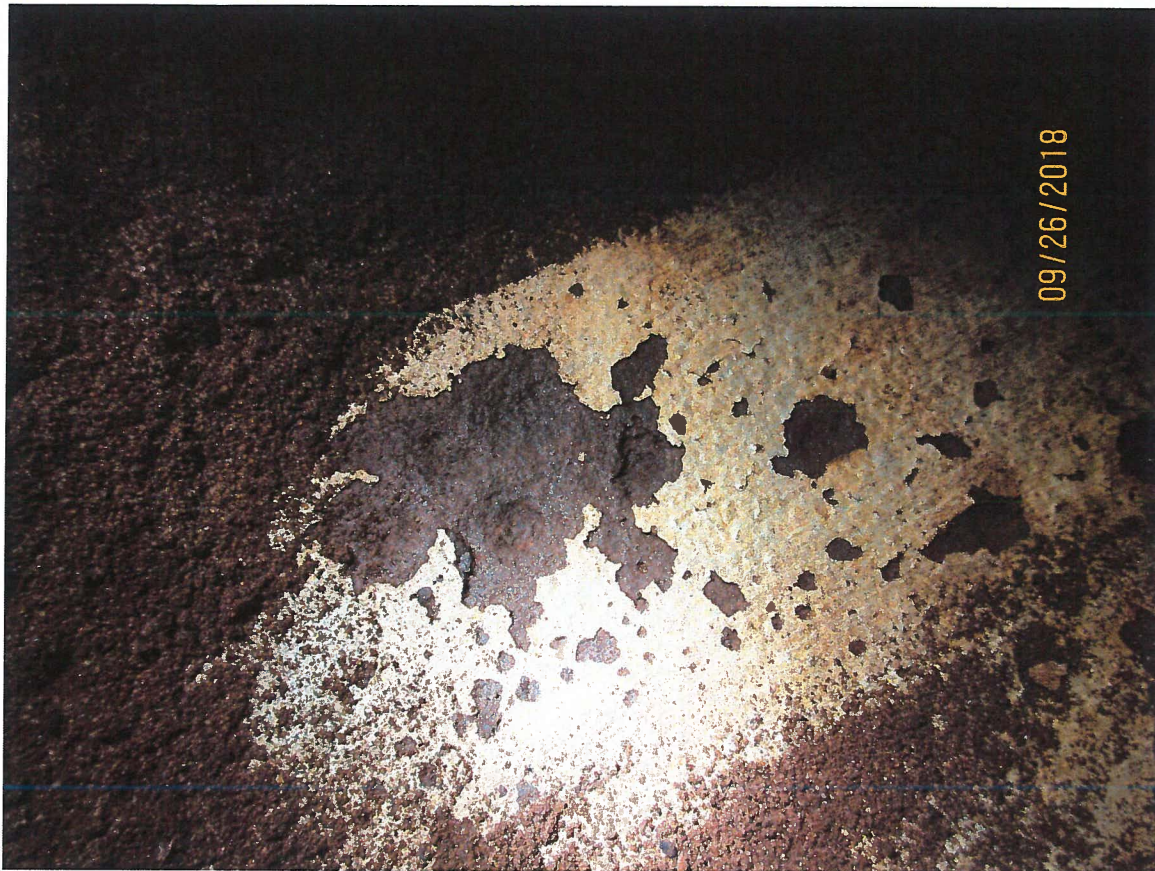
**Manway entrance and gasket seating area:**  N/A. Minor chipped coating with light surface corrosion present. Minor pitting in entrance and flange face (face pitting .050").

**Shell** (note pitting, corrosion, laminations, blisters, etc. - size and location): Chipped and missing coating with light surface corrosion as well as pitting is present. Large pits located along bottom of shell (.050" to .200").

**Heads** (note pitting, corrosion, laminations, blisters, etc. - size and location): Chipped and missing coating with light surface corrosion and pitting present. (Pitting is not measurable).

**Internal Nozzle Welds:** (include type and condition welds) Majority of nozzle welds are visually acceptable. 2" & 4" nozzles have heavy pitting around the welds and also inside of nozzles.

Steam lines with chipped coating and minor pitting present. (Nothing measurable). Diffuser and demister both have moderate scaling and surface corrosion.

Sand blast and clean vessel. Locate pitting/damage that is not acceptable and make repairs as required. Re-coat vessel internals. Clean sealing surface area of the manway.

Repair large pitting at bottom of shell and heavy preferential corroded oil drain; solids drain and also the drain nozzle welds.

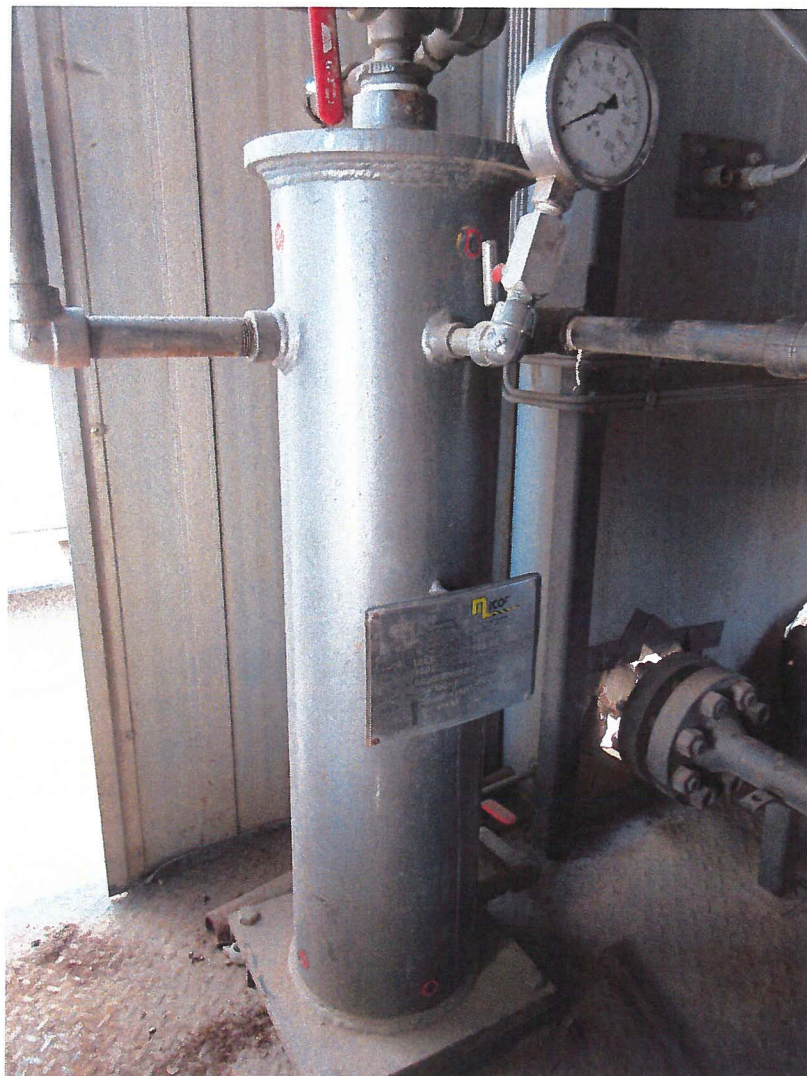
**Condition of Foundation and Anchor Bolts:** Anchor bolts are in place and secure. Baseplate-to-deck/frame attachment welds appear sound. All (4) anchor bolt nuts are in place and secure. Baseplate is bolted (4) to (2) channel iron, welded to skid deckplate. Bolts show light surface corrosion.

**Condition of Steel Supports, Saddles, and Bolting:** All support structural welds appear sound. (4) anchor bolts have light chipping and surface corrosion.

**Condition of Paint and/or Insulation:** The paint is in acceptable condition with minor localized chipping and peeling. There is no insulation.

**Condition of Nozzles, Flanges, Repads, and Weepholes:** All threaded connections. There is no evidence of leaks at any of the threaded connections. There is light chipping on the threaded connections.

**Condition of Welds; Head and Shell Metal Surfaces:** All (exposed) metal surfaces are painted. There is no distortion or indication of corrosion beneath the paint coating. The pressure boundary welds have no visual weld defects.

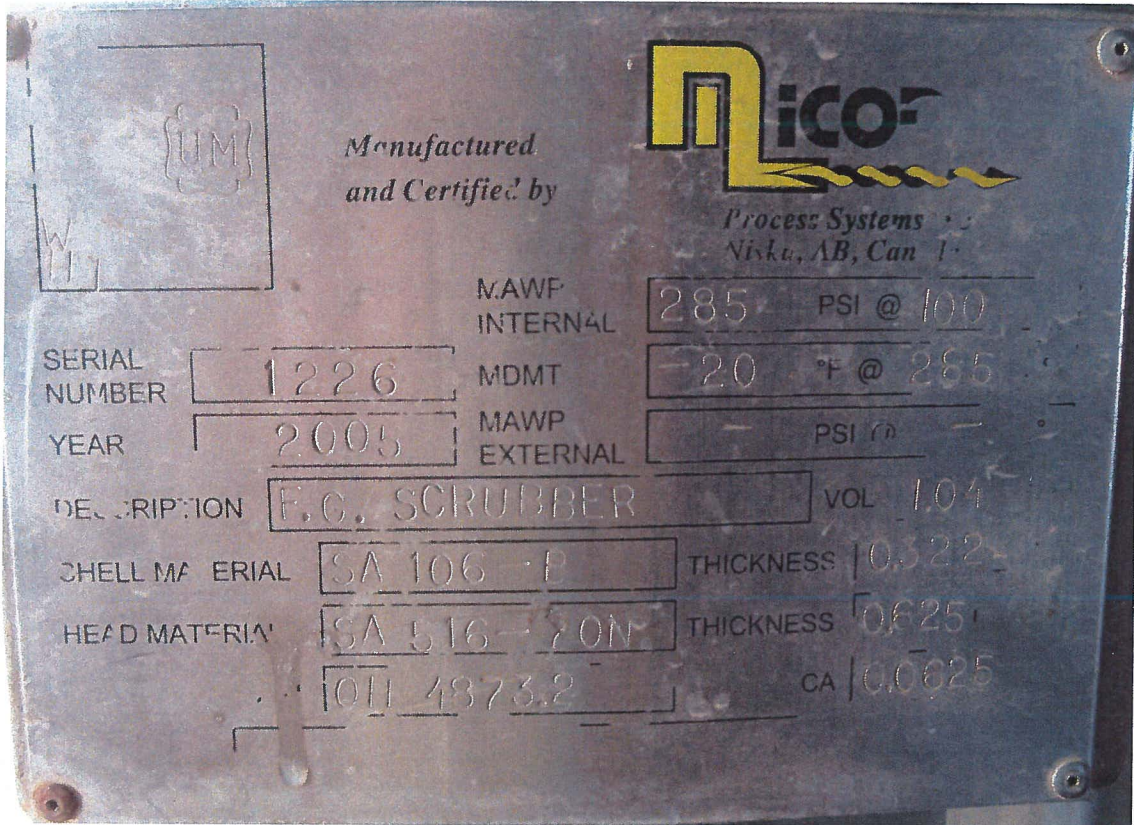
**Condition of Nameplate and/or Bracket:** The nameplate is intact. Nameplate bracket is securely attached. Stamping is legible, but the painted wording on the nameplate is wearing off.

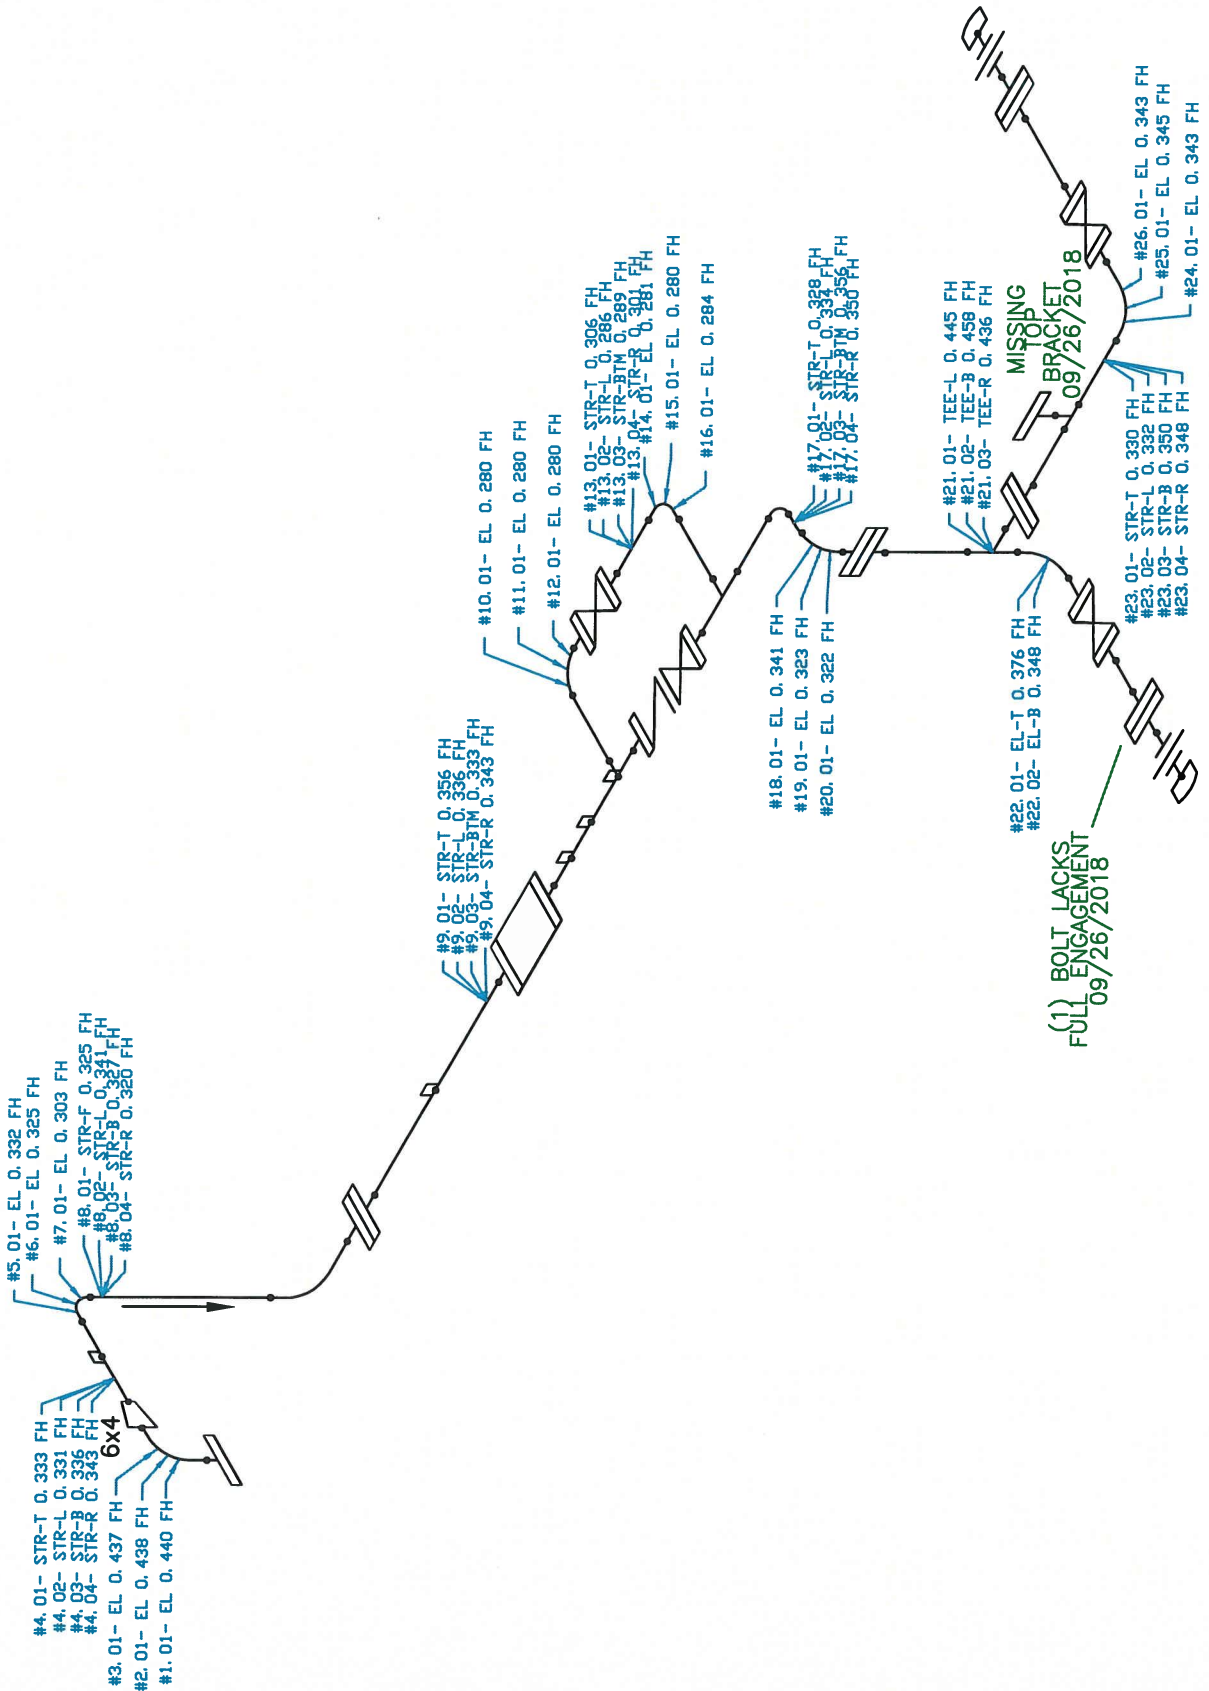
**DESC: GAS OUT-6/4/3 SCH 80/40 PIPE**  
**DWG#: GAS-OUT-1.01-26.01**

<b>Coating Condition:</b>	<b>Comments:</b>
<input checked="" type="checkbox"/> Good <input checked="" type="checkbox"/> Fair, Some Blistering/Peeling <input checked="" type="checkbox"/> Corrosion Present (Describe) <input type="checkbox"/> Other <input type="checkbox"/> No Issues	Minor chipped and scratched coating with light surface corrosion. Some areas are missing coating on 2" lines.

Supports/Hangers:	Comments:
<input checked="" type="checkbox"/> In Serviceable Condition <input type="checkbox"/> Foundation Is Damaged <input type="checkbox"/> Additional Support Needed <input checked="" type="checkbox"/> Hanger/Support Is Distorted/Broken/Missing <input type="checkbox"/> Pipe Slide Or Shoe Is Off Of The Support <input type="checkbox"/> Makeshift Support <input checked="" type="checkbox"/> Loose Support Needed To Be Tightened <input type="checkbox"/> Fireproofing Missing Or Damaged <input checked="" type="checkbox"/> Support/Hanger Is Corroded <input type="checkbox"/> Other <input type="checkbox"/> No Issues	Brackets and vertical supports are acceptable. There are missing and/or loose brackets (pg. 1-3) with light surface corrosion present.

Flanged Connections:	Comments:
<input checked="" type="checkbox"/> Bolting Serviceable <input type="checkbox"/> Short, Missing Or Damaged Bolting <input checked="" type="checkbox"/> Nuts Lack Full Engagement <input checked="" type="checkbox"/> Flanges Serviceable <input type="checkbox"/> Flange Material Or Rating Inconsistent For System <input type="checkbox"/> Flanges Deformed Or Damaged <input checked="" type="checkbox"/> Corrosion Present (Describe) <input checked="" type="checkbox"/> Gaskets <input type="checkbox"/> Flange Rating Issues <input type="checkbox"/> Other <input type="checkbox"/> No Issues	Flanges and bolts are all in acceptable condition. Light surface corrosion present. (3) bolts lack full engagement (pg. 1 & 3).

Mechanical Observations:	Comments:
<input checked="" type="checkbox"/> Deadleg <input type="checkbox"/> Damaged Flex Hose <input type="checkbox"/> Crack <input type="checkbox"/> Biological Growth <input type="checkbox"/> Threaded Exposed <input type="checkbox"/> Threaded Connections Not Seal Welded <input type="checkbox"/> Expansion Joint Issues <input type="checkbox"/> Low Point Without Drain <input type="checkbox"/> Open Ended <input type="checkbox"/> Vibration (Excessive) <input type="checkbox"/> Weephole <input checked="" type="checkbox"/> Other <input type="checkbox"/> No Issues	End caps, vents and drain are present with no visible corrosion. 2" line (pg. 3) appear to be slightly curved/bent. No visible external damage present. There are minor damaged/ deformed hammer unions.

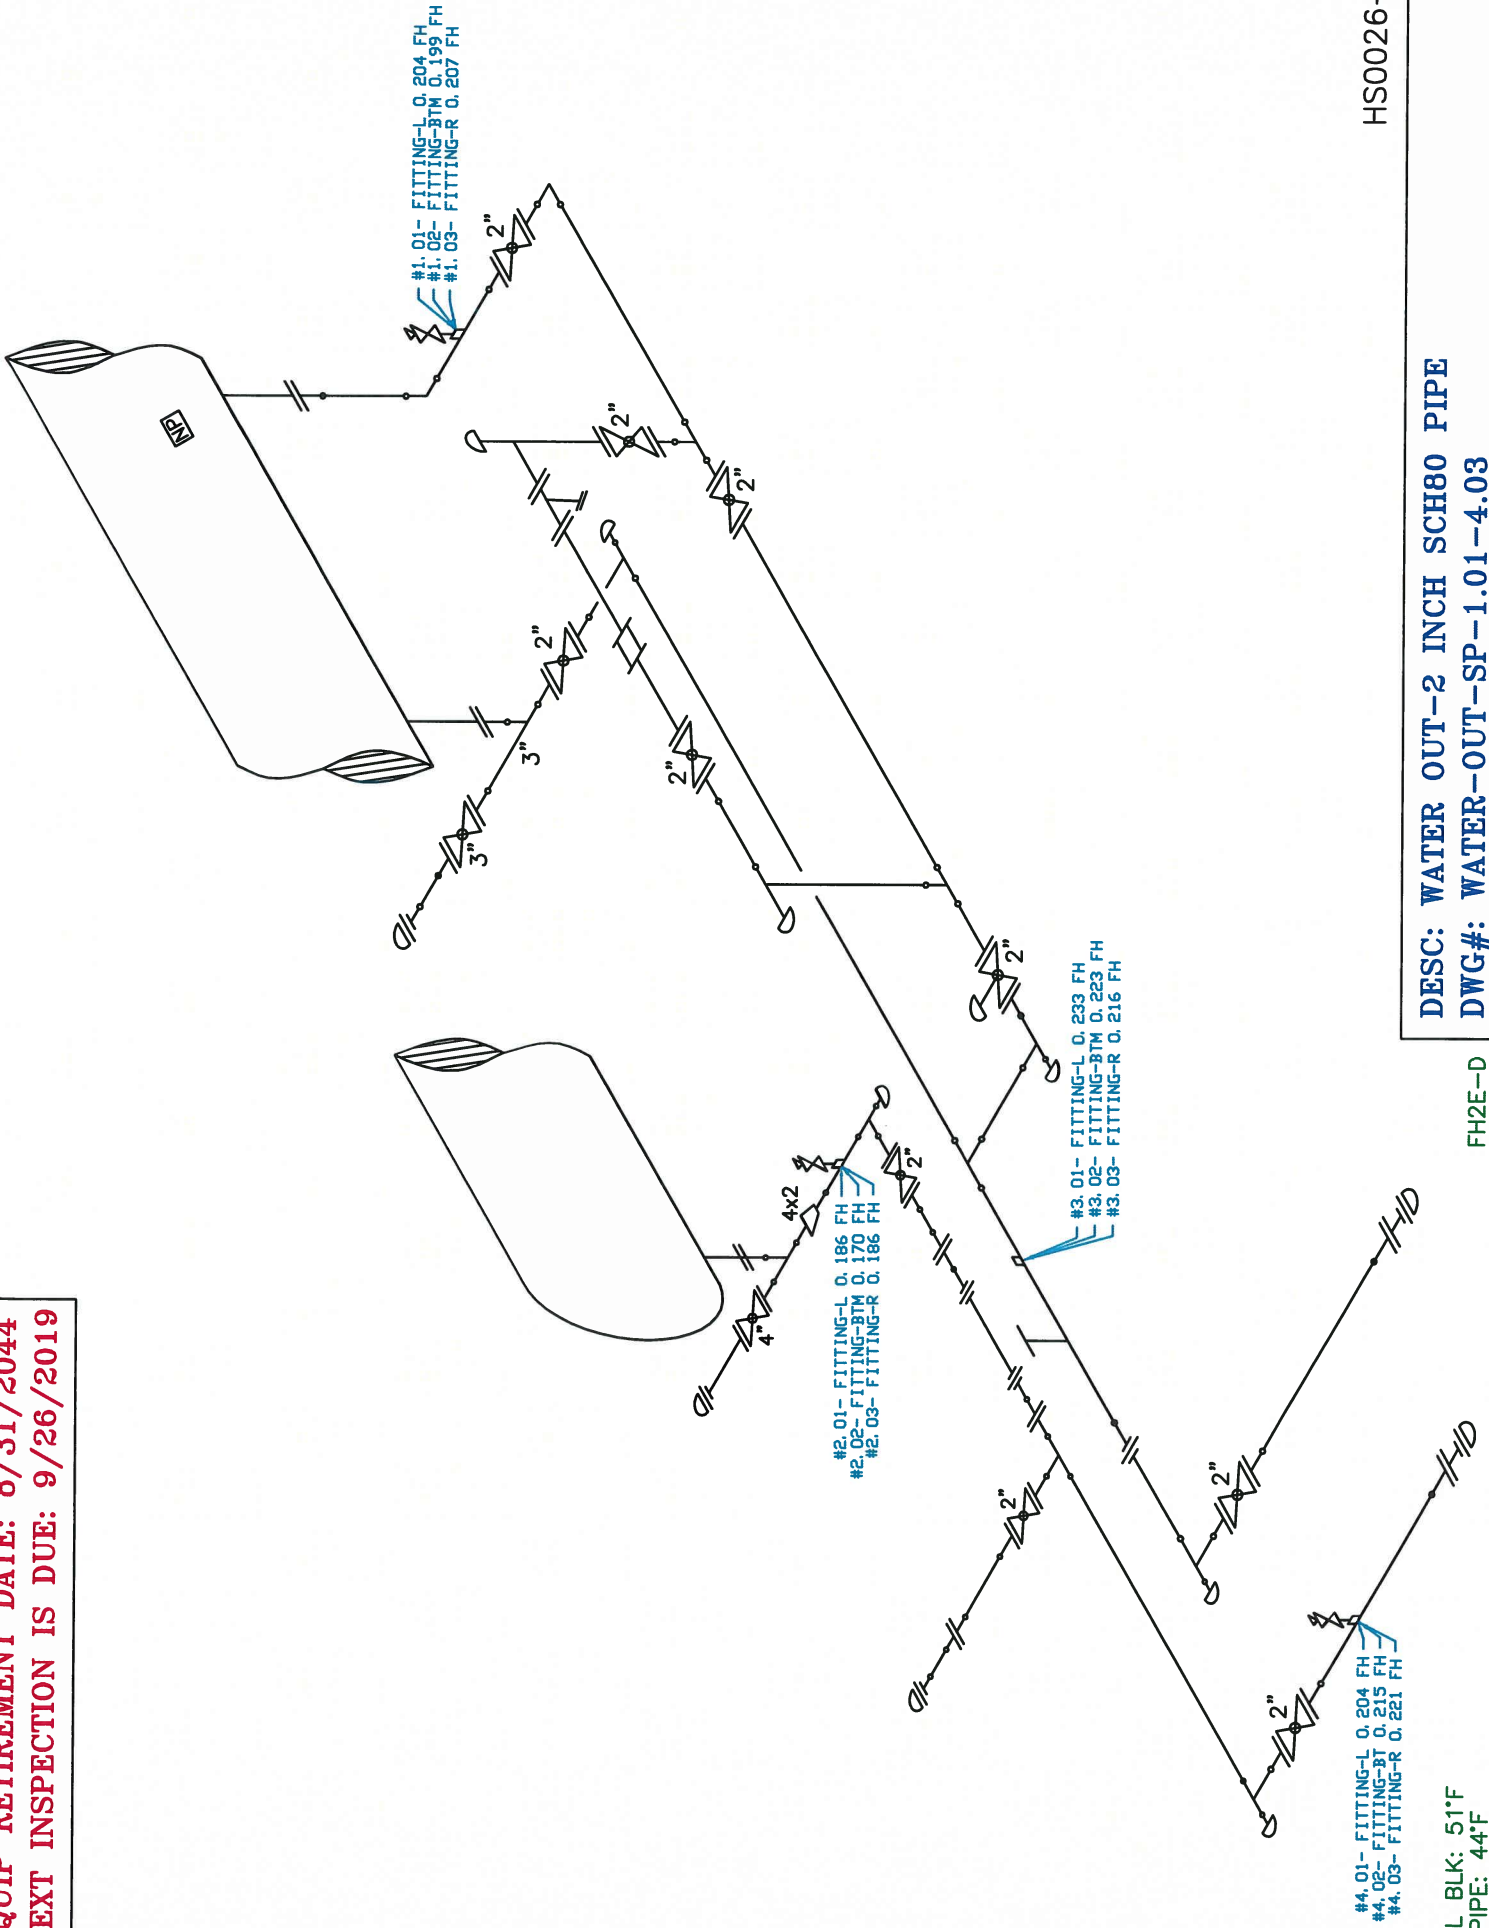
#4.01- FITTING-L 0.204 FH  
#4.02- FITTING-BT 0.215 FH  
#4.03- FITTING-R 0.221 FH

#2.01- FITTING-L 0.186 FH  
#2.02- FITTING-BTM 0.170 FH  
#2.03- FITTING-R 0.186 FH

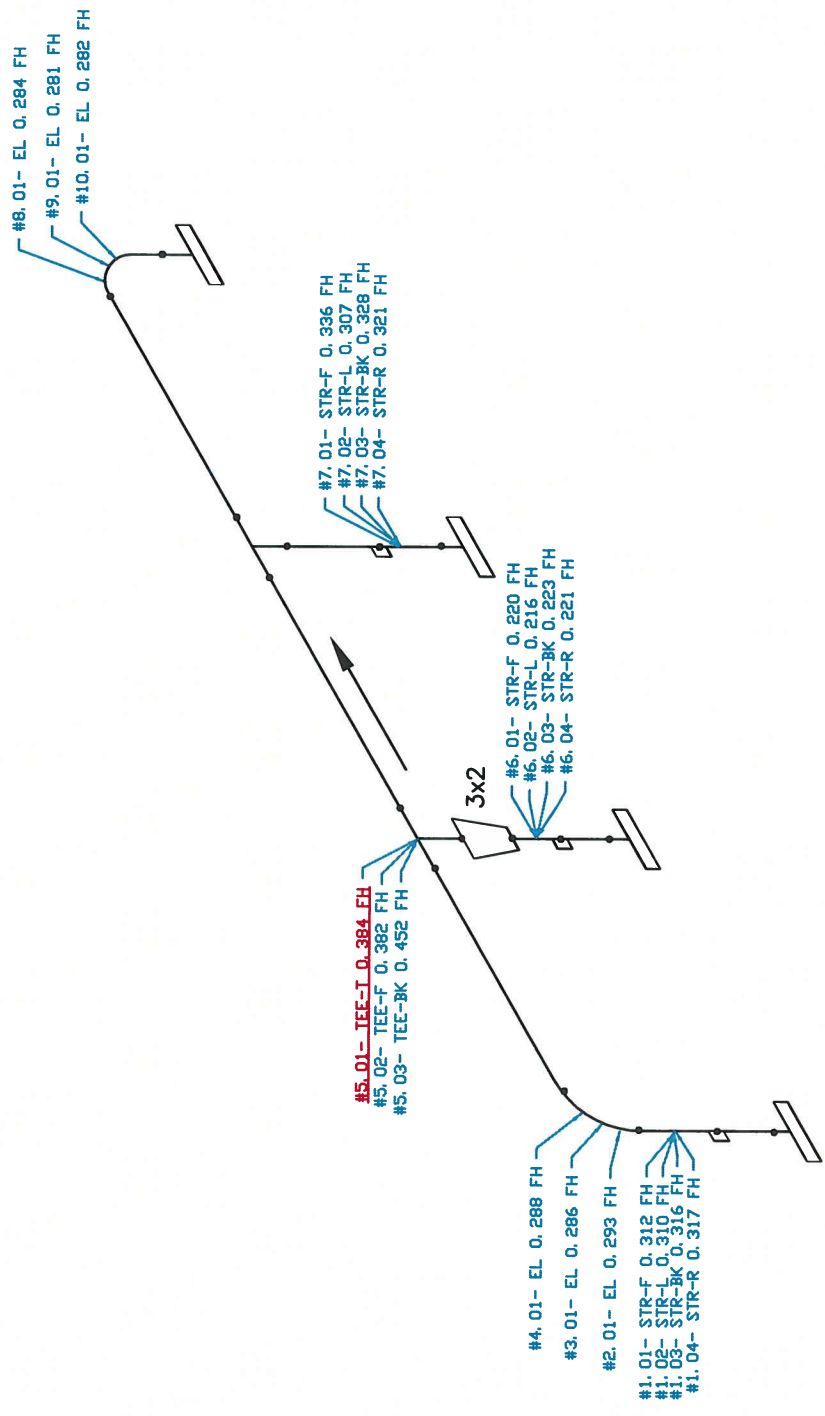
DESC: HEADER-3 INCH SCH80 PIPE  
 DWG#: HEADER-1.01-10.01

Caution TML Logic: TML Corrosion Rate > 15.0 MPY .OR. TML Remaining Life < 3.00 Years.  
There are 1 Caution TMLs in this Eq/Circ ID.
