# ATMOSPHERIC STORAGE TANK INSPECTION FORM

Date 2020-06-12  
CLIENT Calroc Industries

Brias Job Number 2530  
LSD Calroc Industires Yard RR 14 Lloydminster

Manufacturer	<u>Universal Industries</u>	Serial Number	<u>97 05</u>
Capacity	<u>750 BBL</u>	Year Built	<u>1997</u>
Code	<u>API</u>	Edition	<u>1993</u>
Diameter	<u>15' 3"</u>	Height	<u>24'</u>
Bottom Thickness	<u>0.250"</u>	Roof Thickness	<u>0.188"</u>
Shell Course 1	<u>0.188"</u>	Shell Course 2 & Up	<u>0.188"</u>

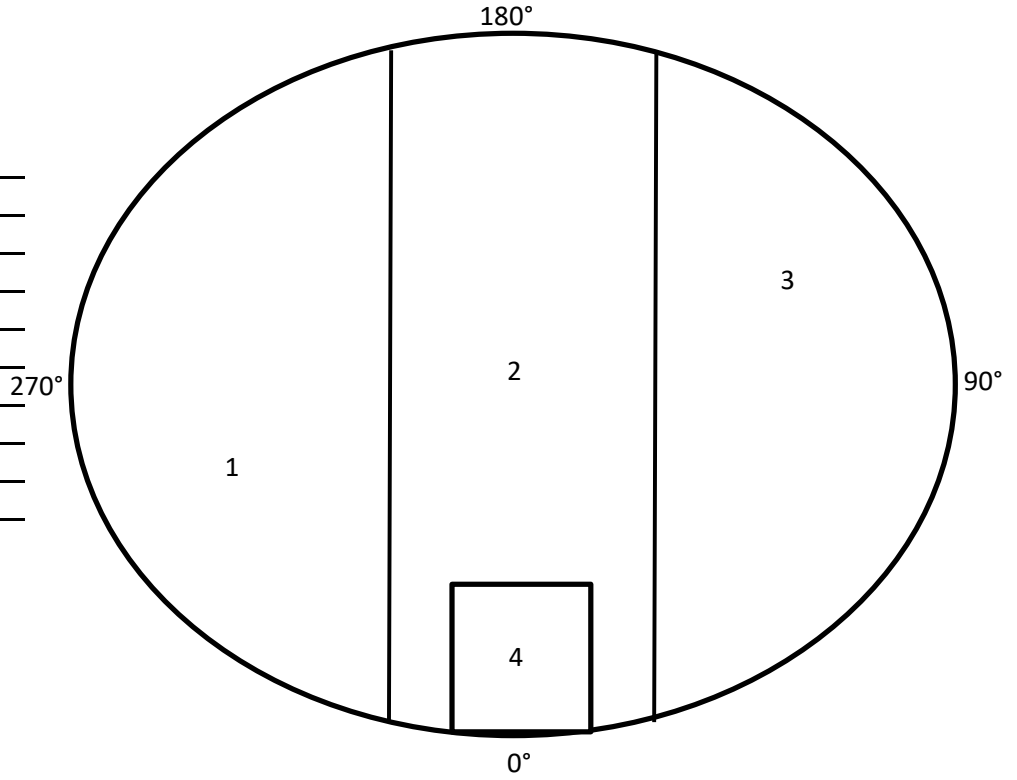
### Bottom Details/ Comments

- 1 Plate 1
- 2 Plate 2
- 3 Plate 3
- 4 Manway
- 5
- 6
- 7
- 8
- 9
- 10

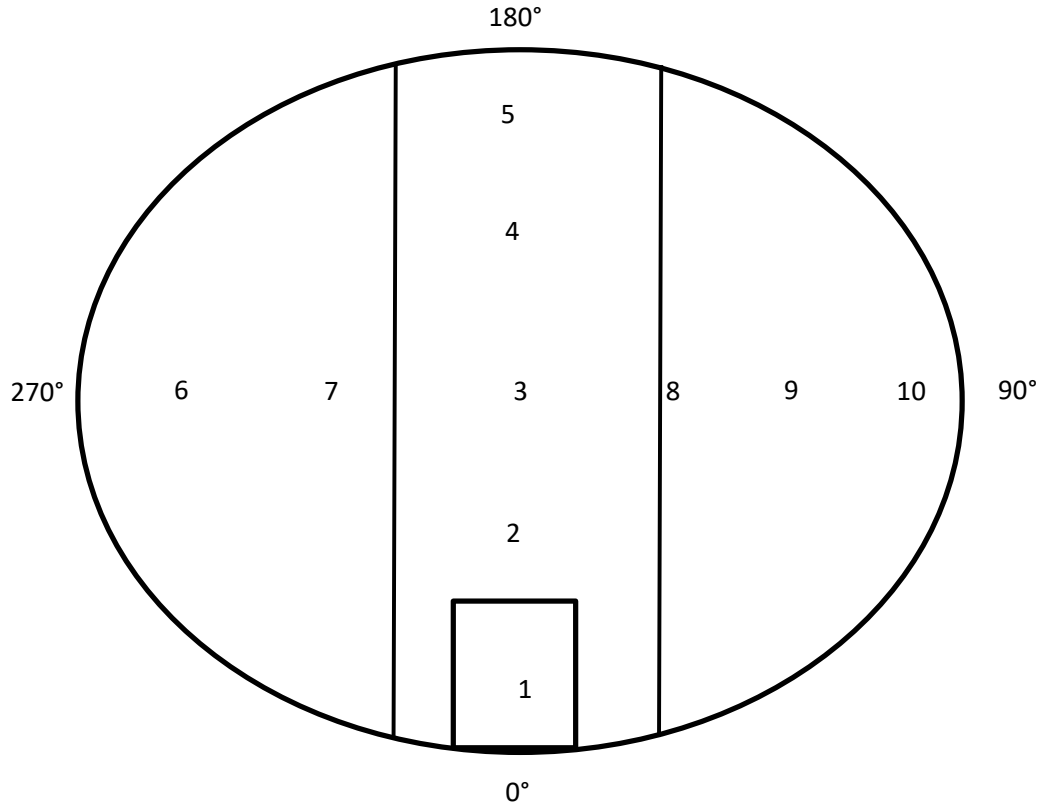
## Bottom UT CORROSION SURVEY

TML #	First Survey Thickness	First Survey Date	Previous Survey Thickness	Previous Survey Date	Last Survey Thickness	Last Survey Date	Corrosion Rate (Inches/Years)	Remaining Life of Bottom(Years)
1	0.250	1997	NA	NA	0.246	2020	0.0002	839.50
2	0.250	1997	NA	NA	0.243	2020	0.0003	469.86
3	0.250	1997	NA	NA	0.247	2020	0.0001	1127.00
4	0.250	1997	NA	NA	0.241	2020	0.0004	360.33
5	0.250	1997	NA	NA	0.246	2020	0.0002	839.50
6	0.250	1997	NA	NA	0.248	2020	0.0001	1702.00
7	0.250	1997	NA	NA	0.245	2020	0.0002	667.00
8	0.250	1997	NA	NA	0.244	2020	0.0003	552.00
9	0.250	1997	NA	NA	0.244	2020	0.0003	552.00
10	0.250	1997	NA	NA	0.248	2020	0.0001	1702.00

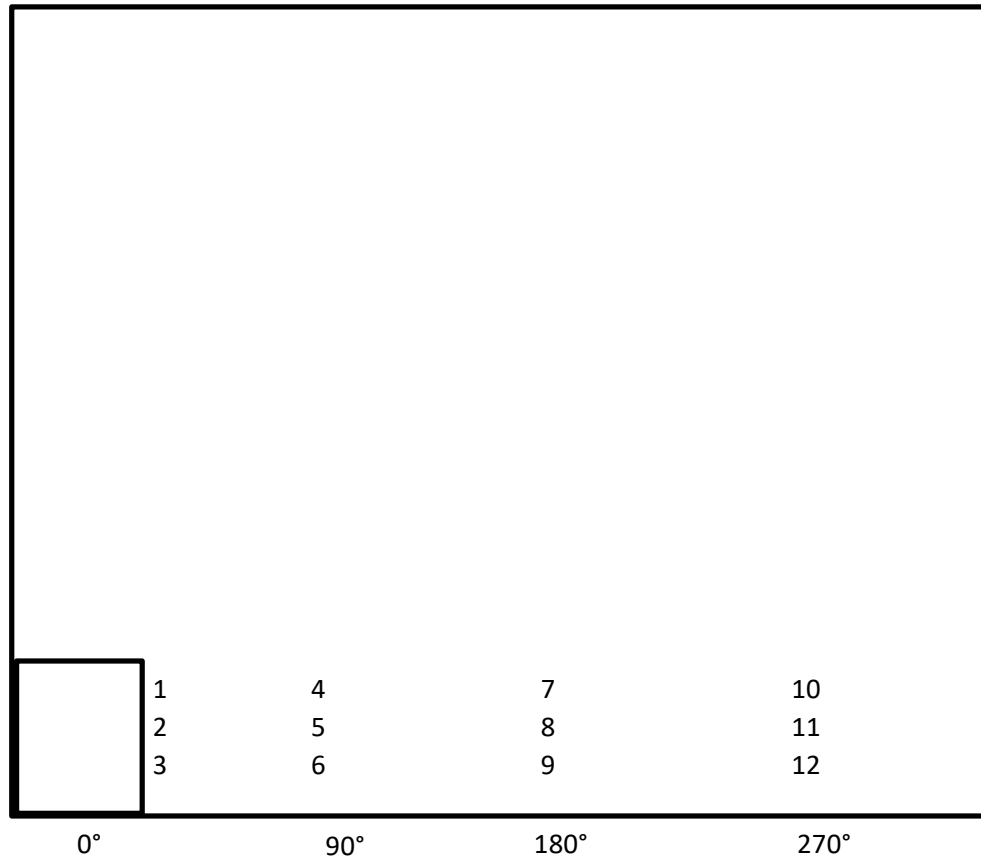
## SHELL UT CORROSION SURVEY

TML #	First Survey Thickness	First Survey Date	Previous Survey Thickness	Previous Survey Date	Last Survey Thickness	Last Survey Date	Corrosion Rate (In./Years)	Remaining Life of Shell(Years)
1	0.188	1997	NA	NA	0.186	2020	0.0001	2139.00
2	0.188	1997	NA	NA	0.183	2020	0.0002	841.80
3	0.188	1997	NA	NA	0.184	2020	0.0002	1058.00
4	0.188	1997	NA	NA	0.187	2020	0.0000	4301.00
5	0.188	1997	NA	NA	0.187	2020	0.0000	4301.00
6	0.188	1997	NA	NA	0.186	2020	0.0001	2139.00
7	0.188	1997	NA	NA	0.185	2020	0.0001	1418.33
8	0.188	1997	NA	NA	0.187	2020	0.0000	4301.00
9	0.188	1997	NA	NA	0.183	2020	0.0002	841.80
10	0.188	1997	NA	NA	0.186	2020	0.0001	2139.00
11	0.188	1997	NA	NA	0.187	2020	0.0000	4301.00
12	0.188	1997	NA	NA	0.184	2020	0.0002	1058.00
