**Ultrasonic
 Inspection Report**

**UT_A 0595729_A 0595773_SN 10-062-
 FGS_jan2026**

Job Scope: To perform a baseline ultrasonic thickness survey on the requested vessels and piping located at 13-09-64-13 w6m in the West Gunderson Field.

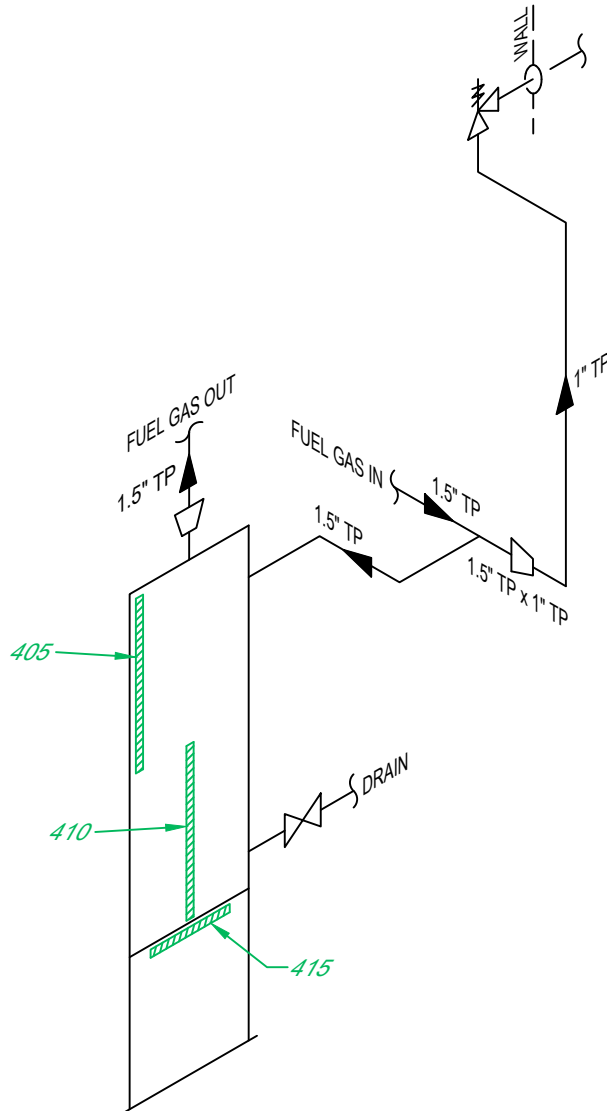
Reg A#: N/A Serial #: 10-062-FGS Drawing#: 3

Customer: FUELLED Description: FUEL GAS SCRUBBER

Shell MAWP: 1034 kPa Shell MAWT: 38°C Shell Material: SA 106 B Nominal: 8.2mm CA: N/S

Nominal Thickness (mm)	Corrosion Allowance (mm)	Flag Thickness (mm)
405			
Description: Upper Shell	8.2		6.7
Date: Jan. 20, 26			
Minimum: 7.9			
Average: 8.3			
Comments:			
410			
Description: Lower Shell	8.2		6.7
Date: Jan. 20, 26			
Minimum: 7.9			
Average: 8.3			
Comments:			
415			
Description: Bottom Head	8.2		6.7
Date: Jan. 20, 26			
Minimum: 15.9			
Average: 16.2			
Comments: <i>Jan 2026_Limited access due to surface corrosion.</i>
