**Ultrasonic
 Inspection Report**

UT_A 0557073_A 0539162_jan2026

Job Scope: To perform a baseline ultrasonic thickness survey on the requested vessels and piping located at 01-25-76-01 w6m in the Eaglesham Field.

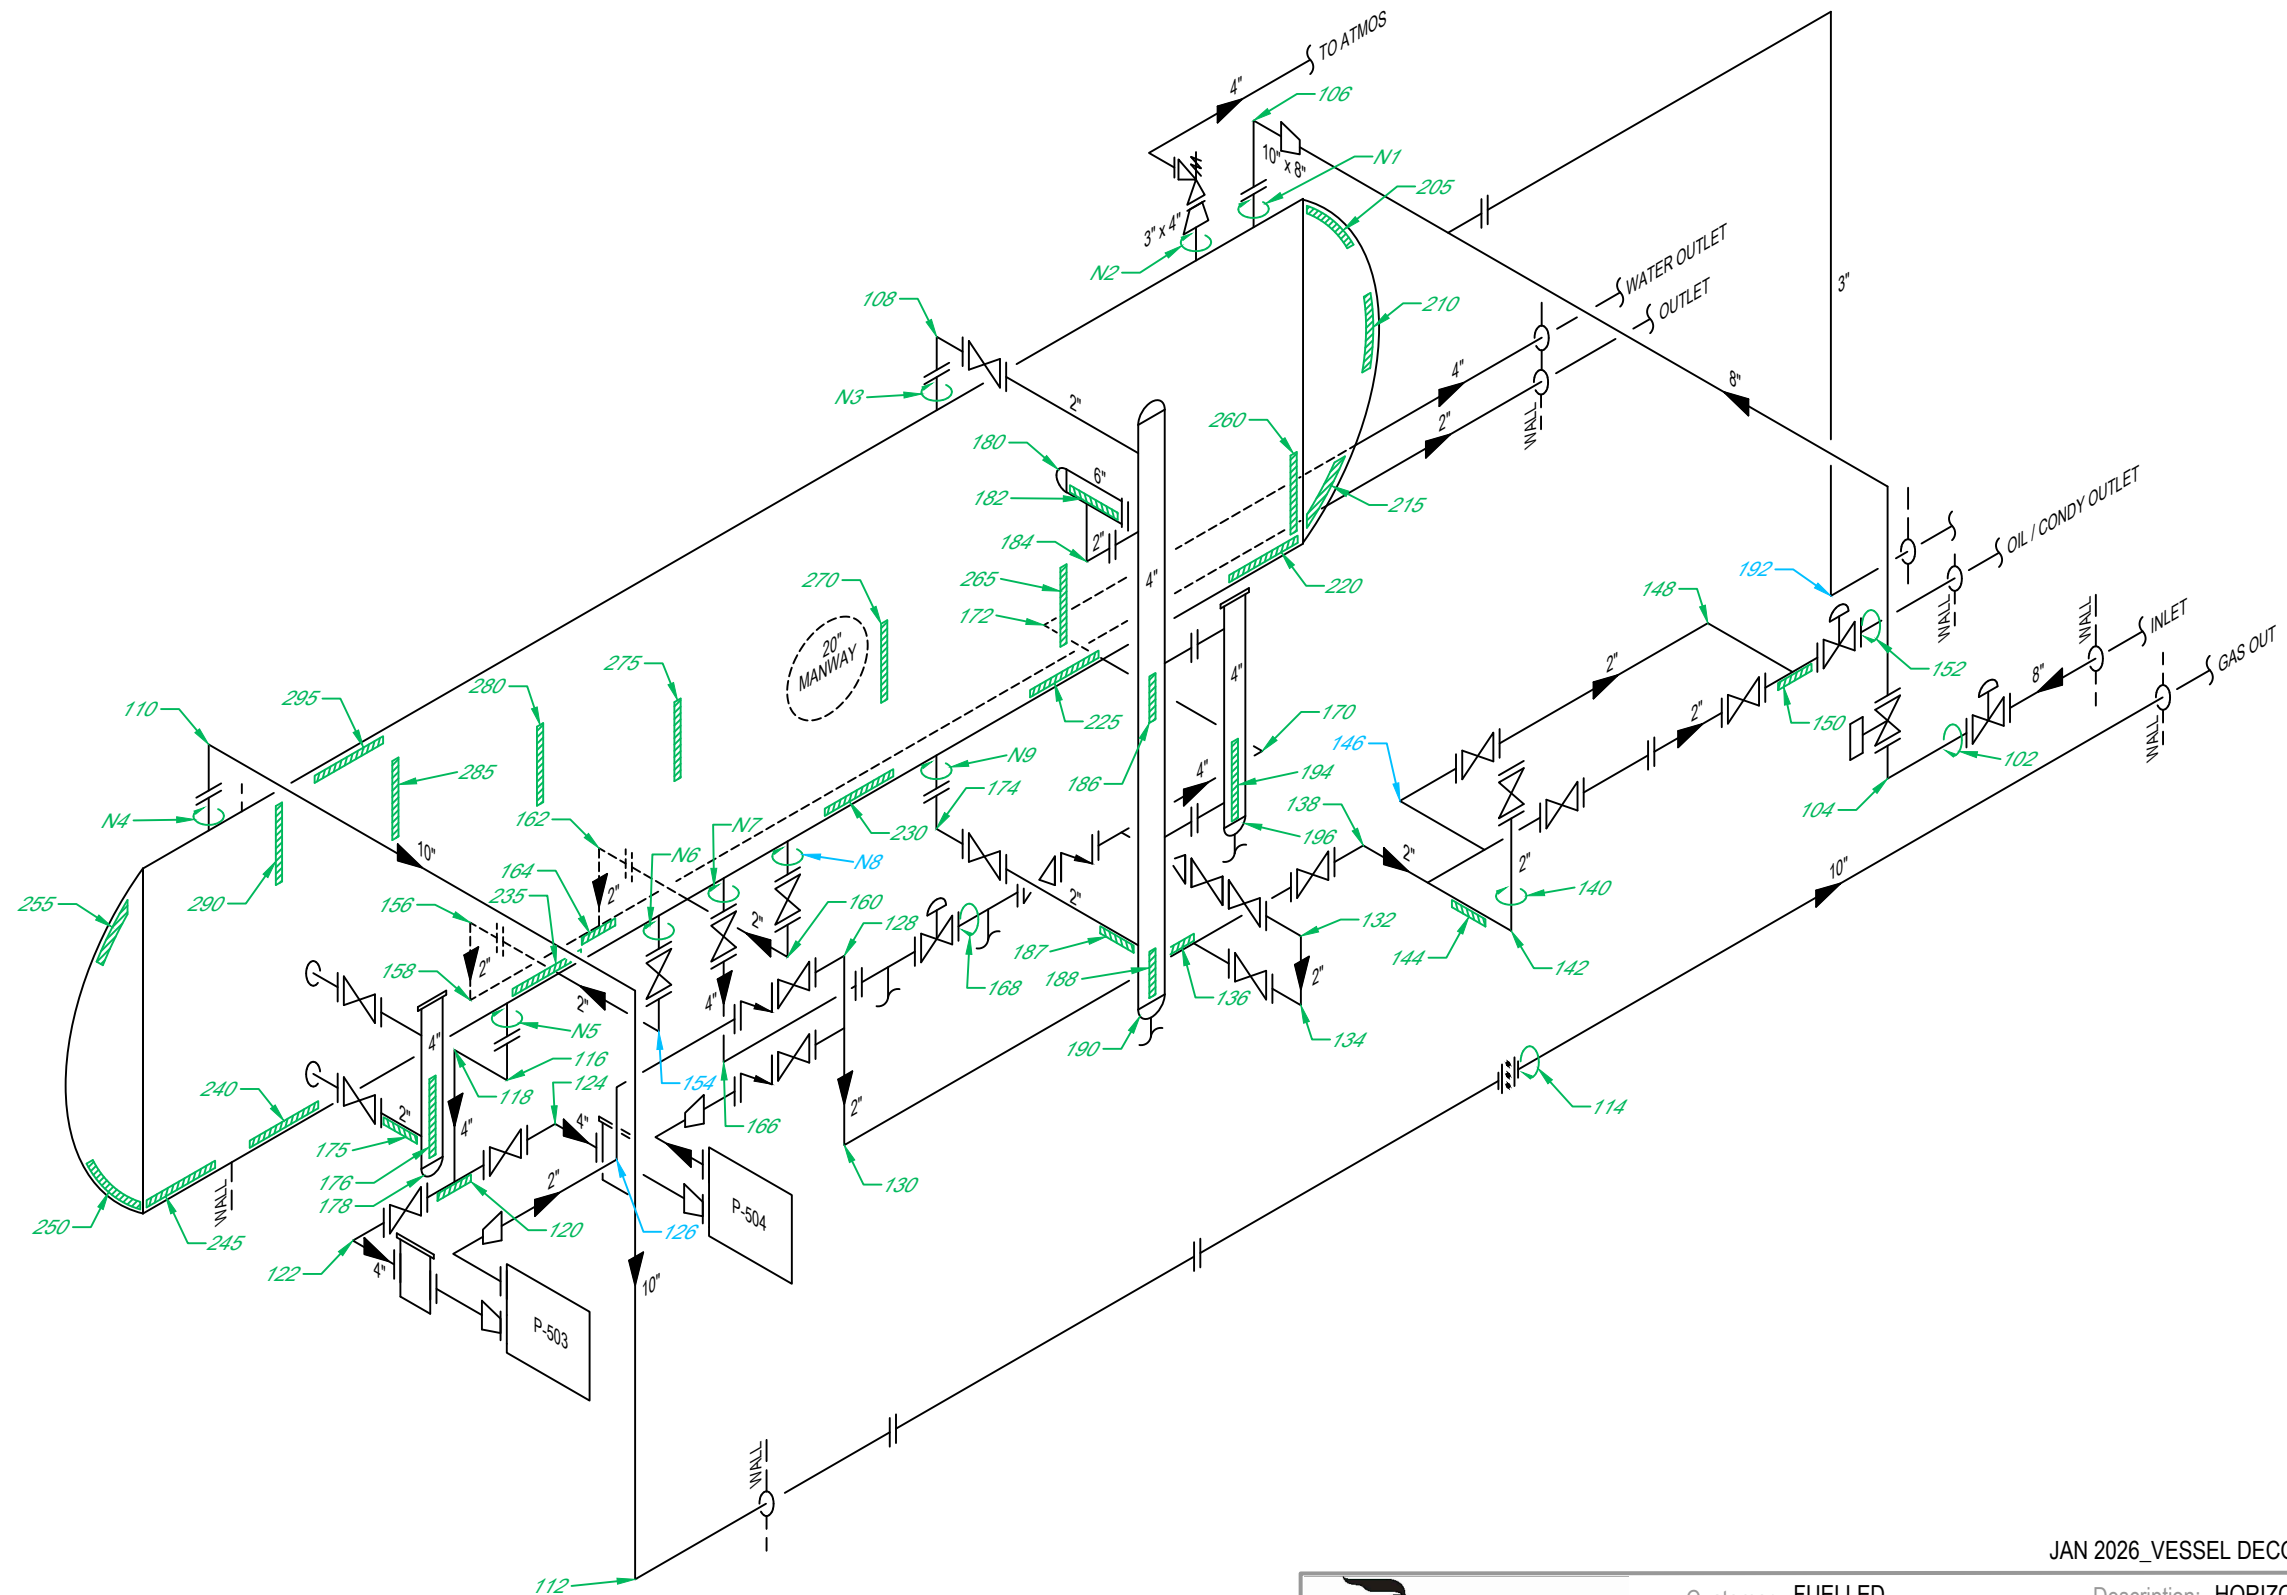
JAN 2026_VESSEL DECOMMISSIONED AND NOT IN SERVICE.

Customer: <u>FUELLED</u>	Description: <u>HORIZONTAL SEPARATOR</u>	
Facility: <u>EAGLESHAM FIELD</u>	Location: <u>01-25-76-01 W6M (LONG RUN EXPLORATION)</u>	
Reg A#: <u>0557073</u>	Serial #: <u>145-03-06</u>	Drawing#: <u>1</u>
CRN #: <u>T6684.2</u>	Manufacturer: <u>MAR-QUINN</u>	Unit #: <u>N/S</u> Year Built: <u>2006</u>
Shell MAWP: <u>4654 kPa</u>	Shell MAWT: <u>93°C</u>	Shell Material: <u>SA 516 70N</u> Nominal: <u>34.9mm</u> CA: <u>1.6mm</u>
Tube "A" MAWP: _____	Tube "A" MAWT: _____	Head Material: <u>SA 516 70N</u> Nominal: <u>33.4mm</u> CA: <u>1.6mm</u>
Tube "B" MAWP: _____	Tube "B" MAWT: _____	Tube Material: _____ Nominal: _____ CA: _____
Size: <u>6ft x 30ft</u>	Manway: <u>20in</u>	MDMT: <u>-29°C</u>
Insulated: <u>PARTIAL</u>	C Stamp: <u>U</u>	RT: <u>1</u> PWHT: <u>N/S</u>
		Boot Shell Mat: _____ Nominal: _____ CA: _____
		Boot Head Mat: _____ Nominal: _____ CA: _____

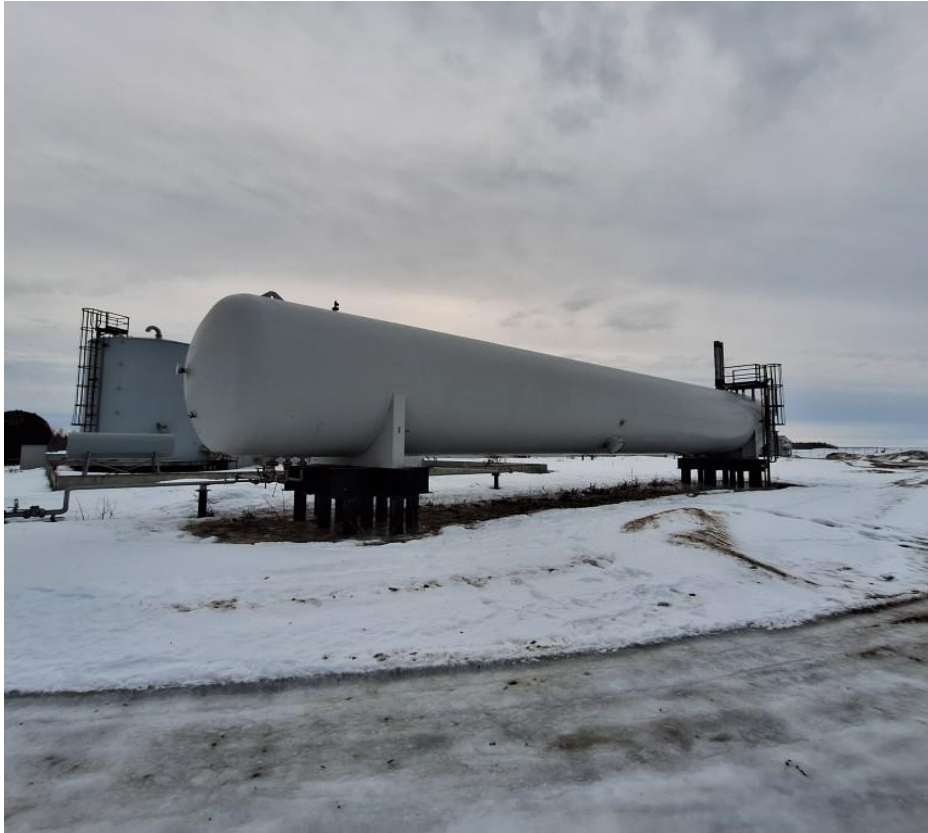
Vessel Overview

Client: **Fuelled**
 Unit #: **n/s**
 Equip Description: **Horizontal Storage Bullet**
 Reg A#: **0539162**
 Drawing #: **2**
