**SHOP FABRICATION  
 QUALITY SURVEILLANCE ASSIGNMENT "INTERIM" REPORT**

Assignment No.	Insp. PO No. TBD	AFE No.	QSI Ref No. 12-004	Report No. 1C	Page No. 1 of 3
Vendor Brothers Specialized Coatings		Location Edmonton, AB.		Vendor Shop No. 26760	
Project Title Muskwa Booster Station 16-22-84-2W5M		Equipment Description 5' x 25' Inlet Separator Vessel (Previously Used)		Equipment Tag No.(s) S/N 476275 V-100	
Surveillance Date(s) January 19 and 24, 2012				Date of Report February 20, 2012

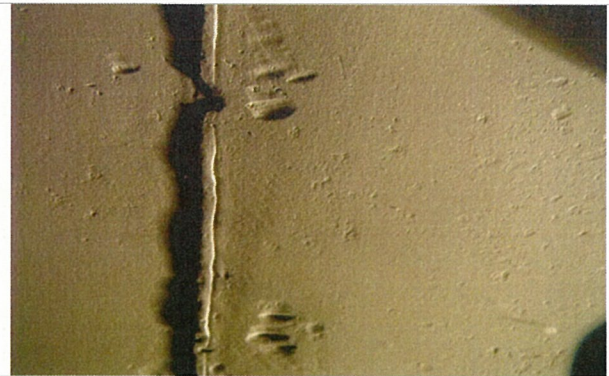
**PROBLEMS , CONCERNS & NONCONFORMANCES** (Identify all fabrication concerns , problems and nonconformances)  
 Indicate when resolution is required by Husky, response date and schedule impact.  
Pitting on the floor was brought to the attention of Roman Wynnnyk, Roman measured the pitting depth and pitting was found to be not deep enough to require attention.

Pitting

**Visual Appearance:** is acceptable, no runs, sags or misses. Coating appears uniform and smooth. Pitts on the floor have been addressed by grinding with a pencil grinder to radius sharp edges of the pits. Devoe 142 epoxy grout was used to fill the pitting; grout was applied after the first coat of Devoe 253. Three coats of Devoe 253 was applied by airless spray.

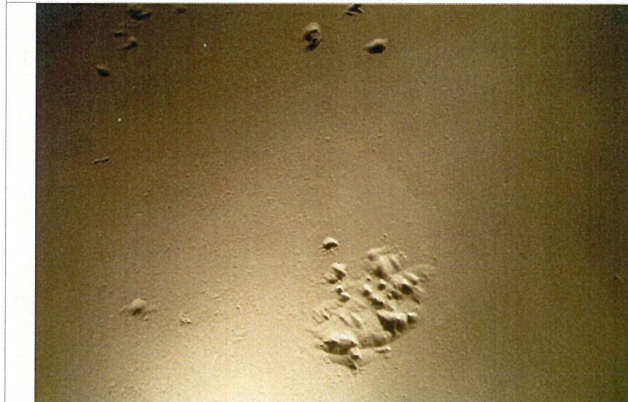
Pitting on the floor

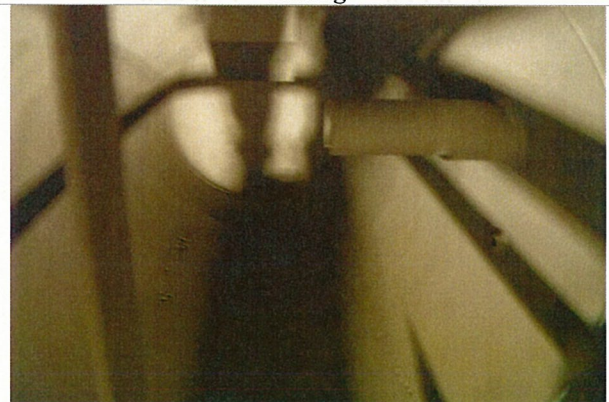
**Comments:** All spent blast media was removed by sweeping and vacuuming, vessel was blown down with clean filtered compressed air. Blast was found to be acceptable and suitable for the application of the internal coating (Devoe 253) to be applied holiday free to a thickness of 10 – 15 mils.

Acceptable internal Blast

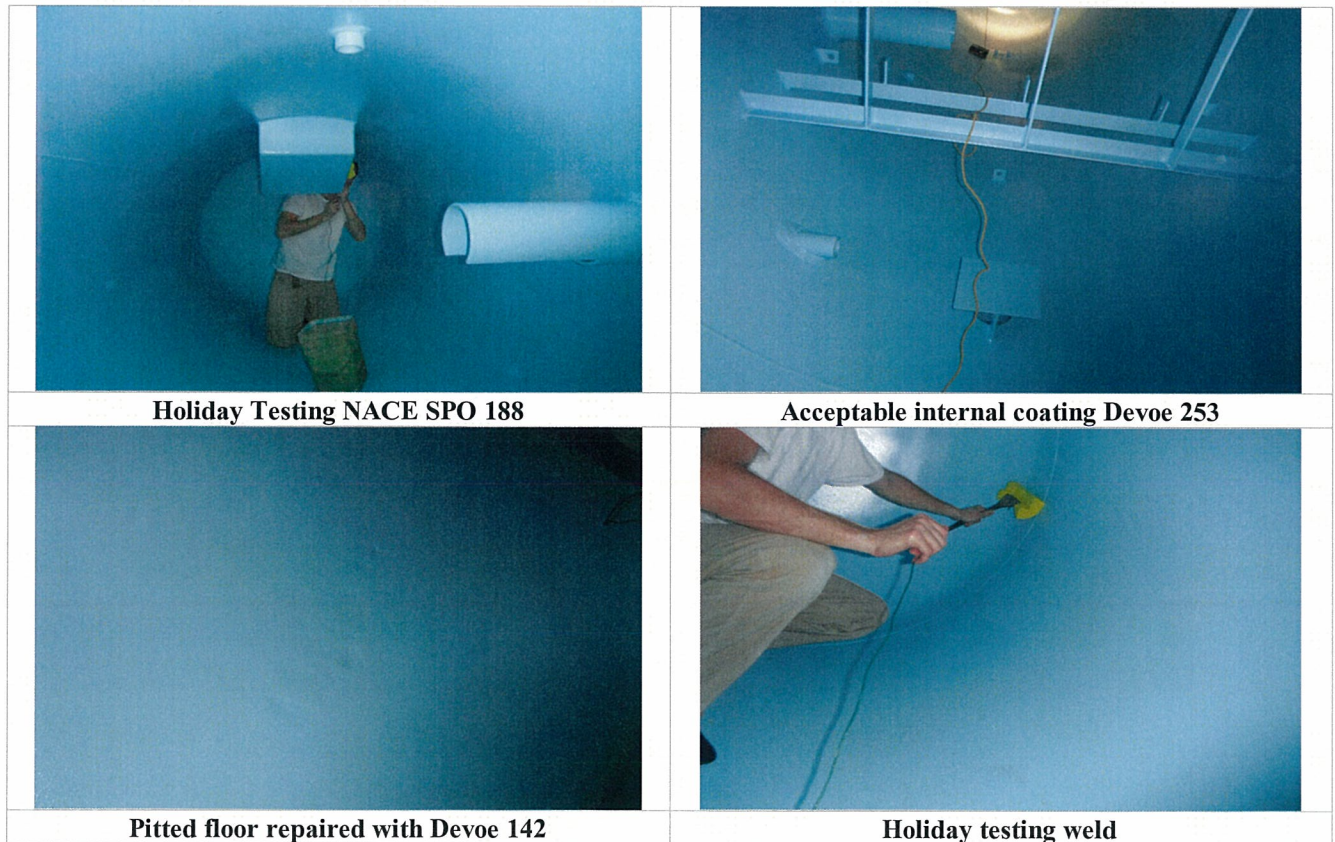
**Status:** Internal coating has been inspected and accepted. Brothers Quality Assurance documents have been reviewed and found to be accurate. Brothers have cleaned the interior of the building containing the vessel removing all debris. Vessel is released for shipping.
