PRESSURE VESSEL & COLUMN INSPECTION REPORT

SAP Equipment ID: 66146035

VESSEL STATIC DATA									
Plant:		MINEHEAD		Op Unit FH01			System		
Prov. Insp. #		A0528420		CRN R8180.2			Equip Tag # 66146035		
Equipment Description				FLARE KNOCKOUT DRUM			Serial # 13728		
Manufacturer				BILTON WELDING & MANUFACTURING			Vessel Class VESSEL		
Internal Access:		NO		Description:			Year Built 2005		
MAWP 345		kPa		@ 150		°C		MDMT 302 °C	
CODE :				RT :			PWHT : NO		
Diameter 1829		Length 3048		(T/T) mm		OAL mm		Horizontal	
Shell Mat'l		UNKNOWN		Thickness 0		mm		Corr Allowance 3 mm	
Head Mat'l		UNKNOWN		Thickness 0		mm		Corr Allowance 3 mm	
Nozzle Mat'l				Thickness		mm		Corr Allowance mm	
Internal Coating : NO				Internal Clad : NO			Capacity m ³		
Manway : NO				Inspection Port : NO			Skirt Legs Saddle		
Nozzle Rating		lb ANSI		Painted : NO			Insulated YES		
PROCESS DATA									
Product Description						Sweet Sour			
Operating Pressure kPa						Operating Temperature °C			
PSV STATIC DATA

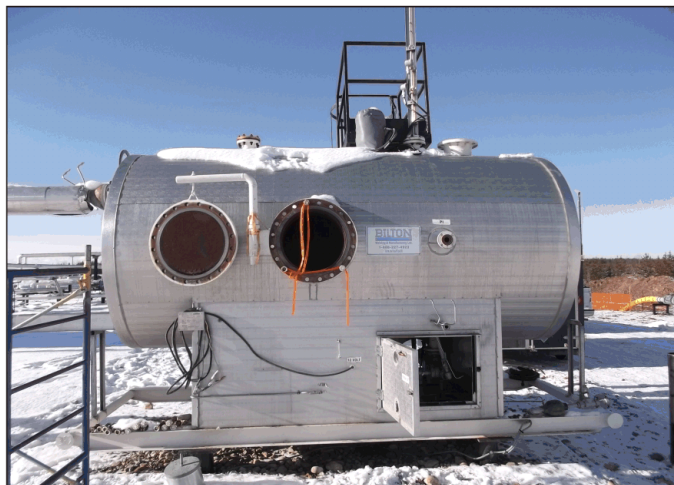
OVERALL

ID	Description	Condition	Location	NCR	Comments
V1	General Other (Please Explain)	ACCEPT			MAJORITY OF VESSEL INSULATED. EXPOSED SHELL ON UNDERSIDE OF VESSEL
V2	General Corrosion	ACCEPT			
V3	General Leaks	ACCEPT			NO LEAKS OBSERVED.
V4	Vibration	ACCEPT			NO VIBRATION OBSERVED.
V5	Dissimilar Flange Rating	ACCEPT			
V6	Ladder/Stairway	ACCEPT			SECURE TO VESSEL.
V7	Heads	ACCEPT			
V8	Guy Wires	N/A			
V9	Electrical Ground	ACCEPT			
V10	Painted Inactive Corrosion	N/A			
V11	Coating/Painting	ACCEPT			PAINT IN GOOD CONDITION.
V12	Expansion Joint or Bellows	N/A			
V13	Gauge/Site Glass	ACCEPT			
V14	Shell	ACCEPT			
V15	Jacket	N/A			
V21	Support Other (Please explain)	ACCEPT			SECURE. GOOD CONDITION.
V22	Foundation	ACCEPT			ON PILINGS. GOOD CONDITION.
V23	Anchor Bolts	N/A			
V24	Saddle/Skirt	ACCEPT			GOOD CONDITION.
V25	Davit	N/A			
V26	Fireproofing	N/A			
V31	Connections Other (Please explain)	ACCEPT			ALL CONNECTIONS IN GOOD CONDITION.

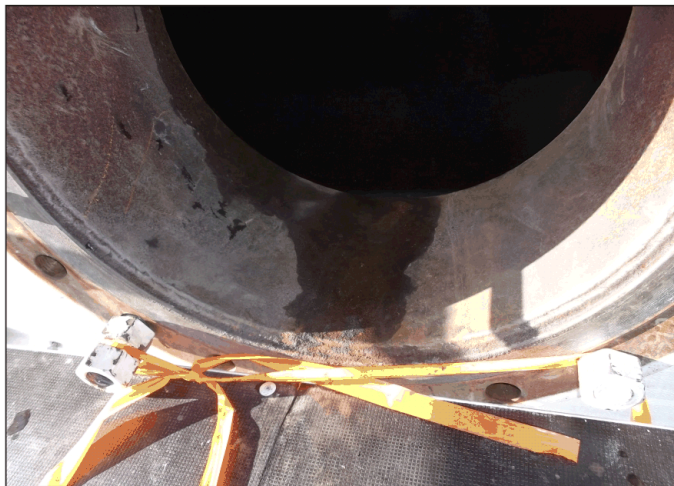
ID	Description	Condition	Location	NCR	Comments
V1	General Other (Please Explain)	ACCEPT			INTERNAL ANODE, ABOUT 5-10 PERCENT CONSUMED.
V2	Corrosion (depth, length, width)	ACCEPT			NO PITTING, ONLY MINOR SURFACE CORROSION.
V3	Erosion	N/A			
V4	Distortion	N/A			
V5	Blisters	N/A			
V6	Deposits	N/A			TIDE LINE VISIBLE ON BOTTOM OF VESSEL.
V7	Heads	ACCEPT			VERY GOOD CONDITION.
V8	Welds	ACCEPT			VERY GOOD CONDITION, MINOR SURFACE CORROSION.
V9	Nozzles	ACCEPT			INLET AND OUTLET NOZZLES HAVE MINOR SURFACE CORROSION.
V10	Shell	ACCEPT			ONLY MINOR SURFACE CORROSION.
V11	Gasket Surfaces	ACCEPT			VERY GOOD CONDITION, NO DAMAGE
V21	Internals Other (Please explain)	ACCEPT			2 FLOAT INTERNAL COLUMNS, MINOR SURFACE CORROSION.
V22	Demister	N/A			
V23	Baffle/Wier	N/A			
V24	Sparger	N/A			
V25	Thermowells	ACCEPT			MINOR SURFACE CORROSION
V26	Metallic Linings	N/A			
V27	Nonmetallic Linings	N/A			
V28	Trays	N/A			
V29	Tray Rings	N/A

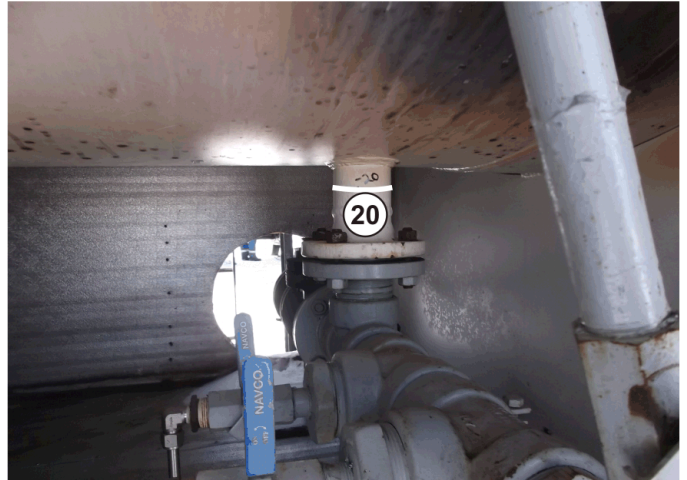
INTERNAL

V30	Other Welded Attachments	ACCEPT			INLET/OUTLET PIPES IN GOOD CONDITION, NO DAMAGE, MINOR SURFACE CORROSION
