Pressure Vessel External Visual Inspection Report

Equipment ID: 66146158

Description:	Separator, 30` X 96`, 1400 Psi
Asset Type:

PRESSURE VESSEL INSPECTION REPORT

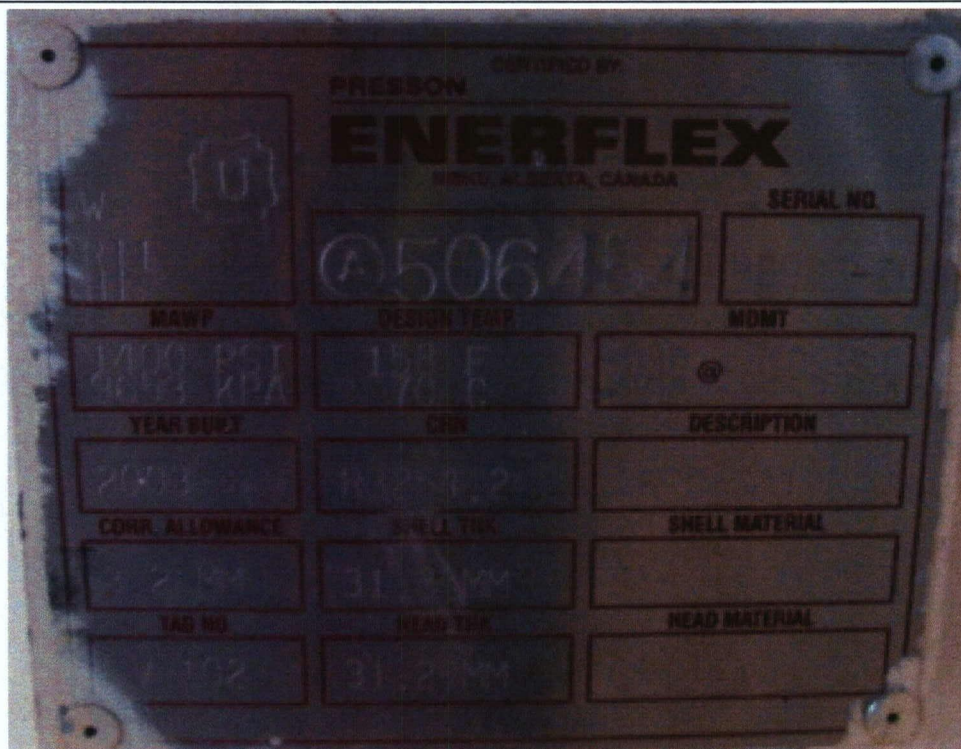
Data Plate

The nameplate is attached and legible with A# 506454 stamped on it. The vessel is painted and the paint is in fair condition with several chips with no corrosion noted. The piping, bolting and external attachments are in good condition. No leaks noted.

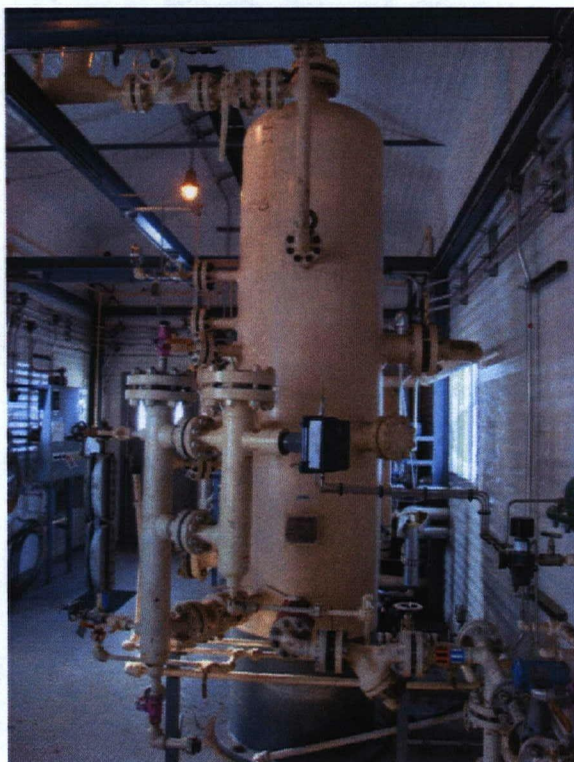
Vessel

FACILITY Minehead Comp Station	DATE March 1, 2009	REPORT # IR090301JNe
INSPECTION OBSERVATIONS		
NONCOMPLIANCES OR INSPECTION DEFICIENCIES ISSUED		
No NCR's were issued.		
EXTERNAL VISUAL INSPECTION		
The overall condition of this vessel is good. The vessel dataplate is legible and has the required information. / <i>Data Plate Condition - Good</i> The vessel is protected with a PSV. The PSV is attached to the vessel, has a set pressure at or under MAWP and a current service date. / <i>PSV Condition - Good</i> The gauges are clearly legible and appear to be functioning properly. / <i>Gauges Condition - Good</i> The vessel appears to be properly secured and level. / <i>Vessel Secure - Yes</i> The vessel is indirectly grounded. / <i>Vessel Grounded - Yes</i> The piping, bolting, tubing and external attachments are secure with no active leaks. / <i>Piping & Bolting Condition - Good</i> The vessel and piping are painted with no notable corrosion found. / <i>Vessel Paint Condition - Good</i> The floor is painted with no notable corrosion found. / <i>Floor Condition - Good</i>

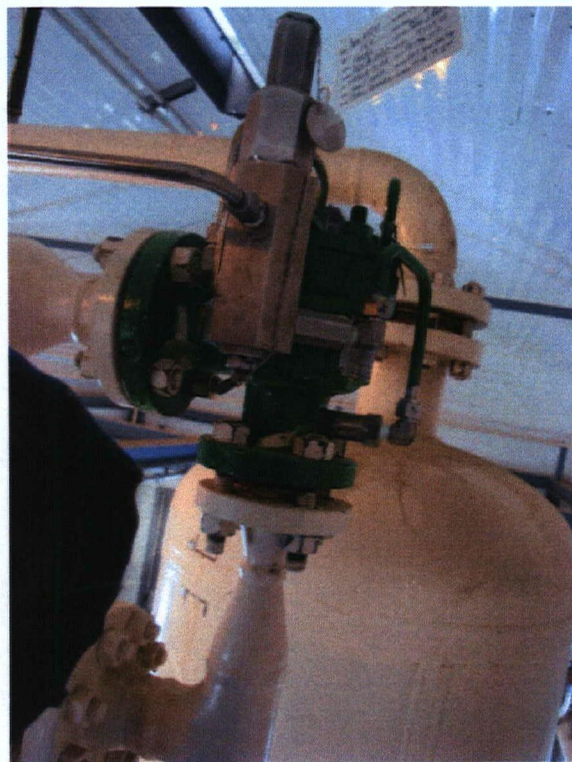
PSV

Tag / Serial No.	Location	Size Inlet	Size Outlet	Set Pressure	Capacity SCFM / Lbs/Hr / GPM	Manufacturer	Model / Type	Service Date
38DC13-120/S7	Vessel	1"	2"	1400 PSI	3667 SCFM	Farris	455618-32-DA	04/07

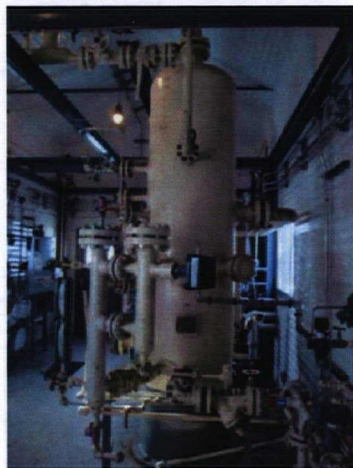
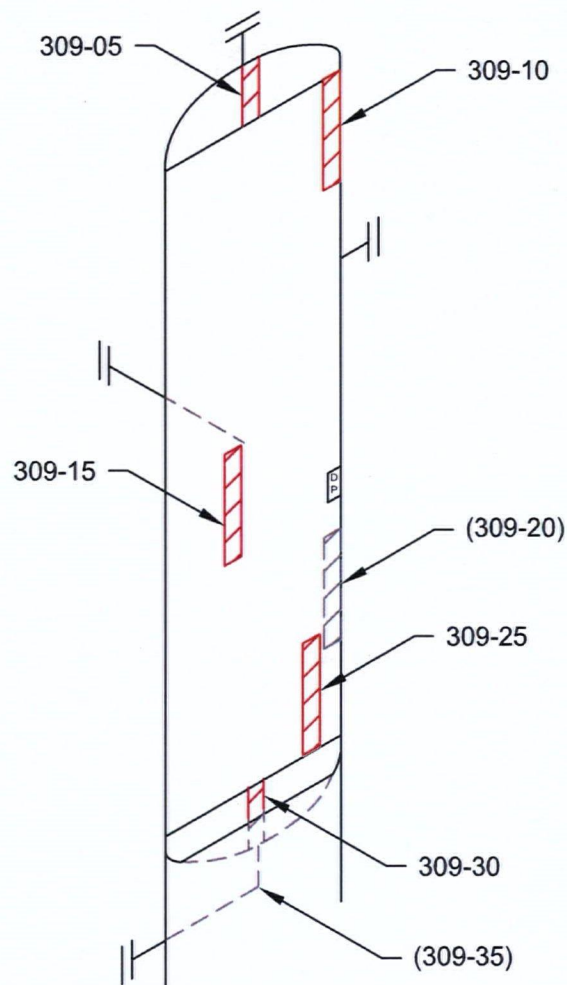
A 0506454

OD	NOMINAL	MATERIAL	CA
VESSEL HEAD	30"	1.230"	SA-516-70	.125"
VESSEL SHELL	30"	1.250"	SA-516-70	.125"
BOOT HEAD	-	-	-	-
BOOT SHELL	-	-	-	-

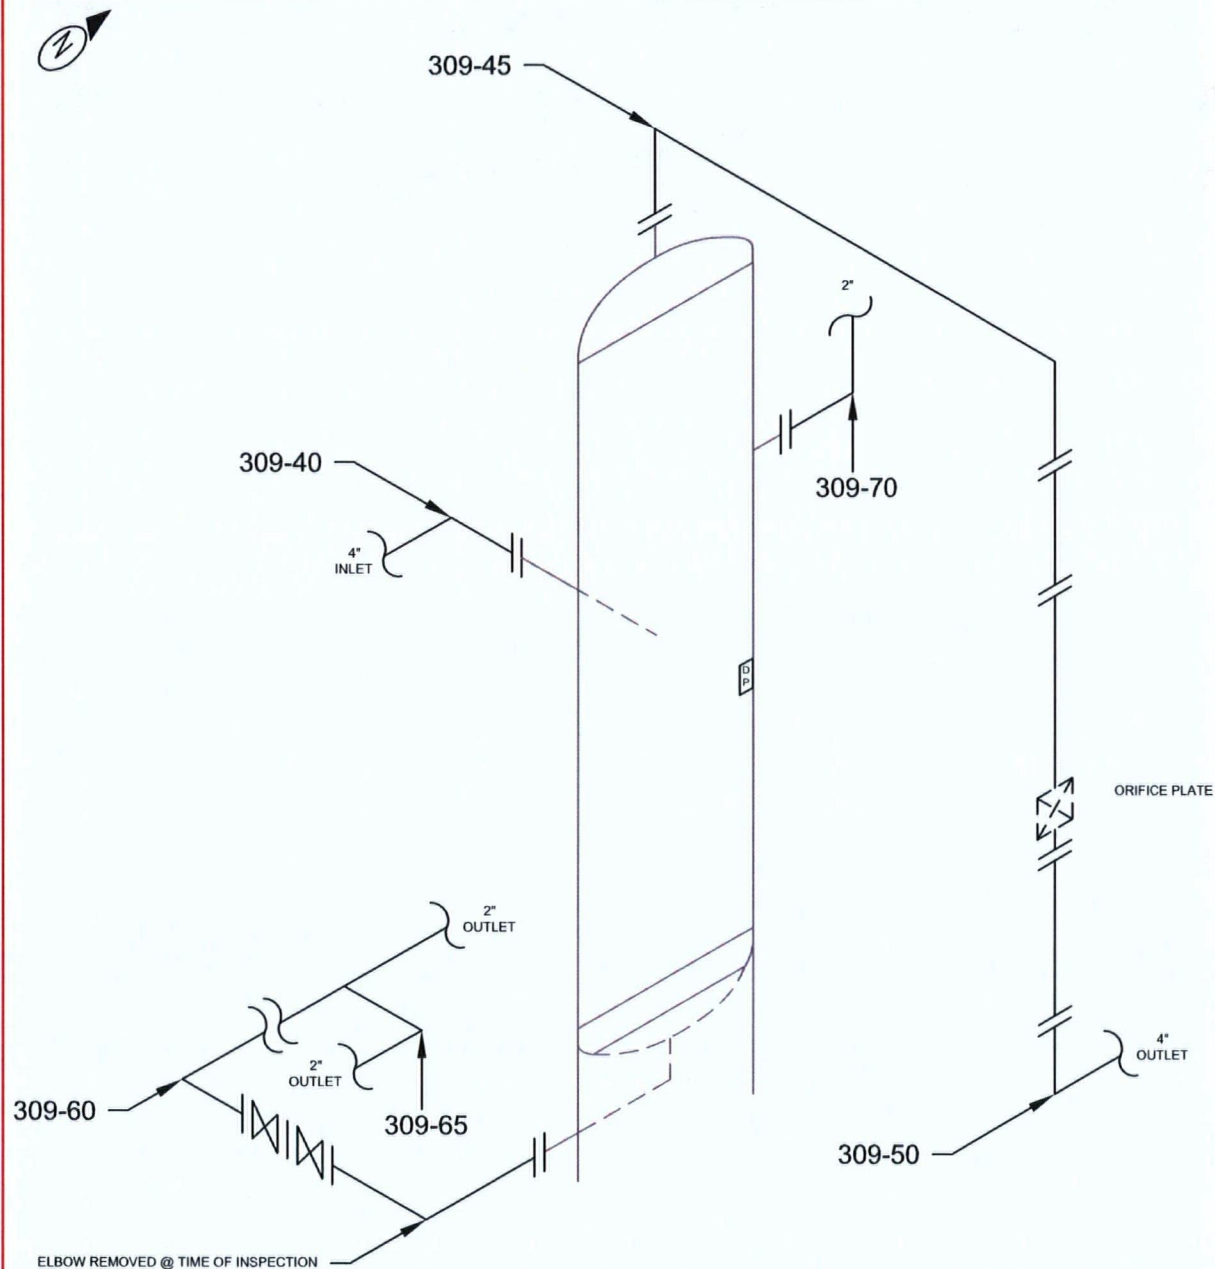
DWG # 309A

EXTERNAL NDE EXAMINATION		
An external ultrasonic corrosion survey was completed as requested. Piping band 309-65, 2" 90 degree elbow has an ID pit. Nominal should be Sch 40 / .154". Low UT reading .114". <i>Inspect in 1 year. [Signature]</i> No other relevant indications were noted at the time of inspection. For more details see formal UT report by Hunt Inspection - Project C2946		
INTERNAL VISUAL INSPECTION		
There was no internal Visual at time of inspection.		
INTERNAL NDE EXAMINATION		
There was no internal NDE at time of inspection.		
PRESSURE TEST		
Test Completed <input type="checkbox"/> Yes <input checked="" type="checkbox"/> No	Test Acceptable <input type="checkbox"/> Yes <input type="checkbox"/> No	Test Report #
INSPECTOR CERTIFICATION		
I, the undersigned certify that the above equipment has been inspected in accordance with the assigned task list and that statements within this report are correct and represent inspection findings

Monitor UT band 309-65 in the future to determine a corrosion rate. Inspect in 1 year. JH
