## PRESSURE VESSEL & COLUMN INSPECTION REPORT

LSD: 11-24-50-20W5

SAP Equipment ID: 66113422

| VESSEL STATIC DATA | | | | | | | | | |
|---|---|---|---|---|---|---|---|---|--|
| Equipment Description 3 Phase Separator | | | | | | | Serial # 10777 | | |

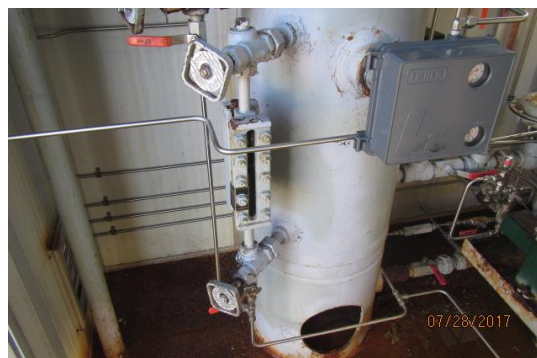
Vessel Overview

A visual external inspection was performed on the vessel and a summary of what was found follows. Data plate secure and legible. Vessel and piping in good condition. PSV last serviced in 2012. Vessel skirt secure to base. Outlet loop piping secure to stand. All vents, drains, and nozzles plugged. Coating failures on inlet piping and flange. Water in skirt and condensation on vessel shell and piping in shack.

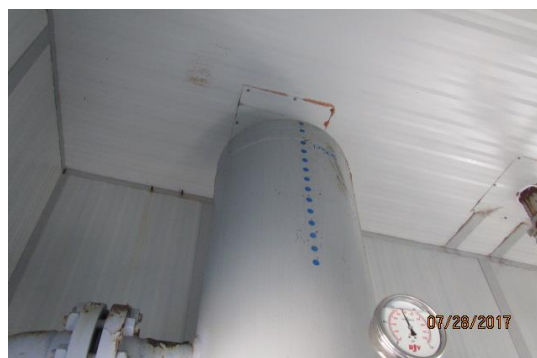
Top Head

| ID | Description | Condition | Location | NCR | Comments |
|---|---|---|---|---|---|
| V7 | Heads | Acceptable | | | No concerns noted |

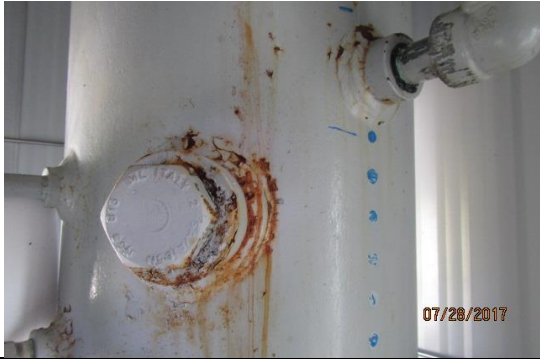
| ID | Description | Condition | Location | NCR | Comments |
|---|---|---|---|---|---|
| V11 | Coating/Painting | Good | | | Failures on shell |

| <p>A photograph of industrial piping. A white pipe with a flange and bolted connection is visible. A date stamp '07/28/2017' is visible in the bottom right corner.</p> | <p>A photograph of a white cylindrical shell with a circular access point or manhole. The area around the access point shows significant rust and corrosion. A date stamp '07/28/2017' is visible in the bottom right corner.</p> |
