# Husky Energy

## PRESSURE VESSEL INSPECTION REPORT

FACILITY Ansell Field DATE February 22, 2009 REPORT # IR090222JNp

Prov. Insp. # -	CRN F 6388.2	Equip Tag # -
Equipment Location (LSD) 31102/17-07-051-18 w5m	Serial # 10818	
Equipment Description Fuel Gas Scrubber	Vessel Class -	
Manufacturer RJV Gas Field Services	Year Built 2006	
MAWP 150 PSI KPag / psig @ 100 °F °C / °F	MDMT -20 °F °C / °F	
CODE : UM <input type="checkbox"/> U <input type="checkbox"/> U2 <input type="checkbox"/> RT : 1 <input type="checkbox"/> 2 <input type="checkbox"/> 3 <input type="checkbox"/> 4 <input type="checkbox"/>	PWHT : YES <input type="checkbox"/> NO <input checked="" type="checkbox"/>	
Diameter 219mm(NPS) Length 760mm (S/S) OAL mm/in	Vertical <input checked="" type="checkbox"/> Horizontal <input type="checkbox"/>	
Shell Mat'l SA 106 B Thickness 8.1mm mm	Corr Allowance 3.17mm mm/in	
Top Head Mat'l SA 234 WPB Thickness 7.16mm mm	Corr Allowance 3.17mm mm/in	
Bottom Head Mat'l SA 516-70 Thickness 19.05mm mm/in	Corr Allowance 3.17mm mm/in

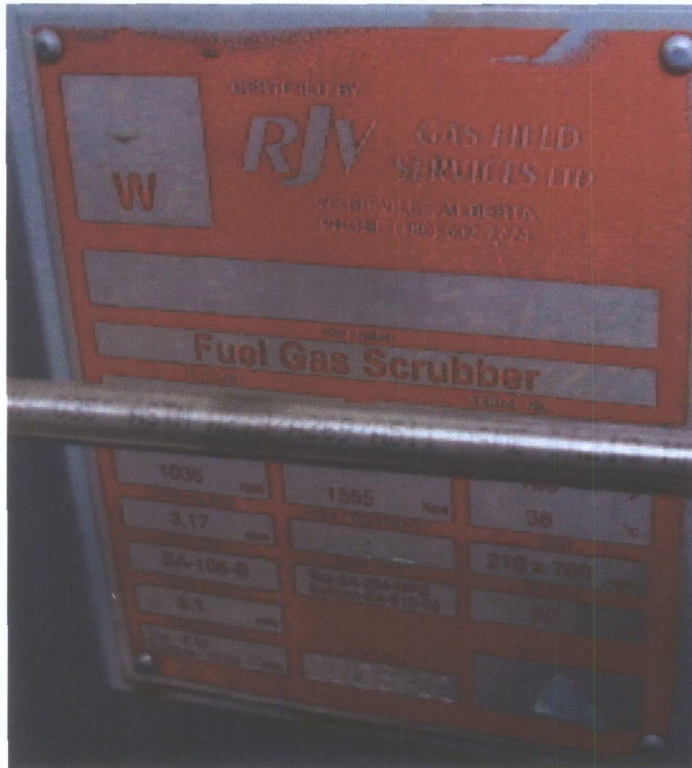
Data Plate

The vessel dataplate is legible and has the required information. / *Data Plate Condition - Good*

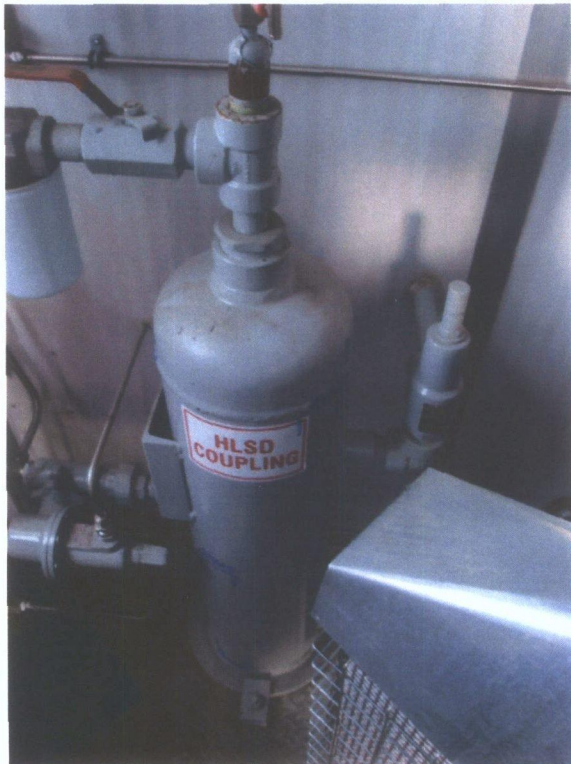
Vessel

The overall condition of this vessel is good.

The vessel appears to be properly secured and level. / *Vessel Secure - Yes*

The vessel and piping are painted with no notable corrosion found. / *Vessel Paint Condition - Good*

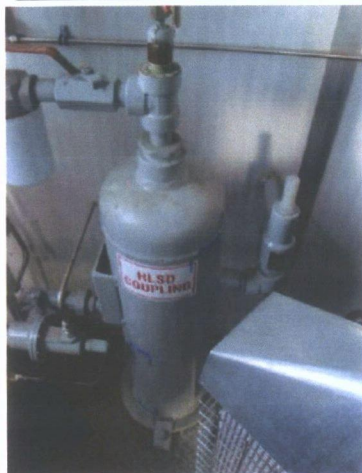
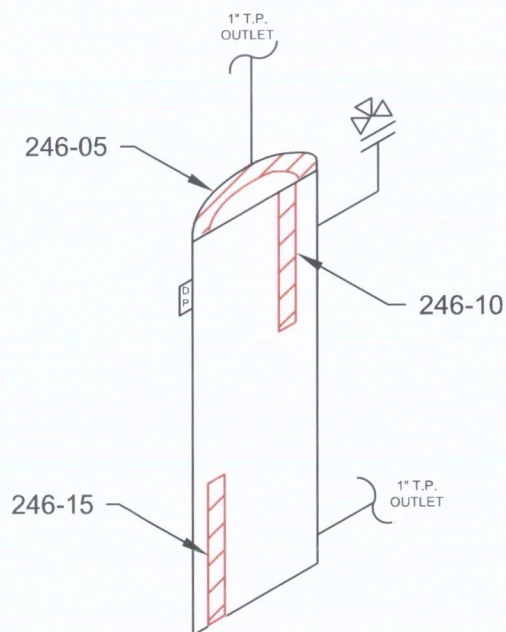
**FUEL GAS SCRUBBER**

OD	NOMINAL	MATERIAL	CA
VESSEL HEAD	8.625"	.282"	SA-234-WPB	.125"
VESSEL SHELL	8.625"	.319"	SA-106-B	.125"
BOOT HEAD	-	-	-	-
BOOT SHELL	-	-	-	-

ALL FITTED PIPING
