SEPARATOR INSPECTION REPORT

Notification Number 6067457 Work Order 6070157
Notification Desc SEPARATOR, 16" 600# 1440 PSI Maintenance Plan QPSEPAR6588
Tasklist Operation (5Y Inspection Interval) 5Y Code Inspection Separator - Sweet Se

PRESSURE VESSEL INSPECTION REPORT

FACILITY Ansell Field DATE February 22, 2009 REPORT # IR090222JNo

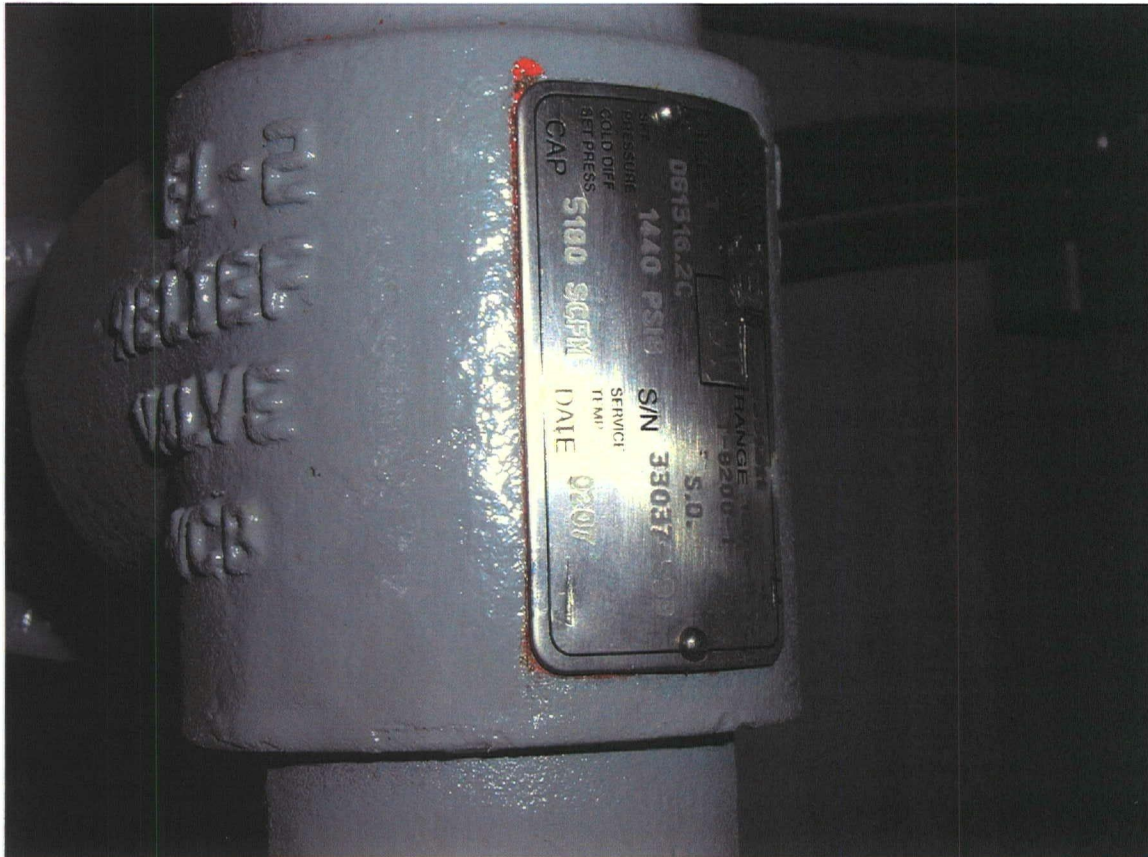
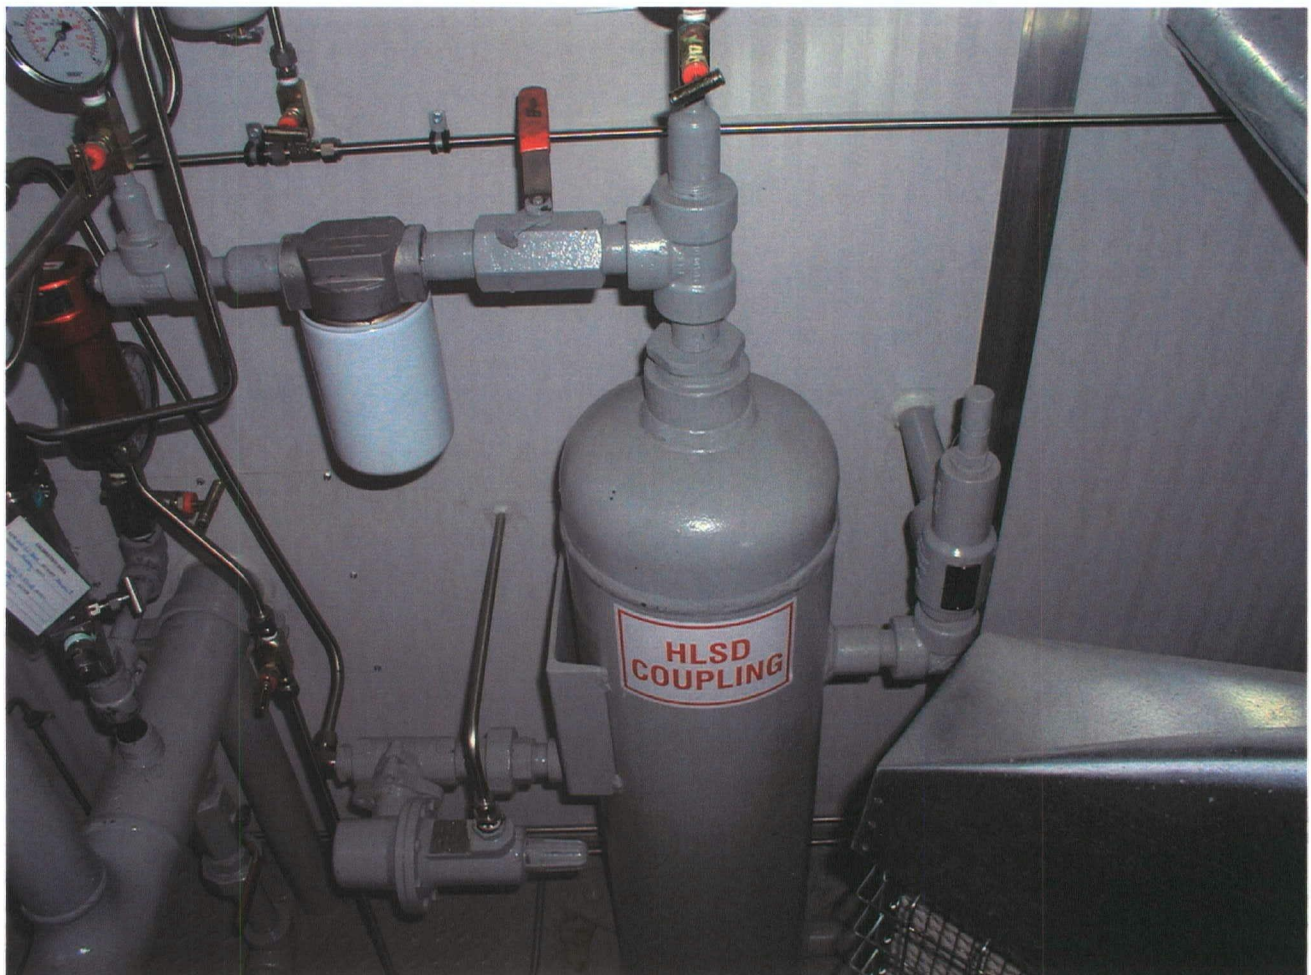
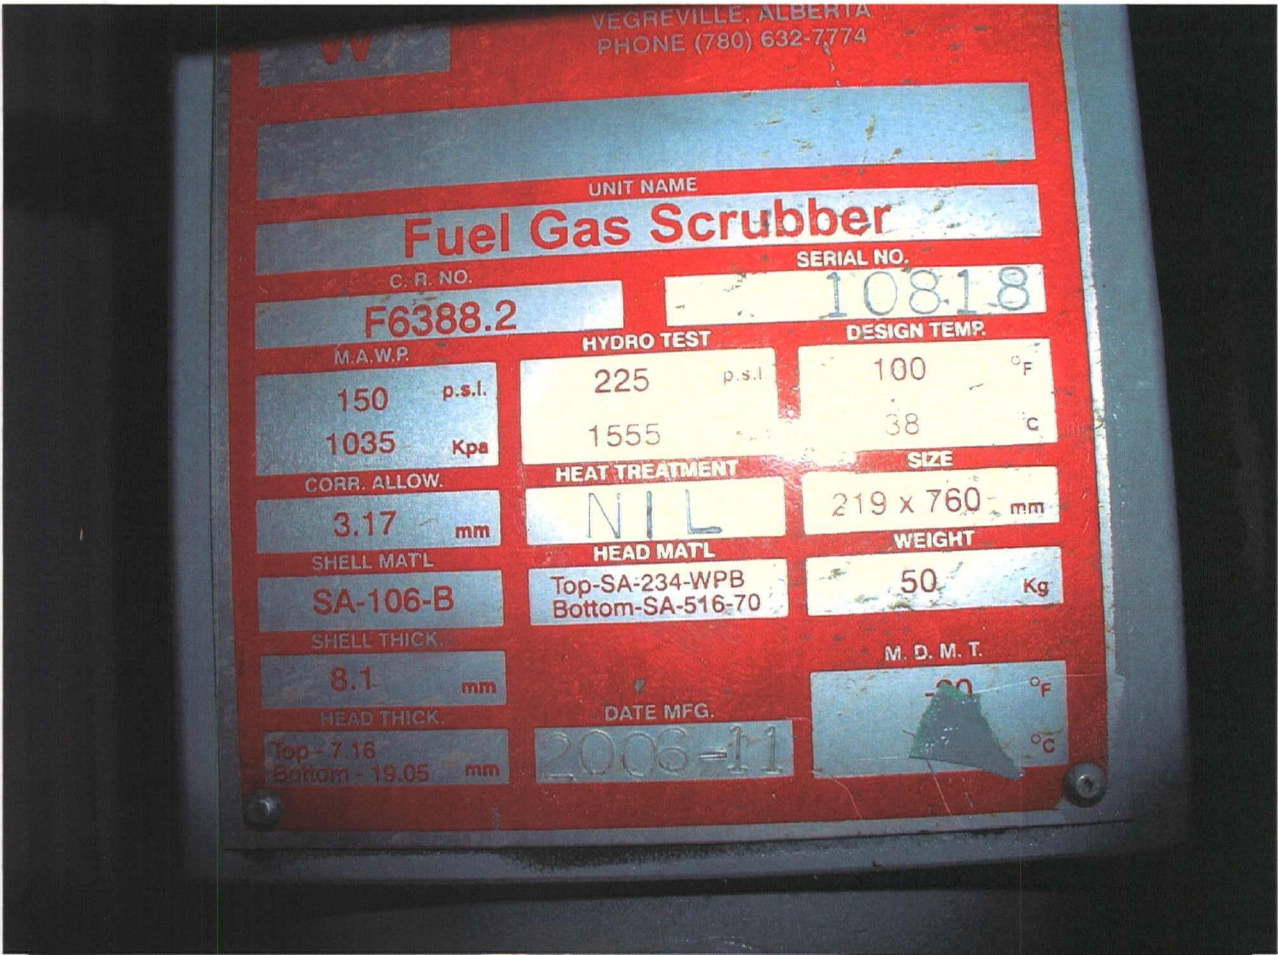
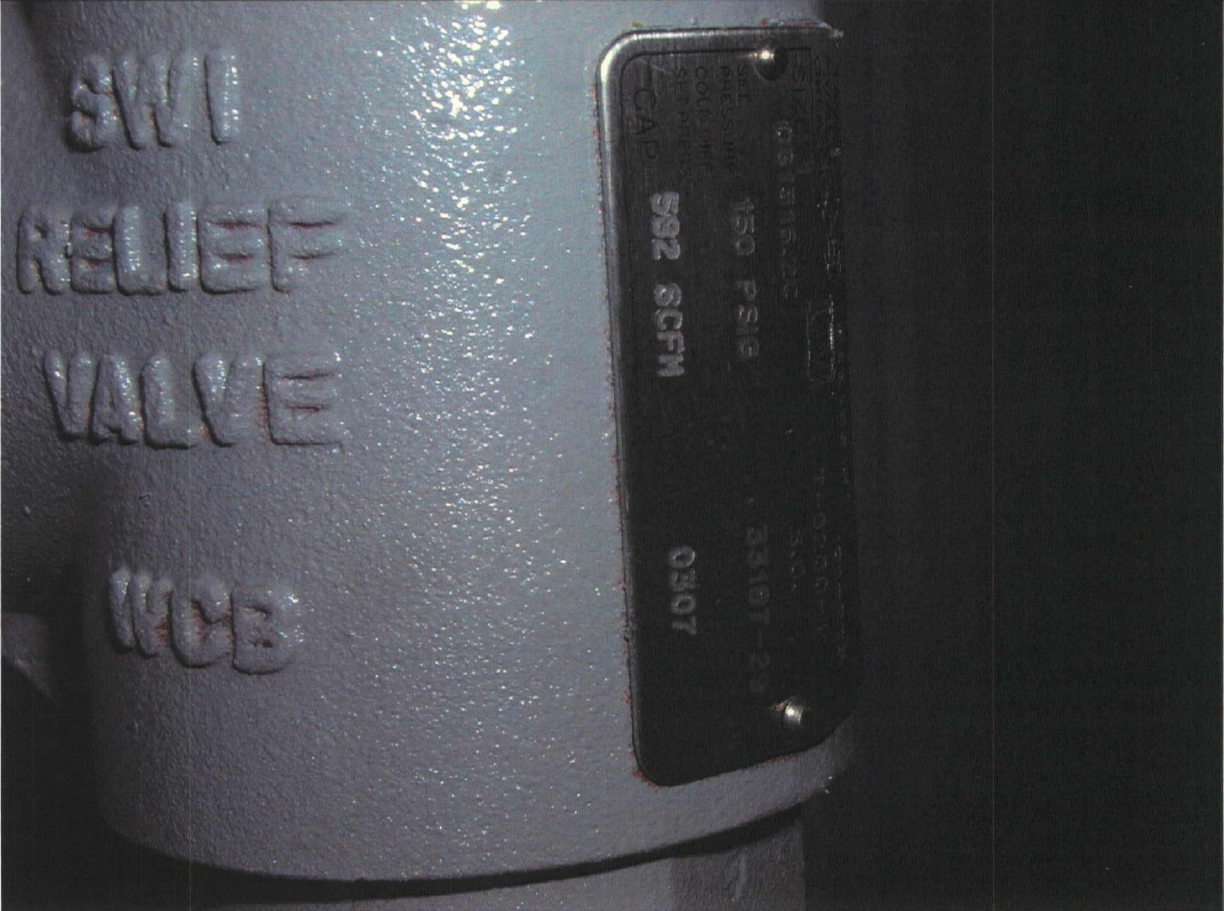
PHOTOS OF A547283 SEPARATOR AND FUEL GAS SCRUBBER

Nameplate on the Separator was attached and legible.
 The paint was in excellent condition with no chips noted.
 The Separator skirt was welded to the floor and was secure.
 PSV was last serviced 02/2007.
 The nameplate states 24.44 mm nominal. The shell is actually fabricated from a 0.843" (21.44 mm) section of pipe. The nameplate needs to be changed to reflect this. The issue is being handled by Calgary Technical Services and the Area Inspector.
 No leaks noted on any connections.
 No other concerns noted.
 The Separator is considered acceptable for continued service.

The Fuel Gas Scrubber was fabricated by RJV in 2006. CRN# F6388.2, Serial# 10818. MAWP: 150 psi at 100F. Diameter 219mm x 760 mm L.
 The paint was in excellent condition. No chips were noted.
 No leaks were noted on any connections.
 No concerns were noted on the scrubber.
 Scrubber PSV info:
 Located: off Scrubber
 Service Date: 03/2007
 The Fuel Gas Scrubber is considered acceptable for continued service

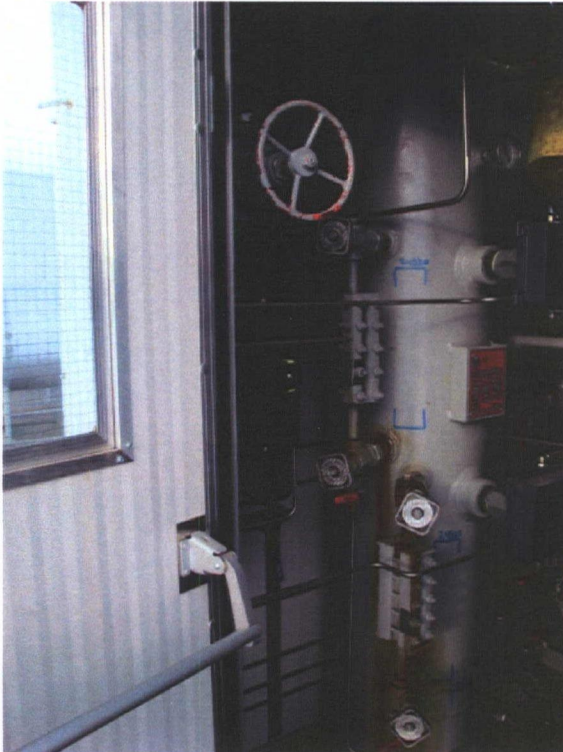
Data Plate

The vessel dataplate is legible and has the required information. / *Data Plate Condition - Good*

Re-stamp shell thickness on nameplate to 21.44mm. *SM*

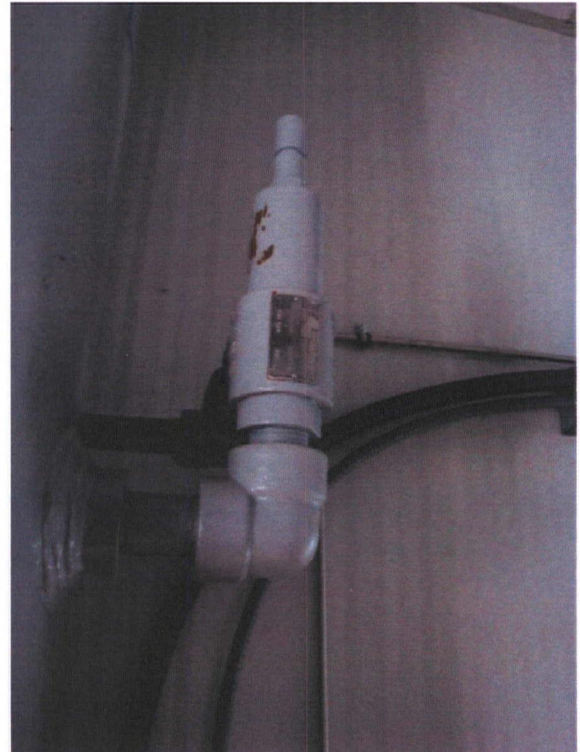
The vessel is protected with a PSV. The PSV is attached to the vessel, has a set pressure at or under MAWP and a current service date. / *PSV Condition - Good*

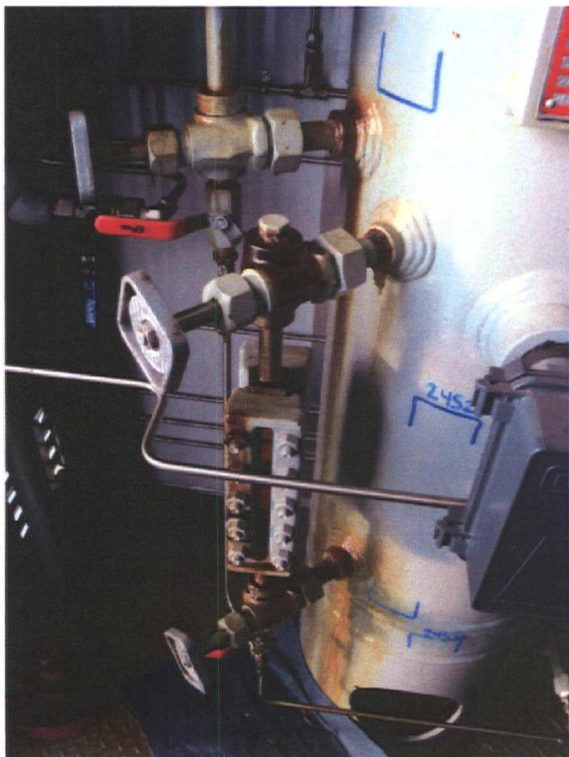
Active Leaks in Sight Glass Fittings

The piping, bolting, tubing and external attachments are secure. There are numerous active leaks in the treaded piping and sight glass fittings. / *Piping & Bolting Condition - Fair*

Tighten any fitting that has an active leak in the sight glass and treaded piping.
