Storage Tank External Visual Inspection Report

System: 40018-100001 102/09-11-047-05W4 (T1)

Description:	TANK, UNIVERSAL 160M3
--------------	-----------------------

Storage Tank Internal Visual Inspection Report

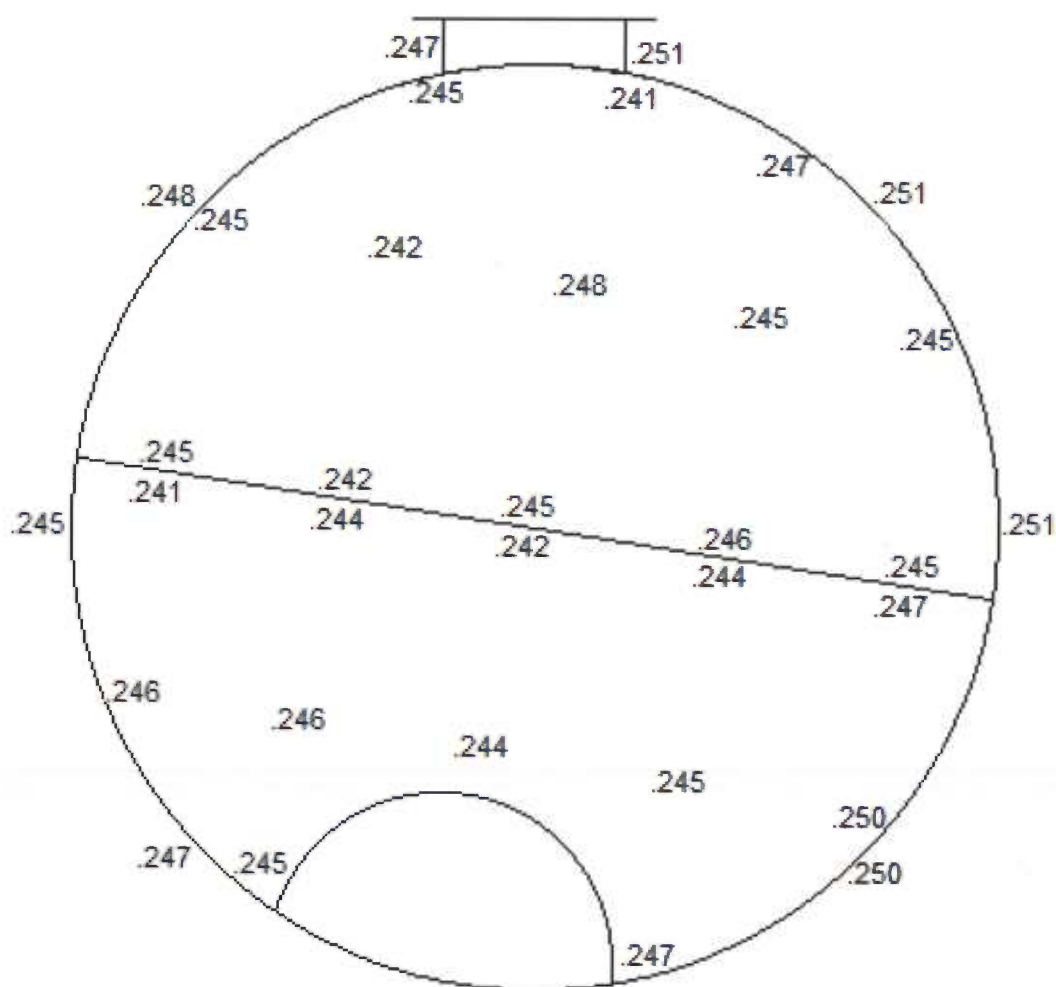
LOCATION 11-11-47-5W4 DATE 2015-11-23 MFG UIL
YEAR 2013 SN 29085-7 CAP 1000 BBL AFE/CC 80043619
FLOOR THK 1/4" SHELL THK 1/4" 3/16" ROOF THK 3/16"
SAP # 66221241

ID	Description	Condition	Location	NCR	Comments
V2	Corrosion	Yes			Underside of tank floor and lower shell.
V7	Welds	Fair			Acceptable
V8	Nozzles	Fair			Acceptable
V9	Shell	Fair			Acceptable
V10	Roof	Fair			Acceptable
V21	Internals Other (Please explain)	Fair			Firetube - Acceptable
T11	Floor	Fair			Acceptable

Random locations of the tank's floor and lower shell were UT thickness tested with some minor metal loss identified. The lowest thickness identified was found to be 0.241". See attached sketch for thicknesses found and approximate locations of tests.

Continue the UT thickness survey on the tank floor and lower shell at next scheduled inspection.
