## Storage Tank External Visual Inspection Report

Description:	TANK, UNIVERSAL 160M3		
	, , , , , , , , , , , , , , , , , , , ,

## Storage Tank Internal Visual Inspection Report

LOCATION
 11-11-47-5W4
 DATE
 2016-05-16
 MFG
 Foremost Universal

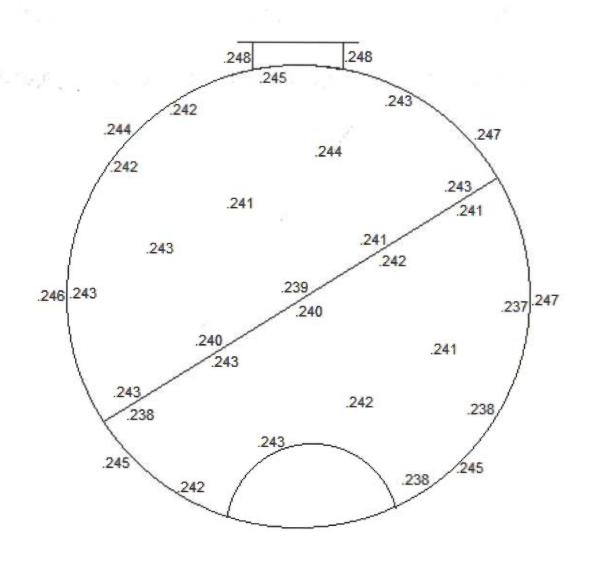
SAP #
 66221236

Random locations of the tank's floor and lower shell were UT thickness tested with some minor metal loss identified. The lowest thickness identified was found to be 0.237". See attached sketch for thicknesses found and approximate locations of tests.

YEAR
 2013
 S/N
 29086-3
 CAP
 1000
 BBL
 AFE/CC
 80043620

FLOOR THK
 1/4"
 SHELL THK
 1/4"
 ROOF THK
 3/16"

Continue the UT thickness survey on the tank floor and lower shell at next scheduled inspection.

Inspect the tank in five years
