SCRUBBERS INSPECTION REPORT

IR100818RPLm

AL HINZ 77275 Area Supervisor: W.O. / C.C.# STATIC DATA 545993 A-4060.32 Alberta Reg. #: CRN: National Board #: -Equipment Number: 62045563 Notification #: Classification: 0196404 Manufacturer: WATERFLOOD SERVICE & SALES LTD Serial Number: **INLET SCRUBBER** 07-30-048-01W4 Equip. Description: Location (LSD): Equipment Tag #: Year Built: 2001 Company I.D.#: BC-158048 Province Installed: ALBERTA Registration #: Skid / Building #: YES YES NO Nameplate Attached: Legible: U1A Available: MAWP: 1724 Kpa Diameter: O.D 406 mm NO Efficiency: % Radiography: MAWT: 93 °C Diameter: I.D. 387 mm Stress Relief: NO Code Stamp: MDMT: -29 °C Length: 1168 mm Ext. Coating: YES Position: VERTICAL SIS m3 Overall Length: 1702 mm NO SKIRT Insulated: Support: Capacity: Type: Manway: NO Internal Coating: NO Size: mm Thickness: Internal Cladding: NO Test Pressure: Type: Thickness: kpa NO Size: Inspection Port: Location: #1 #2 mm mm Material **Thickness** Corrosion Allowance Type SHELL N/A 9.53 TOP HEAD **ELLIPTICAL** SA-516-70 9.53 SA-516-70 **BOTTOM HEAD ELLIPTICAL** 9.53 mm mm Nozzle Description I.D. # **NPS** Flange **Thickness** Type Material Length Rating **RFWN

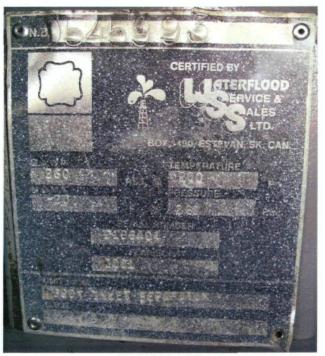
NAMEPLATE

The nameplate is in tact and legible.

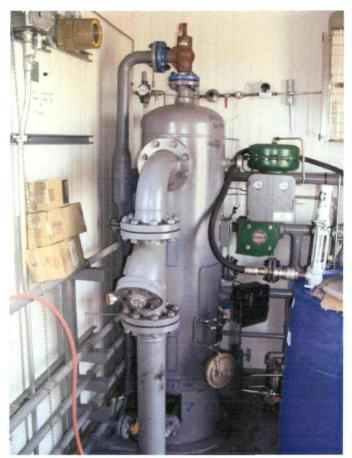
OVERALL VIEW

There were no rejectable defects observed at this time; the vessel can be recommended fit for service.

The pressure retaining welds are in tact with no evidence of deterioration or visible cracking.

The vessel support is securely welded to the skid floor.

The vessel is painted with no notable coating defects.

The piping and piping attachments are in fair condition with no detectable leaks.

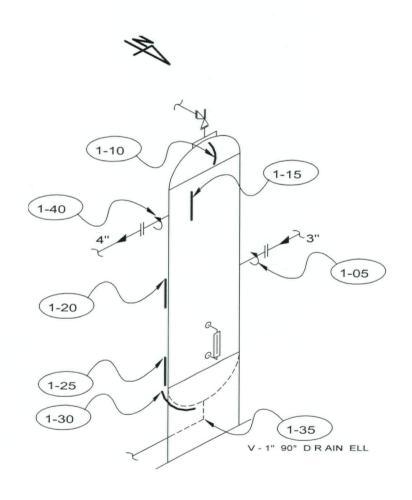
TML	TML LOCATION ITEM DESC.					
INIL						
1-05	3" INLET NOZZLE	B-T				
1-10	TOP HEAD	B-T				
1-15	TOP SHELL	T-B				
1-20	ACROSS INLET	T-B				
1-25	BOTTOM SHELL	T-B				
1-30	BOTTOM HEAD	T-B				
1-35	V - 1" 90° DRAIN ELL	T-B				
1-40	4" OUTLET NOZZLE	B-T

ı	@ LOW PNT
г	7.3
H	8.9
Г	9.2
Г	9.3
Г	9.4
Г	9.7
Г	3.7
Г	8.3

BELOW	BELOW		
NOMINAL	MINIMUN		
0.3	-		
0.7	-		
0.3	-		
0.2	-		
0.1	-		
	-		
0.9	-		
0.3	-
