# PRESSURE VESSEL & COLUMN INSPECTION REPORT

**LSD:** 06-25-046-03W4      **Date:** 2015-01-20      **SAP Equipment ID** 62045563

VESSEL STATIC DATA										
<b>Plant:</b> Rivercourse				<b>OP Unit:</b>			<b>System:</b>			
<b>Prov. Insp . #:</b> 0545993		<b>NB#:</b> N/S		<b>CRN:</b> A4060.32			<b>Equip Tag#:</b> 62045563			
<b>Equipment Description:</b> SCRUBBER							<b>Serial #:</b> 0196404			
<b>Manufacturer:</b> WATERFLOOD							<b>Vessel Class:</b> vessel			
<b>Internal Access:</b> No				<b>Description:</b>			<b>Year Built:</b> 2001			
<b>MAWP:</b> 1793 kpa				<b>At Temp</b> 93 C			<b>MDMT:</b> -29 C			
<b>Code:</b> N/S				<b>RT:</b> None			<b>PWHT:</b> No			
<b>Diameter:</b> 406 mm		<b>Length:</b> 1168 mm		<b>(T/T):</b> mm		<b>OAL:</b> mm		<b>Orientation:</b> Vertical		
<b>SHELL</b>		<b>Mat'l:</b> Unknown SA 106B		<b>Thickness:</b> 0.00 9.53 mm			<b>Corr Allowance:</b> 0.00 1.6 mm			
<b>HEAD</b>		<b>Mat'l:</b> Unknown SA 516-70		<b>Thickness:</b> 0.00 8.3 mm			<b>Corr Allowance:</b> 0.00 1.6 mm			
<b>Nozzle</b>		<b>Mat'l:</b>		<b>Thickness:</b>			<b>Corr Allowance:</b>

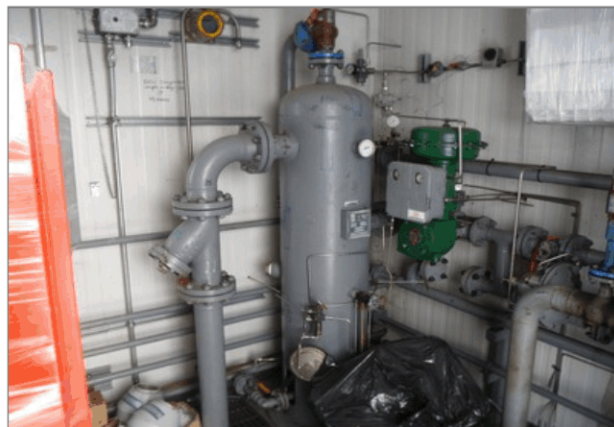
OVERALL

VESSEL IS FIT FOR SERVICE.

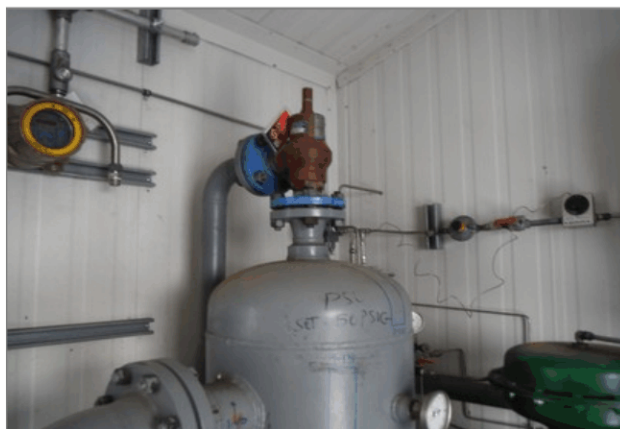
PSV SERVICE IS PAST DUE.

RECOMMEND TO SERVICE PSV BEFORE PUTTING VESSEL BACK INTO SERVICE.

Service PSV prior to re-commissioning the vessel.
