#### Pressure Vessel External Visual Inspection Report

## Condensate Building Fuel Gas Scrubber SAP# 66068141 Serial# 2001 6549 01P

12-05-054-20W5M Galloway Gas Plant

# Husky Energy 14 60814 PRESSURE VESSEL INSPECTION REPORT

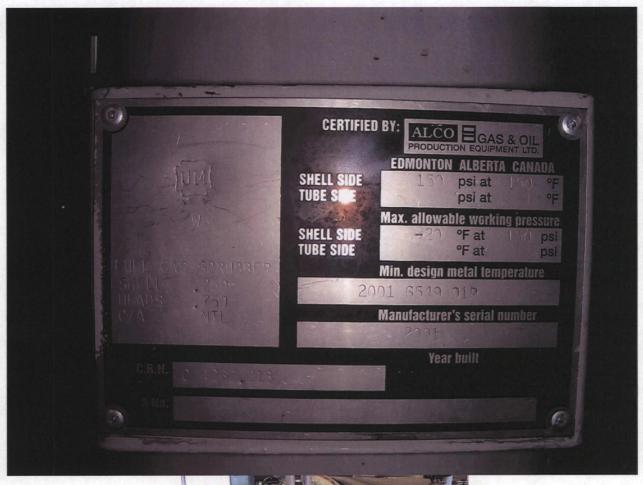
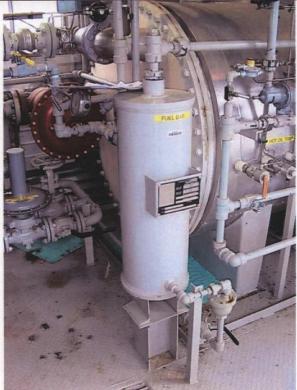
The nameplate is attached and legible, with Serial# 2001 6549 01P stamped on it. There is no A# on the FGS, nor is one required as per AR/2006, UM pressure volume limits. The approximate volume is 1.41 cubic feet. The fuel gas scrubber is painted and the paint is in good condition with no chips or corrosion noted. The piping, bolting and external attachments are in good condition. The scrubber is securely attached to the skid. No leaks noted. The scrubber is protected by a PSV Serial#: 438391-55-KE located on the piping that was last serviced 06/2006. PSV data:

The overall condition of the scrubber is good and it is suitable for continued service.
