SEPARATOR INSPECTION REPORT

Notification Number 6057335 Work Order 6059705
 Notification Desc SEPARATOR, NATCO 48" X 96" 285 PSI Maintenance Plan QPSEPAR6147
 Tasklist Operation (5Y Inspection Interval) 5Y Code Inspection Separator - Sweet Se

Equipment Number 66102897 Equipment Description SEPARATOR, NATCO 48" X 96" 285 PSI
 Class SEPARATOR Tag Number
 Serial Number 42586-55 Year Built
 Manufacturer NATCO
 Location L7-05-006-00017 Location Description 111/03-16-052-25W3/00 SWB
 Provincial Number PM Activity Code
 Status Codes NOPR ORAS Equipment Status In Service - Fully Utilized

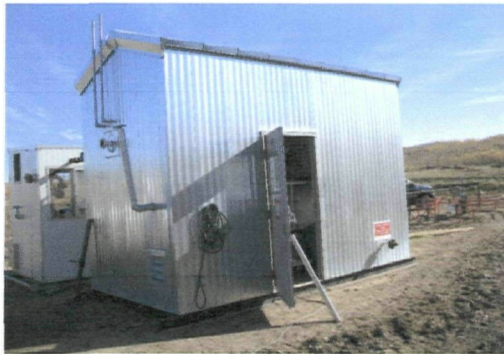
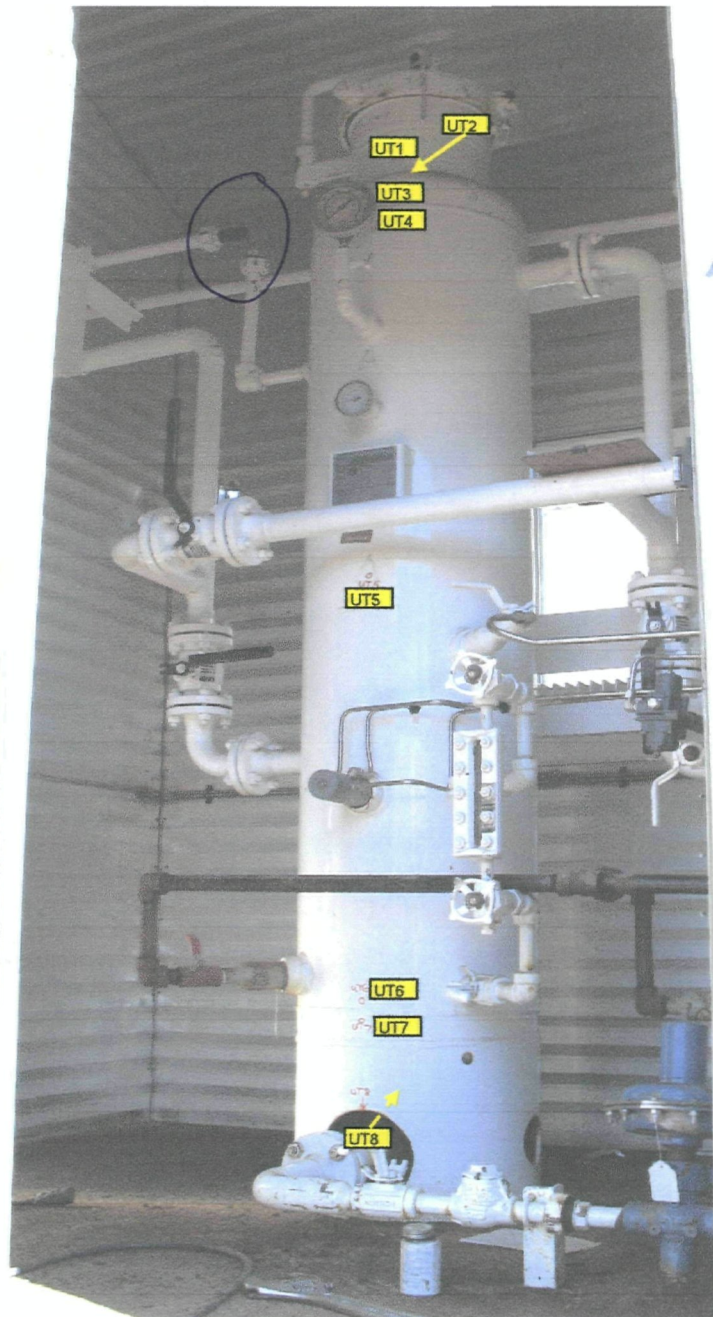
ITEM:	DESSICANT DRYER
LOCATION	TANGLEFLAGS
LSD:	A5-31-50-24W3M
MAKE:	NATCO
YEAR:	2001
SERIAL#:	42586-55
EQ#:	66102897
INV#	
CRN #:	P6749.23
REG #:	A465646 S00212
HEAD	
SHELL	20" \varnothing
C.A:	
MAWP:	285PSI @ 100F
PSV:	OUT FOR SERVICE
OTHER	HEAVY WHITE PAINT UT#8 -BOTTOM HEAD

DATE:	Oct-06							
LOCATION	READING	READING	READING	READING	READING	READING	READING	READING
UT 1	0.513"							
UT 2	0.510							
UT 3	0.541							
UT 4	0.341							
UT 5	0.360							
UT 6	0.358							
UT 7	0.397							
UT 8	0.361
