MSS GUIDED WAVE TESTING REPORT

Client: Husky Energy

Glycol Heater 5.5 O.D. coil, S.N. 99160

Job No. 18-393

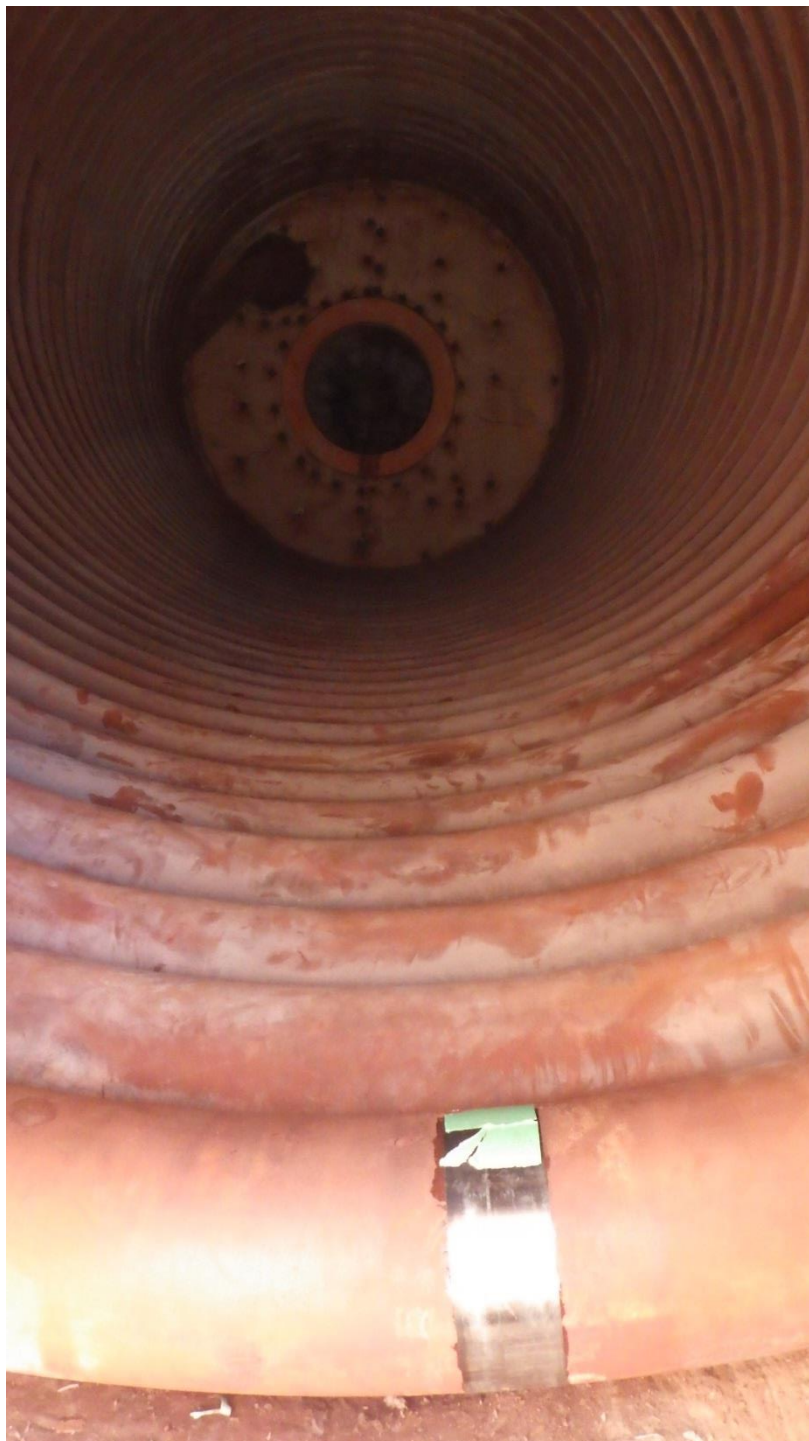
FIGURE 1 MSS SCAN LOCATION(GUIDED WAVE SHOTS 1)

No indication of wall loss found within the Guided wave scan. The scan shows one indication "Q1" which is assumed to be a pipe support wear pad.
