# Storage Tank External Visual Inspection Report

Organization: Husky	Inspection Date: 16/12/2014 12:00:00AM
Plant: Lloydminster Production	Equipment ID: 1000008038
	Asset No:
	System: 00002 MORGAN 10-34-051-04W4 TREAT
	Operating Unit: H1-01-006 MORGAN

Description:	TANK, GLM 120M3 STORAGE

## Storage Tank Internal Visual Inspection Report

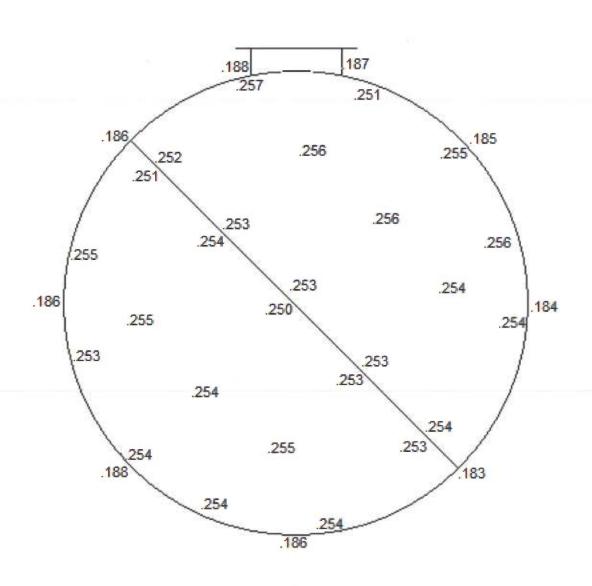
Random locations of the tank's floor and lower shell were UT thickness tested with some minor metal loss identified. The lowest thickness identified was found to be 0.183". See attached sketch for thicknesses found and approximate locations of tests.

LOCATION
 Morgan Battery
 DATE
 2014-12-16
 MFG
 GLM

YEAR
 2008
 S/N
 08-291-14
 CAP
 750
 BBL
 AFE/CC
 80028615

FLOOR THK
 1/4"
 SHELL THK
 3/16"
 ROOF THK
 3/16"

SAP #
 1000008038
 3/16"
 1/10
 1/10
 1/10

Continue the UT thickness survey on the tank floor and lower shell at next scheduled inspection.
