# FACILITY INSTALLATION / READINESS CHECKLIST

**REPORT #** 111117CWa  
**Shop Inspector** n/a  
**Date** n/a  
**Field Inspector** Christy Walsh  
**Date** November 21, 2011

**FACILITY:** FH-BC-007 **LSD :** 07-05-063-06W6M

**FACILITY:** FH-BC-007 Kakwa      **DATE:** November 17, 2011      **REPORT #:** IDR 111117CWa

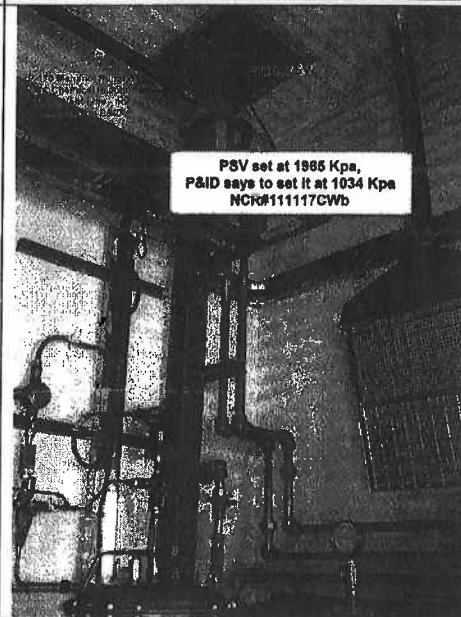
The set pressure of this PSV is set to high at 285 psi (1965 kPa) to adequately protect PRV151, PRV152, PRV153, PRV154, PRV155, & PRV156 as they have a MAWP of 250 psi. The P&ID requires that this PSV to be set to 150psi (1034 kPa). These PRV's are located downstream of F-150 & F-151. See attached P&ID.

☐ Scrap ☐ Use "As-Is" ☐ Repair ☒ Alteration ☐ Replace ☐ Return to Supplier  
Describe actions required to resolve the NCR :  
Remove the pressure safety valve and get it reset to 150 psi (1034 kPa) at an authorized maintenance facility.

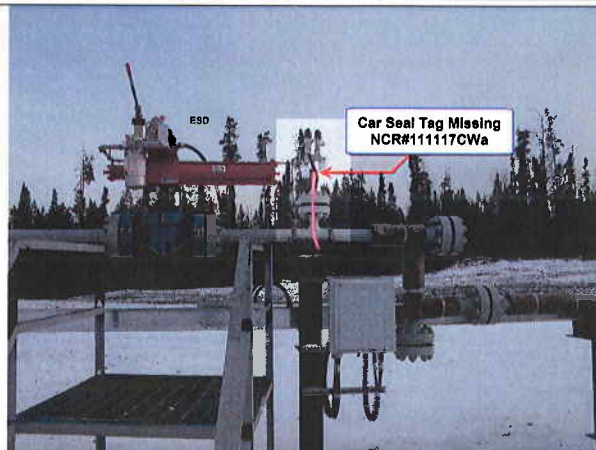
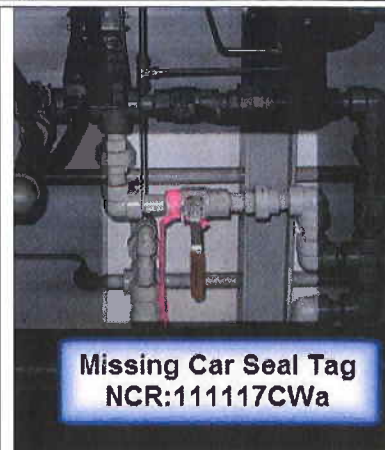
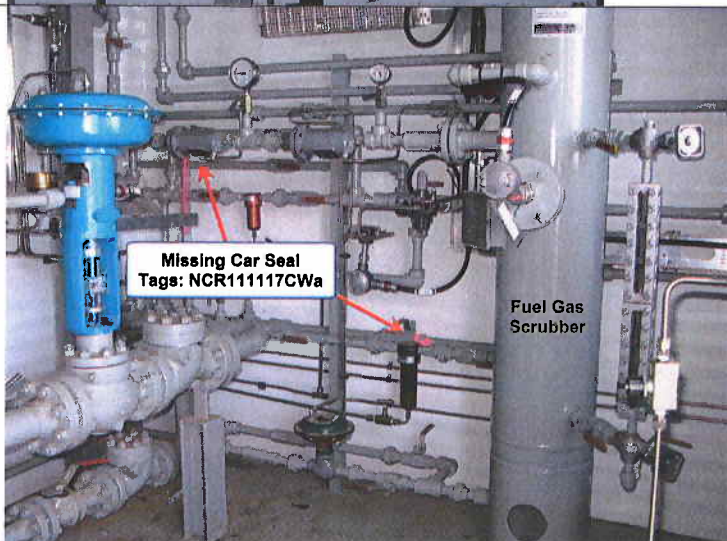
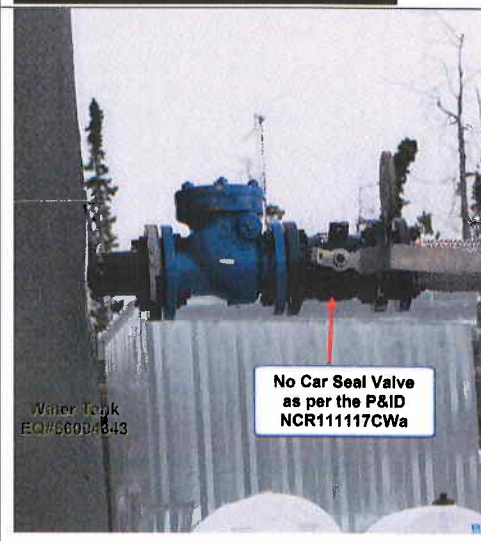
Six valves have been identified on P&ID as needing car seal tags to be installed in either the open or closed position. No car seal tags have been installed.

- Install the car seals tags as outlined in the P&ID or
- perform a multidisciplinary hazard assessment to assess the need for car sealed valves, document its findings and forward to the area inspector if the HAZOP should determine that car sealed valves are not necessary.

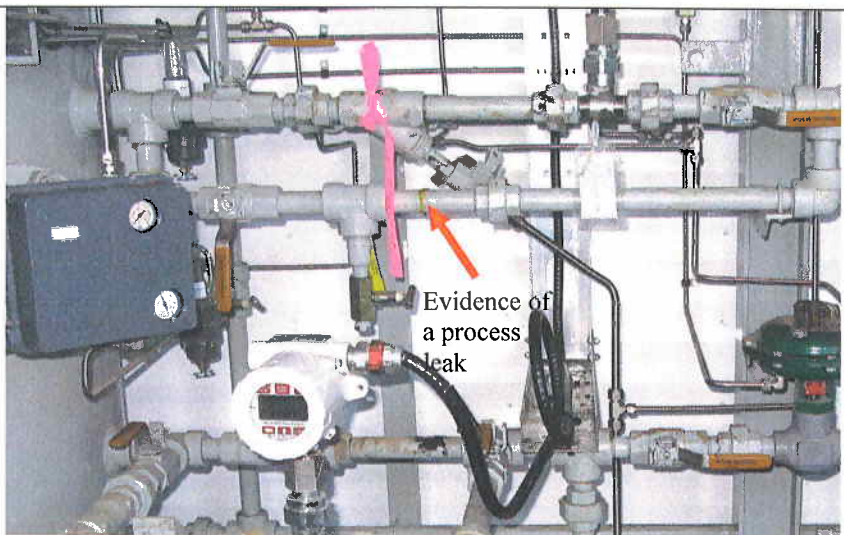
Prov. Reg. # 602337 CRN: V3914.213 Serial # 5B1009-20  
 Equipment Location(LSD): 07-05-063-06W6M Equipment ID #: n/a  
 Equipment Description: Fitting off of Separator Service: Emulsion ☒ Sweet  
 Manufacturer: 5Blue Process Equipment Year Built: 2011 ☐ Sour  
 MAWP 1440 kPag / psi @ \_\_\_\_\_ °C / F MDMT: - °C / F Capacity: \_\_\_\_\_ m3

Level 3 IDR: Faulty welding, piping joint make-up or flange connection (no immediate safety hazard – repair or replace at next outage)

☐ LEAVE "AS-IS"   
 ☒ PERFORM REPAIR   
 ☐ PERFORM ALTERATION   
 ☐ REPLACE UNIT  
☐ INTEGRITY ASSESSMENT REQUIRED  
**Comments:**  
 Repair and replace as necessary to eliminate the process hazard of leaking components / flange connections

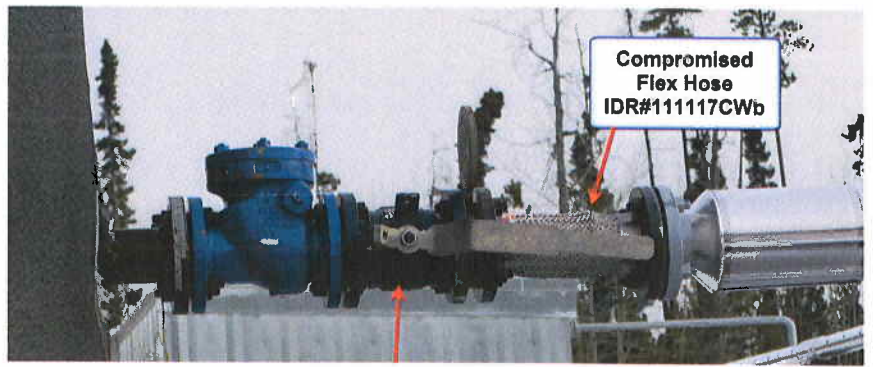
Flex hose is not installed correctly. According to DS-PF-05 Metallic Flex Hose specification...

8.1 Care must be taken to ensure that the flex hose is not subjected to excessive stresses or other mechanical forces during the installation process.

Replace gasket

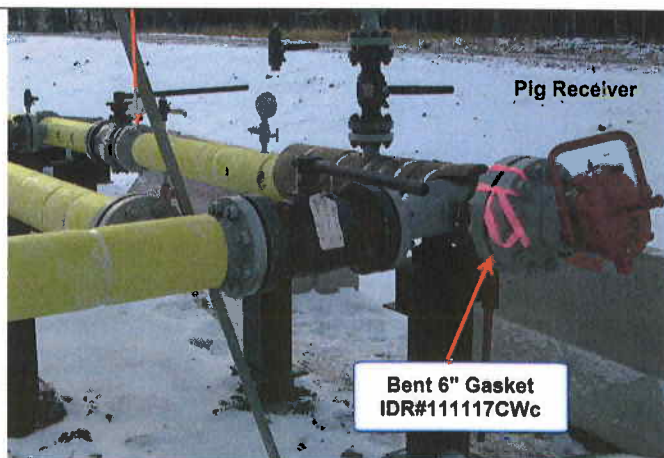
6" gasket is found to be installed incorrectly and bent over significantly within the flange.

Replace gasket
