PRESSURE VESSEL & COLUMN INSPECTION REPORT

SAP# 66194539	Date: May 13, 2022	LSD 11-29-046-04 w 4	Report # IR220513GENo
---------------	--------------------	----------------------	-----------------------

Plant: WILDMERE	Op Unit: AS	Work Order: 60894910
Prov. Insp.# AB A 528730 NB -	CRN R9332.231	Equip. Tag# V-100
Description: SEPARATOR	Serial #: PV-811	Year Built: 2005
Manufacturer: CORLAC INDUSTRIES LTD.	Vessel Class: SEPARATORS	
MAWP: 4964 Kpa @ 38 °C	MDMT: -29 °C	
Shell Material: SA-106B	Thickness: 9.5 mm	Corr. Allowance: 1.6 mm
Head Material: SA-234WPB	Thickness: 8.3 mm	Corr. Allowance: 1.6 mm
Nozzle Material: SA-105N	Thickness: NPT	Corr. Allowance: - mm
Code: ASME VIII (U)	RT 2	PWHT: No
Internal Access: No	Type: N/A	Internal Coating: No
Painted: Yes	Insulated: No	Location: N/A
Product Description: Natural Gas	Sweet	Operating Pressure: 400 Kpa @ 15 °C

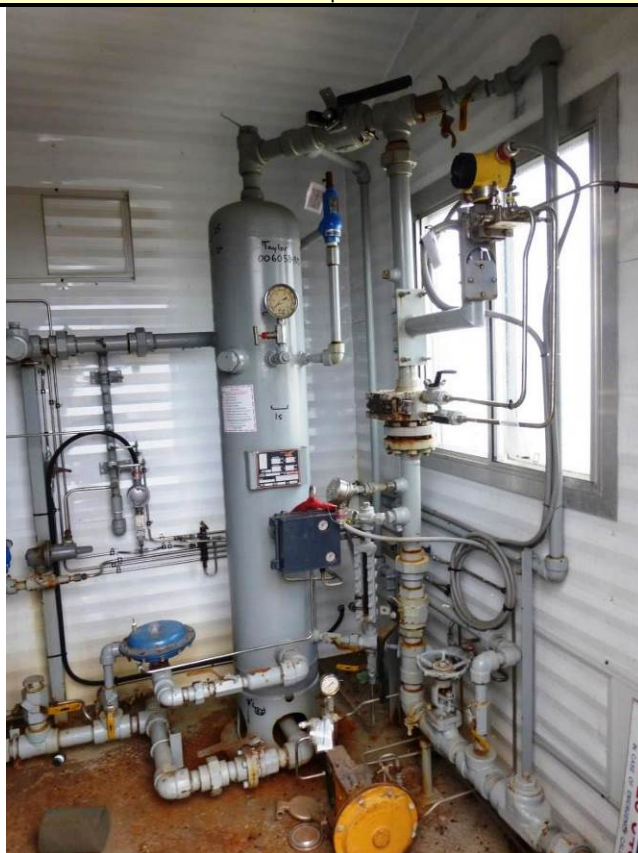
Overall

A visual external inspection performed to the applicable standards did not identify any concerns with the pressure boundary of this equipment, there were no significant deficiencies noted.

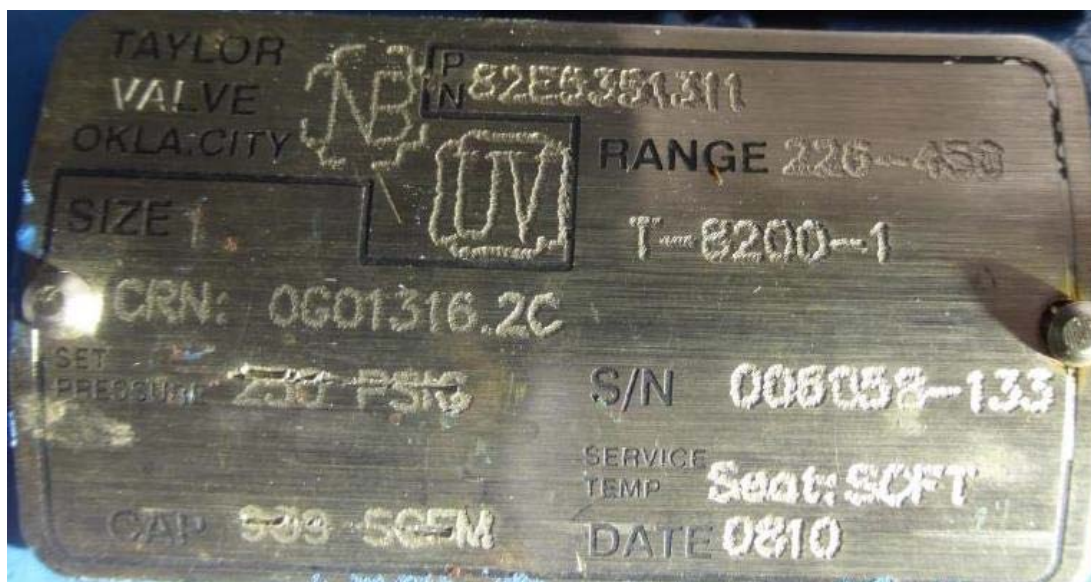
PSV Nameplate

Company Info			
Name:	HUSKY ENERGY		
Area:			
LSD:	100/11-29-046-04 W4		
Valve Loc:	ROUTE 211		
Valve ID#:	SAP-238548		
Item Description			
Make:	TAYLOR		
Model:	82E5351311		
Serial #:	006058-133		
Size:	1	E	1
Set Press:	285	psig	
Capacity:	1068	scfm	
B Press:	0	psig	
CDTP:	285	psig	
Flange Rt:	Threaded	X	Threaded
CRN #:	OG01316.2C		
QC Data			
GCS #:	40313	SV#	15589
Date:	10/23/2020

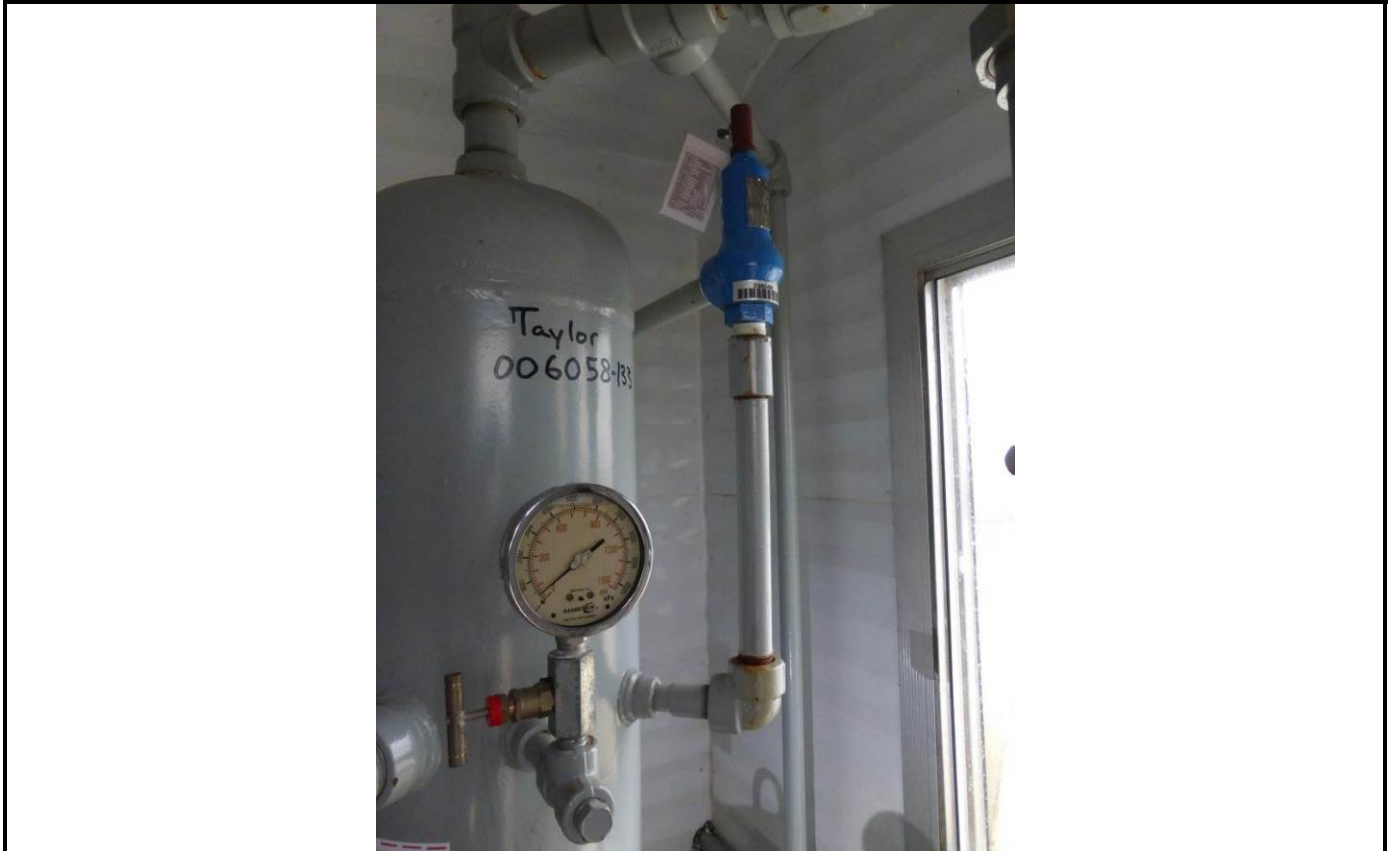
PSV Overall

V22	Foundation	N/A			
V23	Anchor Bolts	N/A			
V24	Saddle/Skirt	Good			The skirt is welded to the skid floor and is in good mechanical condition.
V25	Davit	N/A			
V26	Fireproofing	N/A			
V31	Connections Other (Explain)	Good			All piping connections to the vessel are secure.
V32	Small Branches	Good			The instrumentation tubing is acceptable, no signs of leakage noted.
V33	Nozzles	Good			The nozzles are straight with no mechanical deficiencies noted.
V34	Manways	N/A			
V35	Reinforcing Pads	N/A			
V36	Inadequate Thread Engagement	Good			All threaded piping and instrumentation connections are secure and of adequate depth / engagement.
V37	Bolting	N/A			
V38	Flanges	N/A			
V39	Leak Clamps	N/A			
V41	Insulation Other (Explain)	N/A			
V42	Damage	N/A			
V43	Penetrations	N/A			
V44	Insulation Jacket	N/A			
V45	Banding	N/A			
V46	Seals/Joints	N/A			
V51	Relief Devices Other (Explain)	Good			The PSV is set to the proper pop pressure and has been serviced within an acceptable time frame.

V52	Relief Devices Corrosion	Good			No corrosion noted.
V53	Relief Devices Leaks	Good			No leaks were present.
V54	Restricted Inlet/Outlet	Good			The inlet and outlet are satisfactory to code requirements.
V55	Manual Operation Lever	N/A
