## TANK INSPECTION REPORT

Notification Number 6062389 Work Order 6064949  
 Notification Desc TANK, GLM 64M3 Maintenance Plan QNATANK11685  
 Tasklist Operation ( 5Y Inspection Interval ) 5Y Code Inspection Tank ~~100-bbl~~

Equipment Number 62045257 Equipment Description TANK, GLM 64M3  
 Class TANK Tag Number T-100  
 Serial Number G-02-244-S1 Year Built 2002  
 Manufacturer GLM  
 Location L7-03-003-00255 Location Description 111/12-31-050-22W3/00 SWB  
 Provincial Number PM Activity Code  
 Status Codes NOPR ORAS Equipment Status In Service - Fully Utilized

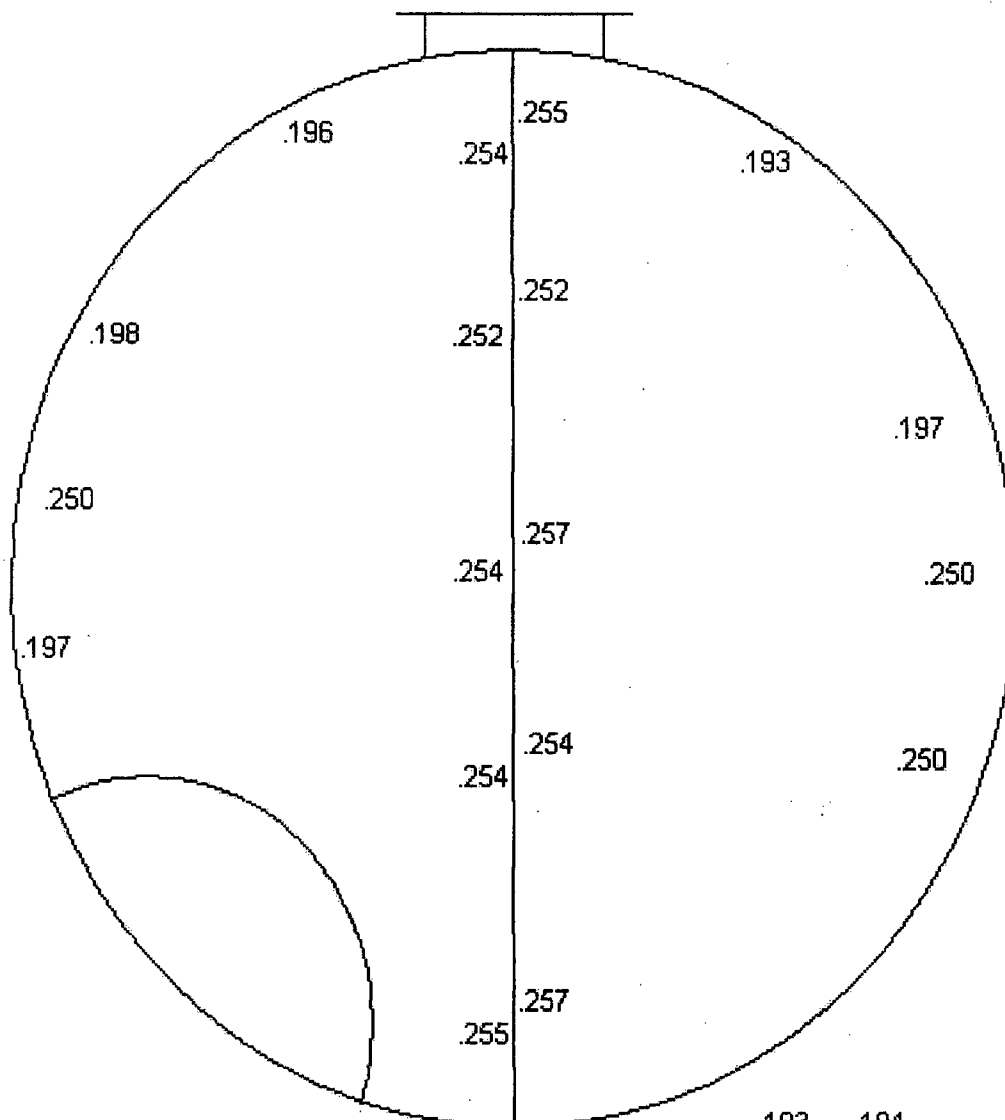
LOCATION 12-31-50-22W3 DATE 2007-07-25 MFG GLM  
YEAR 2002 S/N D02 244 S1 CAP 400 BBL AFE/CC 72120  
FLOOR THK 1/4" SHELL THK 3/16" ROOF THK 3/16"  
SAP # 62045257

Random locations of the tank's floor and lower shell were UT thickness tested with some metal loss identified. See attached sketch for thicknesses found and approximate locations of tests.

Due to metal loss identified on the floor shell the inspection interval should remain at five years (60 months).

Replace the anodes prior to recommissioning the tank.  
 Continue the UT thickness survey on the tank floor and lower shell at next scheduled inspection.
