FILTER INSPECTION REPORT

Notification Number 6075961 Work Order 6079051
 Notification Desc FILTER, HORIZONTAL 60" OD X 16'0" Maintenance Plan QPFILTER1264
 Tasklist Operation (1Y Inspection Interval) 1Y Code Inspection Filter - Sweet Servi

Equipment Number 66120331 Equipment Description FILTER, HORIZONTAL 60" OD X 16'0"
 Class FILTER Tag Number
 Serial Number 626132 Year Built 2006
 Manufacturer BROMLEY MECHANICAL SERVICES
 Location SS-SK-052-00003 Location Description MATADOR 14-24 COMPRESSOR STATION
 Provincial Number 0557602 PM Activity Code
 Status Codes NOPR ORAS Equipment Status In Service - Fully Utilized

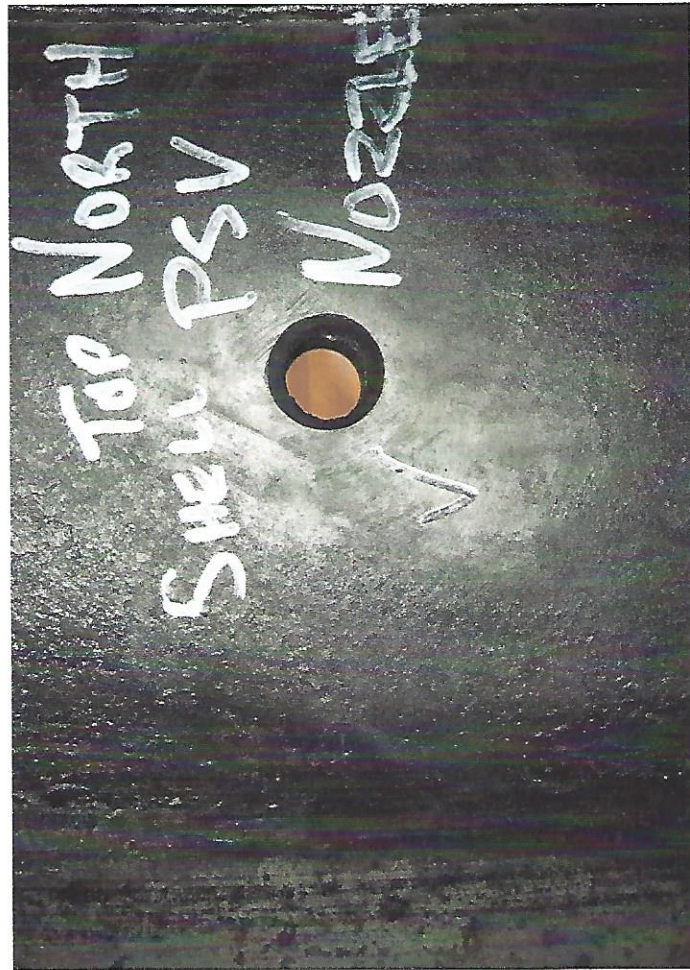
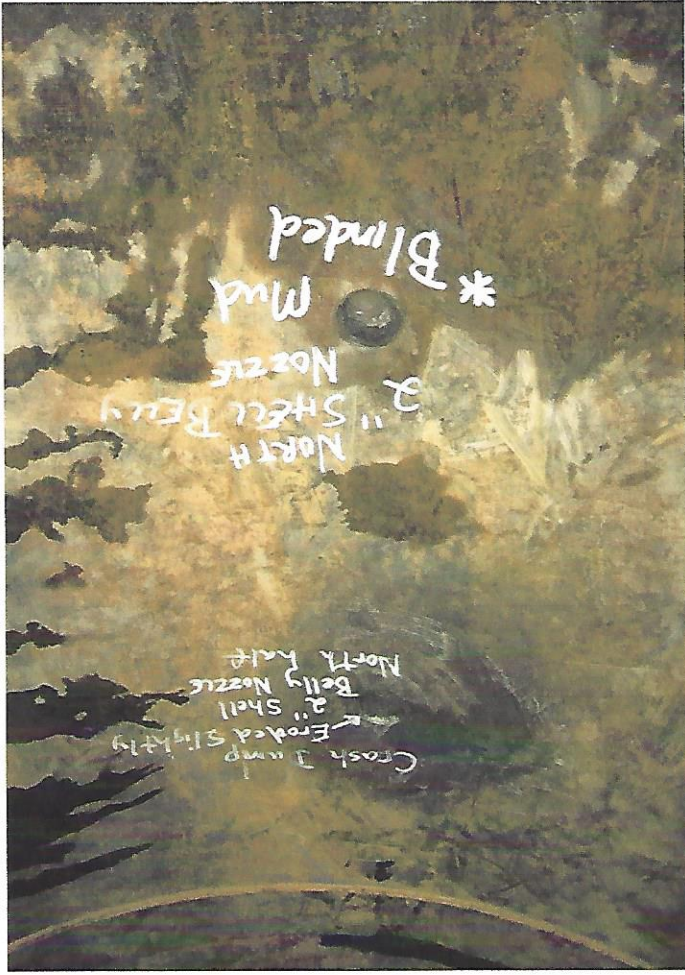
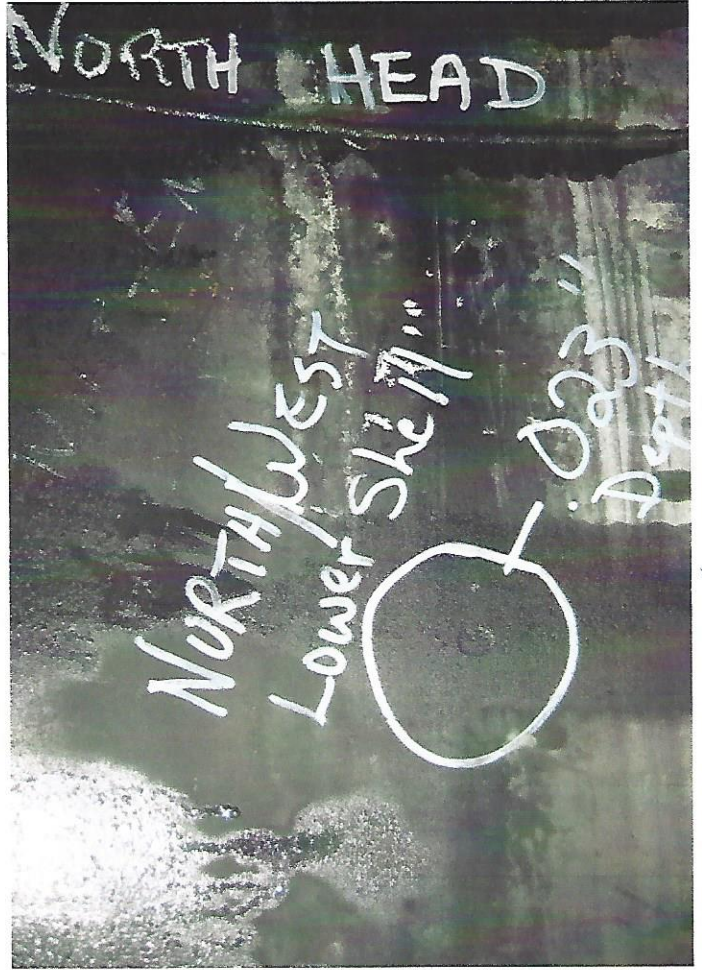
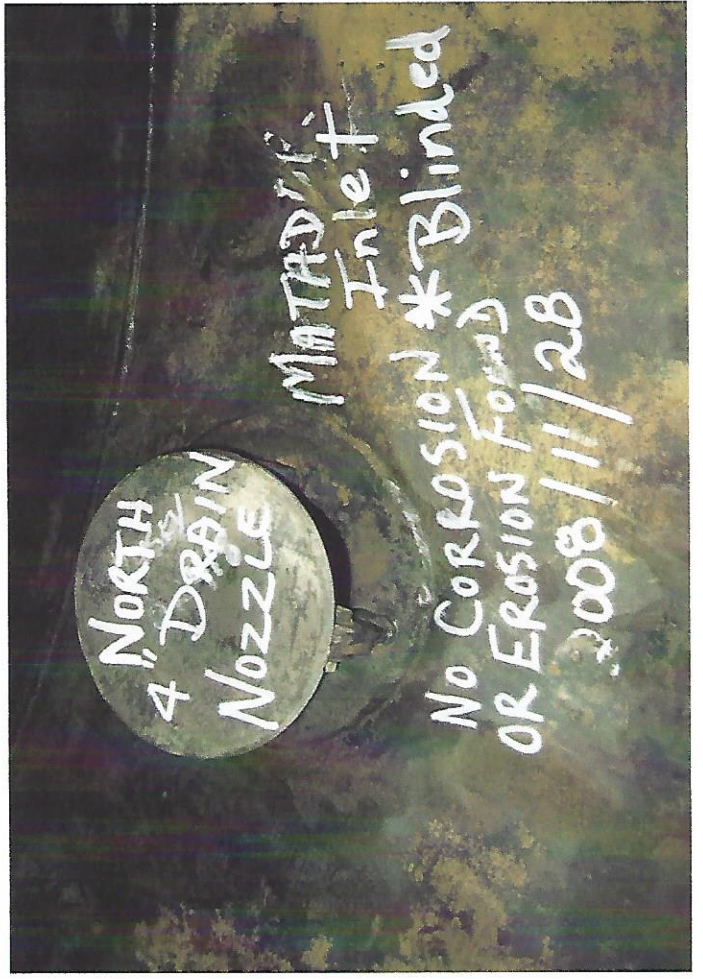
-manway nozzle,blind plate,support arm in good condition
 -inlet nozzle has welded support around expanded metal,access to outlet nozzle was not removed at inspection,no signs of any erosion or corrosion
 -2" crash dump nozzle has a small eroded cut on inner west side of nozzle
 -all other nozzles were in good condition with no corrosion found
 -4" north nozzle with vortex breaker is in good condition. Nozzle is not used,external side of nozzle is blinded.
 -22" ID x 36" deep belly pot is in good condition, 2-4" check valve flappers were found at bottom of pot. Drain has a vortex breaker plate covering nozzle,felt with fingers,could not detect any noticeable defects
 -all weldments are visually acceptable
 -inlet nozzle and deflector are in good condition
 -north head has some small diameter pitting that was detected on Sept. 2007 inspection as well, max pit depth 0.063"
 -NW lower shell has a small corroded pit 0.035"

2" Nozzle
Shell Belly
* Blinded
✓ Good Condition

Crash Dump
Eroded Slight
2" Shell
Belly Nozzle
North Half

-recommend applying EC-124 grout repair coating to 2" crash dump nozzle and other minor corroded areas mostly on south head in summer of 2009
