DIAMONDBACK
INTEGRITY

UT Survey Information

Equipment Description: Global Flow Metering Skid

UT Survey Report	
	Date:	May 9th, 2024
Report #		DBI45-01
Static Data		
Owner:	IPC Canada	
Facility/Area:	Dollard Sask	
LSD:	N/A	
A No.:	-	
Serial No.:	-	
CRN:	-	
Description:	Global Flow Metering Skid

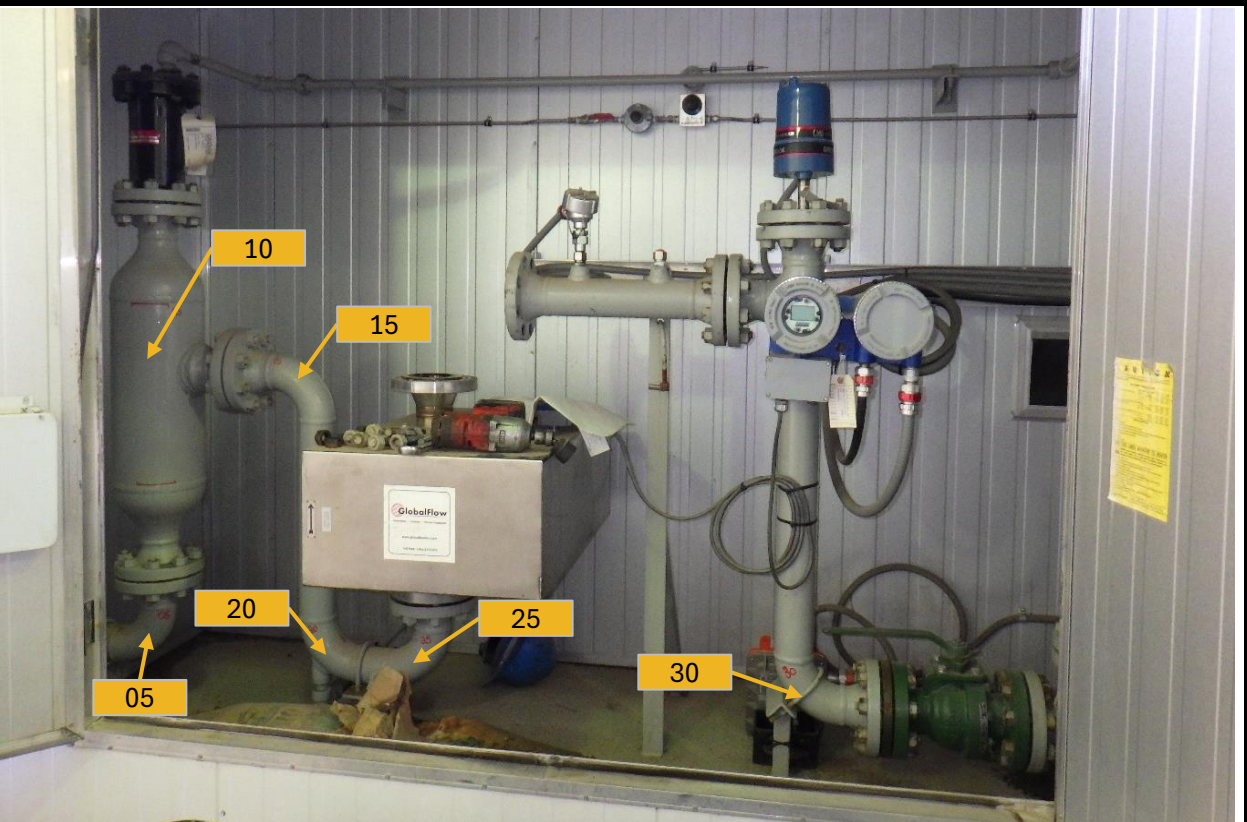
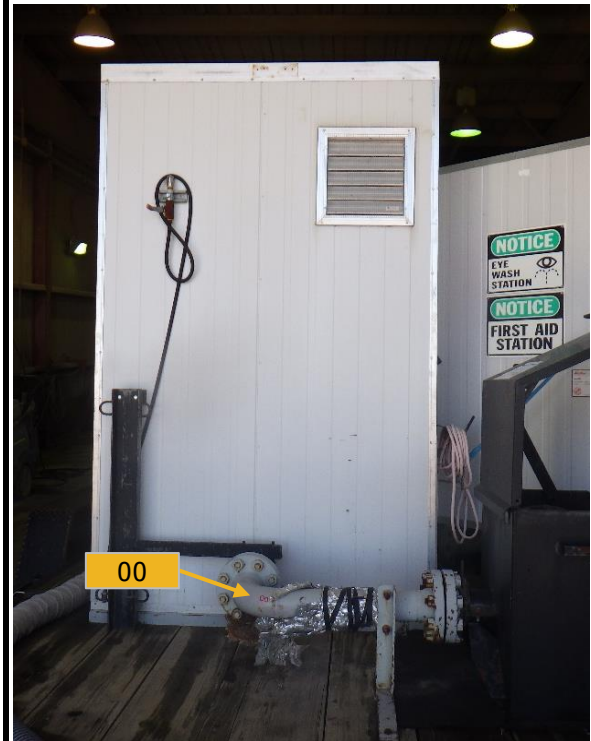
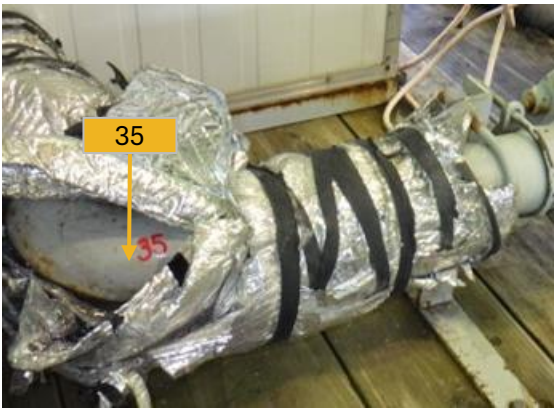
Internal Inspection Photos

Internal Inspection Summary - An elbow was removed to allow for visual inspection. Minor deposits were visible throughout. No areas of corrosion or mechanical damage was identified throughout the inspection. Good overall condition.
