Crescent Point

VISUAL INSPECTION REPORT-PRESSURE VESSEL

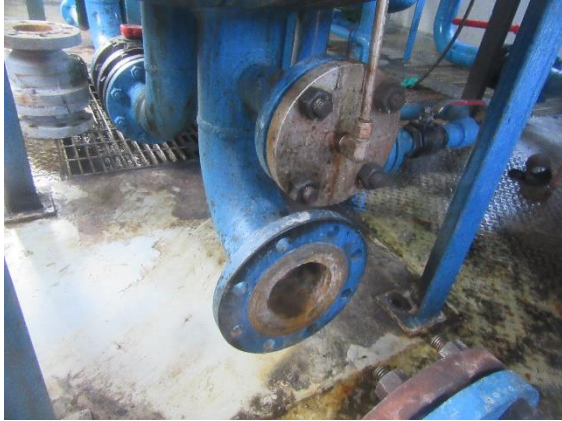
Welds	Uniform Corrosion:	<input checked="" type="checkbox"/> Insignificant amount	Comment	
	Pitting Corrosion:	<input type="checkbox"/> None noted	Comment Pitting and minor corrosion throughout filter plate	
	Welding Defects:	<input checked="" type="checkbox"/> None noted	Comment	
NDE	<input checked="" type="checkbox"/> NDT was performed by: Ryan Hogg		Extent: Bottom head externally	
	NDE Type: UT	NDE Type:		
	Results: UT on bottom head showed pitting corrosion internally – nominal 0.500" pitting to 0.295" in center of head 4" area between the nozzles.			
Nozzles	Obstructions:	<input checked="" type="checkbox"/> None noted	Comment

Recommended Actions	<p>Due to the design of the filters the bottom head is pitting throughout, there is no access for repairing. The filter is at the end of life – prepare for a future replacement - vessel could be pulled – nozzle replaced and internals blasted and coated.</p>		
Integrity Status	Suitable for Continued Service <input checked="" type="checkbox"/> Yes <input type="checkbox"/> No <input checked="" type="checkbox"/> Future Repairs Required		
Inventory Status	<input checked="" type="checkbox"/> Active <input type="checkbox"/> Out of Service <input type="checkbox"/> Surplus <input type="checkbox"/> Rental <input type="checkbox"/> Scrap
