ULTRASONIC REPORT

CUSTOMER / CLIENT:	RARE OILFIELD SERVICES	CLIENT JOB NO.:		REPORT NO. :	231214-UDT-1
CONTRACTOR:		CLIENT CODING:		PAGE:	1 OF 3
PROJECT:	UT ON SEPERATOR A0438682			DATE:	14-Dec-23
LOCATION / LSD:	TWIST OILFIELD MANUFACTURING, STETTLER, AB			TECHNICIAN:	DUSTIN TUCKER
CODE / CLIENT SPEC:	ASME VIII Div. 1 / ASME V Art. 5 (2021)	APPROVER:	TYLER HEBBLETHWAITE	ASSISTANT:

Vessel External Inspection Report

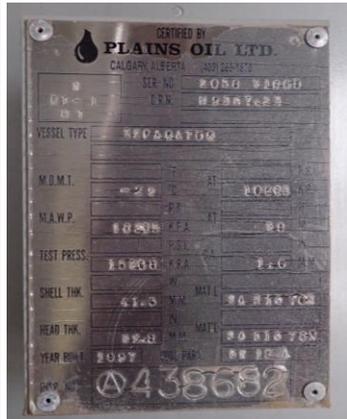
TML #	Dia.	Nom.	UT Low	UT Avg	% Wall Loss	Comments
00	36"	1.567	1.582	1.602	0.0%	Top Head
05	36"	1.626	1.615	1.624	0.7%	Shell
10	36"	1.626	1.622	1.629	0.2%	Shell
15	36"	1.626	1.623	1.631	0.2%	Shell
20	36"	1.567	1.579	1.588	0.0%	Bottom Head / 50%~ scanned
25	2.375"	0.343	0.316	0.329	7.9%	90° Drain Nozzle
30	2.375"	0.218	0.190	0.203	12.8%	45° Drain Elbow
35	8.625"	0.500	0.478	0.503	4.4%	90° Outlet Elbow
40	8.625"	0.500	0.470	0.484	6.0%	90° Outlet Elbow
45	8.625"	0.500	0.463	0.487	7.4%	90° Outlet Elbow
50	3.5"	0.300	0.276	0.287	8.0%	90° Outlet Elbow
55	8.625"	0.500	0.504	0.523	0.0%	90° Inlet Elbow
60	8.625"	0.500	0.480	0.499	4.0%	90° Inlet Elbow
65	2.375"	0.218	0.182	0.198	16.5%	90° Drain Elbow
70	2.375"	0.218	0.195	0.207	10.6%	90° Drain Elbow
75	2.375"	0.154	0.143	0.151	7.1%	90° PSV Outlet Elbow
80	3.5"	0.216	0.211	0.220	2.3%	90° PSV Outlet Elbow
