Fueled Pump Package Inspection Report
Pump Model 59T-3 With 2.5” Plungers

Performed by
Rotating Right (2016) Inc.
10/21/2024

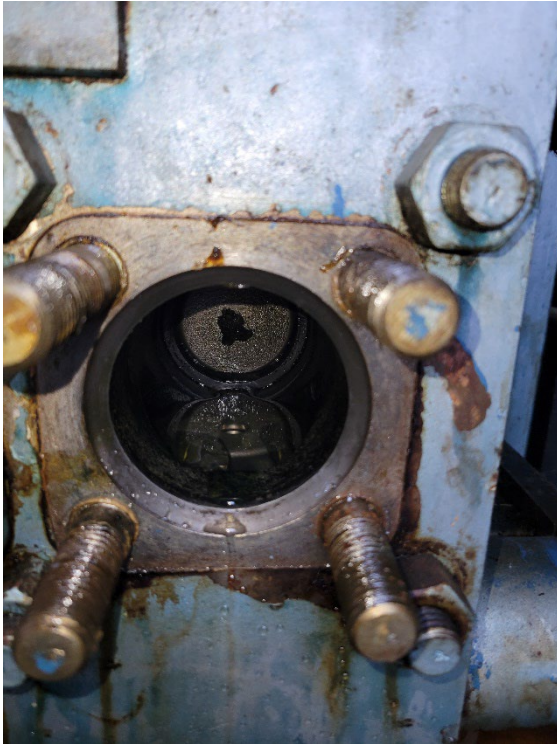
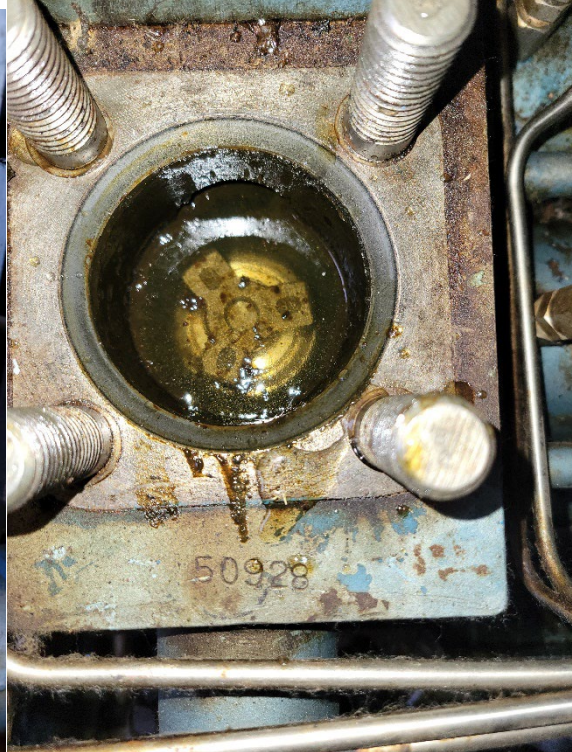
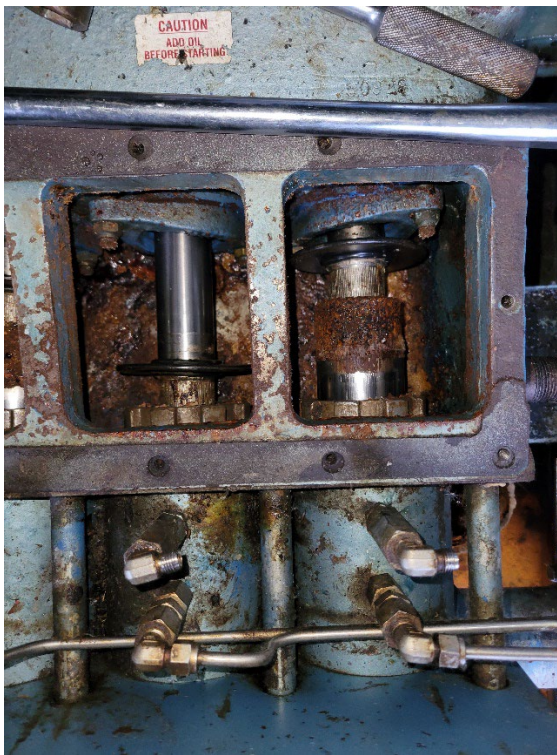
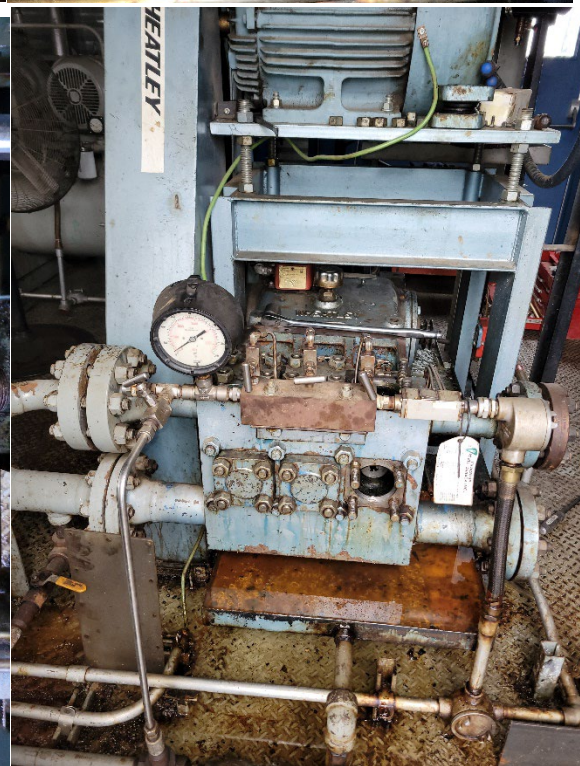
Power End

- 1.1 – Lube oil is clean
- 1.2 - Crankshaft condition is good
- 1.3 - End play is good
- 1.4 - Connrod bearings are good
