VESSEL INSPECTION SUMMARY

Report #: 137868-WG-13
 Inspect Date: 06/09/2009
 Page: 1 of 2
 IRISNDT #: 137868

Client: CNRL District: Medicine Hat Field: 07-32-012-13W4
 Facility: Grand Forks Unit: Oil Battery LSD: 07-32-012-13W4
 Jurisdiction #: A2698238 Equip Tag #: Serial #: P90-0038-A
 CRN #: K3252.2 Nat'l Bd #: Year Built: 1991
 Manufacturer: Process Industries Equipment Description: Free Water Knock Out (FWKO)
 Status: In Service Date Removed From Service: Service: Sour
 MAWP Shell 75 Psi @ 200 °F Height/Length: 432 in. Code Stamp: Y N
 MAWP Tube Psi @ °F Size/Diameter: 120 in. O.D. Insulated: Y N
 Support Type: Saddle RT: 2 Volume: ft³ / m³ PWHT: Y N
 C.A. 0.0625" Coated Y N Clad: Y N Manway: Y N

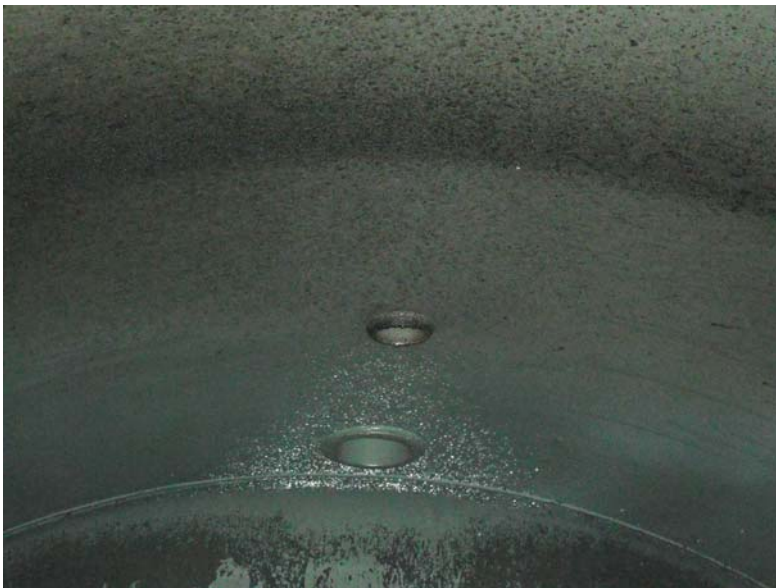
Grand Forks-FWKO_ Internal Nozzles

The vessel was removed from service for cleaning and inspection. Associated flanges/bolting/gaskets/threads were intact and showed no evidence of deterioration, visible cracking or process leaks. All inside uninsulated piping found to be secure and in acceptable condition with no corrosion.
