**Magnetic Particle
Inspection Report**

02-02-69-03w5m Comp #2_MT_sep2023

Client: Cardinal Energy	Facility: South Mitsue Plant	Date: Sept 21, 2023
LSD: 02-02-69-03w5m	Item(s) Inspected: All Compressor #2 Scrubbers & Bottles	Job #: 4880
Material: Carbon Steel	Thickness: various	WO #: N/A
Ref. Code: Client Request	Surface Preparation: Painted/Brushed	Surf. Temp: 15°C
Procedure: MT-01 Rev. 8	MT Technique: 5.2 Wet Visible	
MPI Equipment: AC Yoke	Asset#: HY-17	Daily 10 lb Lifting Power Verification Completed
Particle Type: 5.2	MFR: Magnaflux	Name: 7HF & WCP-2
Light Source: White Light	Light Intensity Verified to >1000Lx

Job Scope: To complete black and white wet visible magnetic particle inspection (MPI) on all suction scrubbers, suction bottles & discharge bottles in compressor #2 at 02-02-69-03w5m (South Mitsue Plant). The following welds were inspected as accessible:

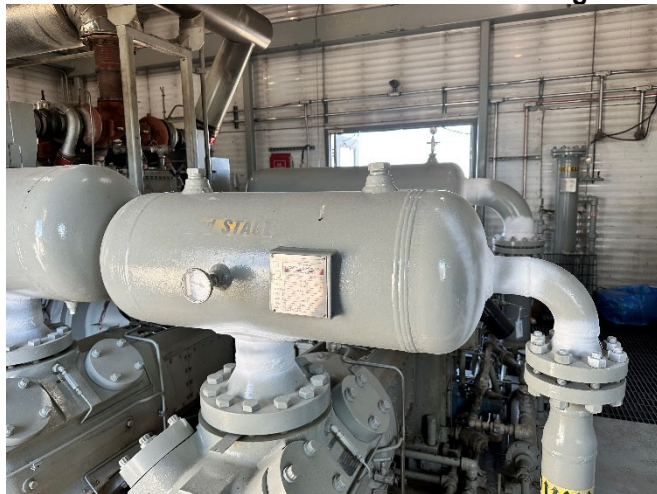
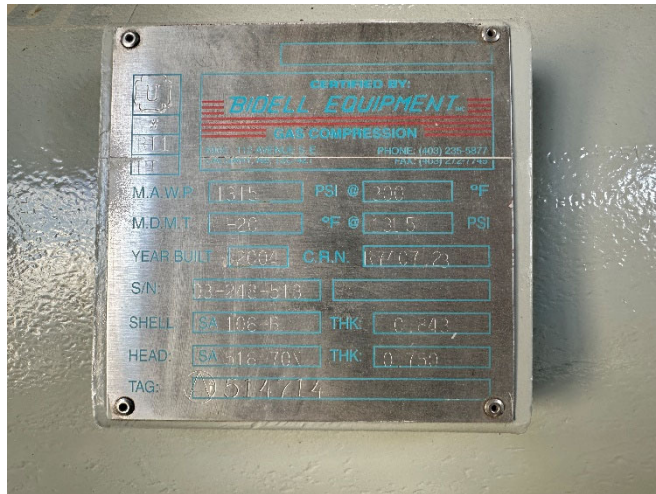
3rd Stage Suction Bottle A#514714

Results: All welds were inspected visually prior to MPI. There were no defects found during the visual inspection. All welds mentioned above were wire brushed or inspected over existing vessel paint. There was one crack measuring 6mm long on the bottom of the inlet nozzle to shell weld on the 3rd stage suction bottle (A#514714). This crack was blended out with a 120 grit sanding disk while on site and passed re-inspection. There were no further cracking or linear indications detected with MPI. All welds are considered acceptable to the reference code regarding MPI.
