Fueled Pump Package Inspection Report

Provided by Surepoint

October 30, 2024

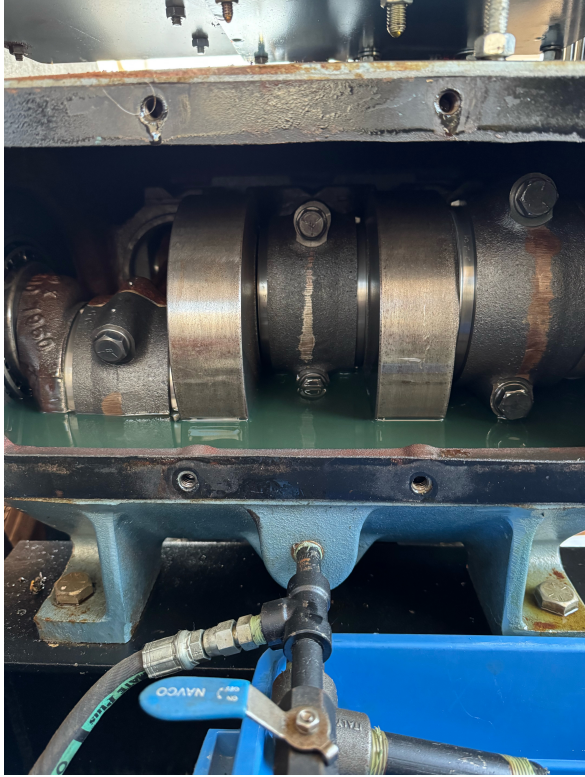
Power End

- 1.1 – Lube oil is clean
- 1.2 - Crankshaft condition is good
- 1.3 - End play is good
- 1.4 - Connrod bearings are good
