**PRESSURE VESSEL  
VISUAL INSPECTION  
REPORT**

Report #: **156732-MD-65**  
Inspect Date: 03/21/2012  
Page: 1 of 24  
Insp. Co. Job #: 156732

Insp. Comp: Matrix Inspection District: Grande Prairie - North Field: Firebird  
Location: 14-01-098-08W6 Unit / Skid #: 16718 LSD: 14-01-098-08W6  
Jurisdiction #: A2738569 Equip Tag #: HT Serial #: HT-6605  
CRN #: K.5298.2 Nat'l Bd #: N/A Year Built: 1991  
Manufacturer: Larsen & D'Amico Equipment Description: Other: Horizontal Treater  
Status: In Service - Equip. Type: Vessel: Treater Service: Sweet  
MAWP Shell: 50 Psi @ 200 °F Volume: 45 m³ Code Stamp: ☒ Y ☐ N  
MAWP Tube: @ Height/Length: 30 Ft. Insulated: ☒ Y ☐ N  
MDMT: 32 °F RT: RT-3 Size/Diameter.: 96 in. O.D. PWHT: ☐ Y ☒ N  
Support Saddle Vessel on Original CNRL Inventory List: ☐ Y ☒ N Manway: ☒ Y ☐ N  
C.A.: 1.6 mm Coated: N/A Clad: N/A J.E.: 0.85 Remote Access: ☒ - Winter Road

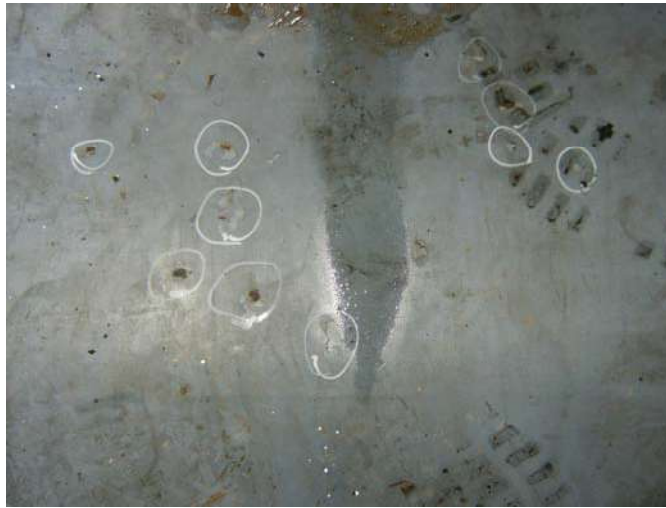
**20 coating repairs**

Clean & touch up coating  
Carseal upstream and downstream PSV valves to ensure they are not accidentally closed  
TA 2012 - Consider recoating the hot section and touch-up repairs in the cold section  
Replace the anodes

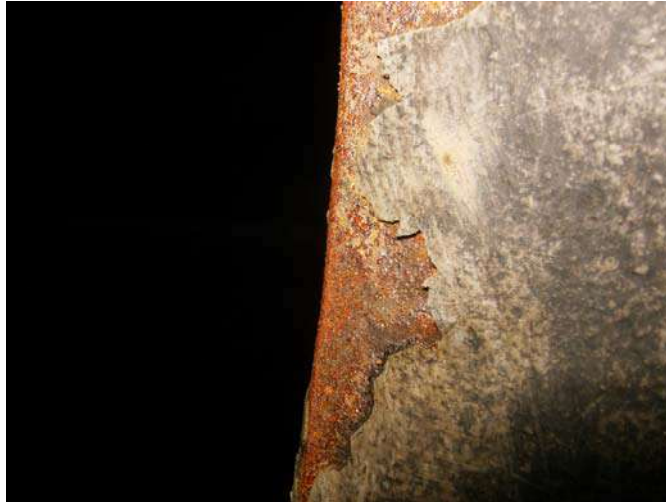
**23 coating repairs**

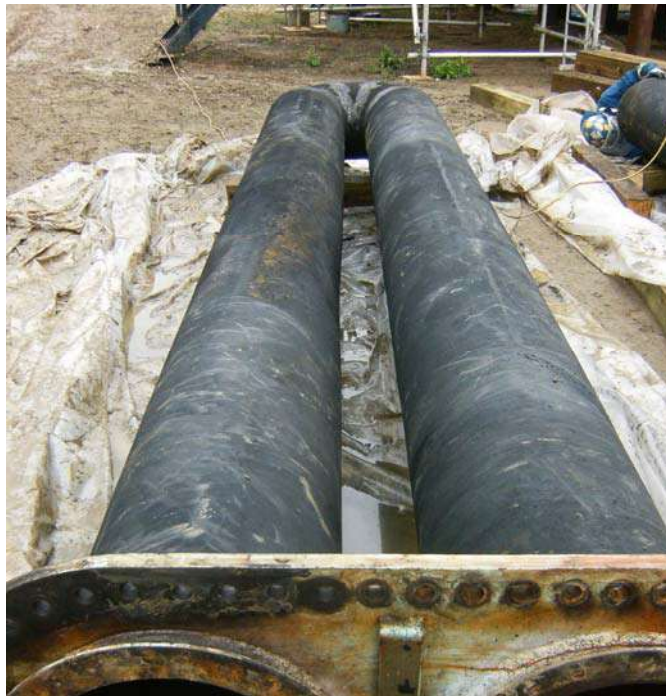
29 firetube overview

MT examination was performed on the hot section of the firetube with no recordable service related defects noted
