<b>Inspections Performed for:</b> FMC Technologies Completion	
<b>Inspection Report for:</b> LH-0033 – Coil 1	
<b>Remaining Life:</b> 4.1 YRS	<b>Date of this Report:</b> 09/11/2018
<b>Average Corrosion Rate:</b> 129.4 MPY	<b>Next UT:</b> 09/11/2019 <b>Next VT:</b> 09/11/2019
<b>Manufacturer:</b> DynaCorp Fabricators	<b>Mfg Serial #:</b> 6J111050
<b>Date Built:</b> 2012	<b>National Board #:</b> None
<b>Alberta registration #:</b> 617901	<b>Canadian Registration #:</b> T9862.2

**FMC Technologies Completion LH-0033 Line Heater**

<b>Inspections Performed for:</b> FMC Technologies Completion	
<b>Inspection Report for:</b> LH-0033 – Coil 2	
<b>Remaining Life:</b> 20+ YRS	<b>Date of this Report:</b> 09/11/2018
<b>Average Corrosion Rate:</b> 17.3 MPY	<b>Next UT:</b> 09/11/2019 <b>Next VT:</b> 09/11/2019
<b>Manufacturer:</b> DynaCorp Fabricators	<b>Mfg Serial #:</b> 6J111050
<b>Date Built:</b> 2012	<b>National Board #:</b> None
<b>Alberta registration #:</b> 617901	<b>Canadian Registration #:</b> T9862.2

<b>Inspections Performed for:</b> FMC Technologies Completion – PA District	
<b>Inspection Report for:</b> LH-0033 Fuel Gas Scrubber	
<b>Remaining Life:</b> 17.9 YRS	<b>Date of this Repo

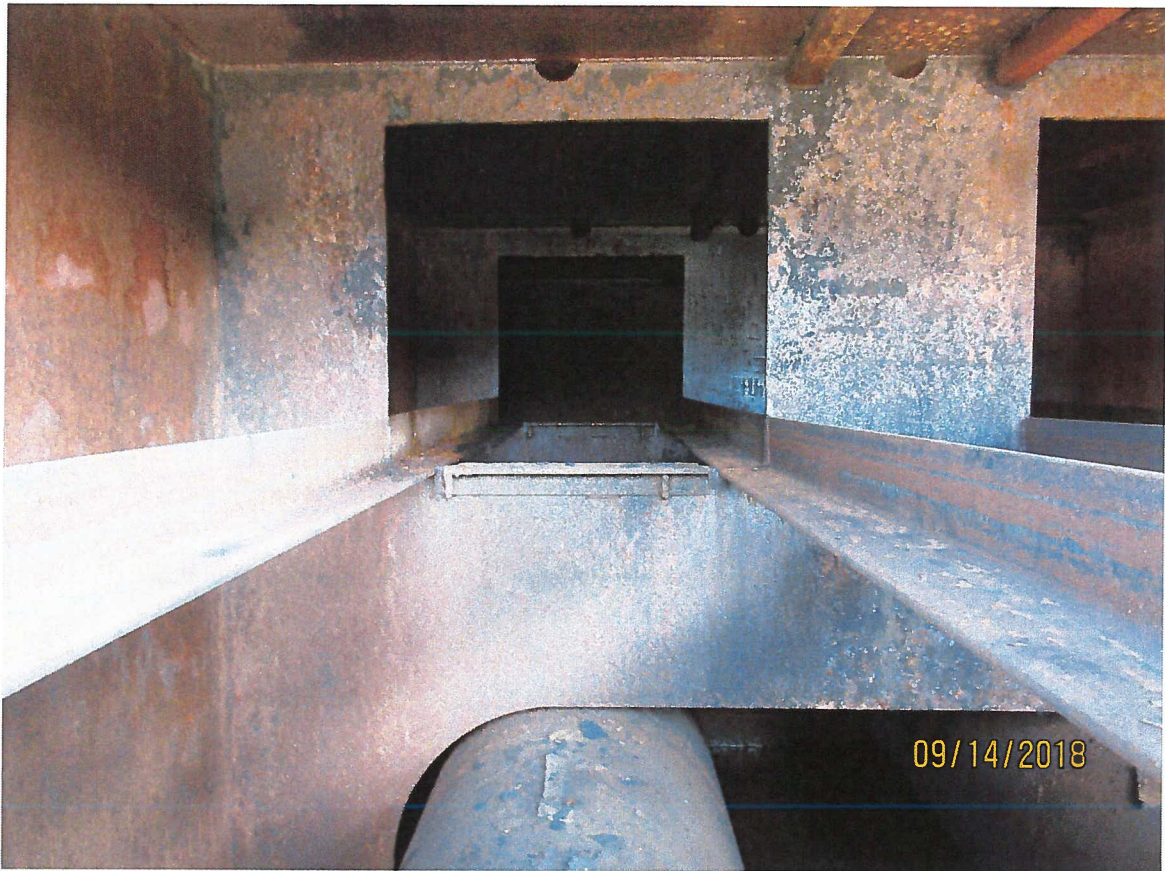
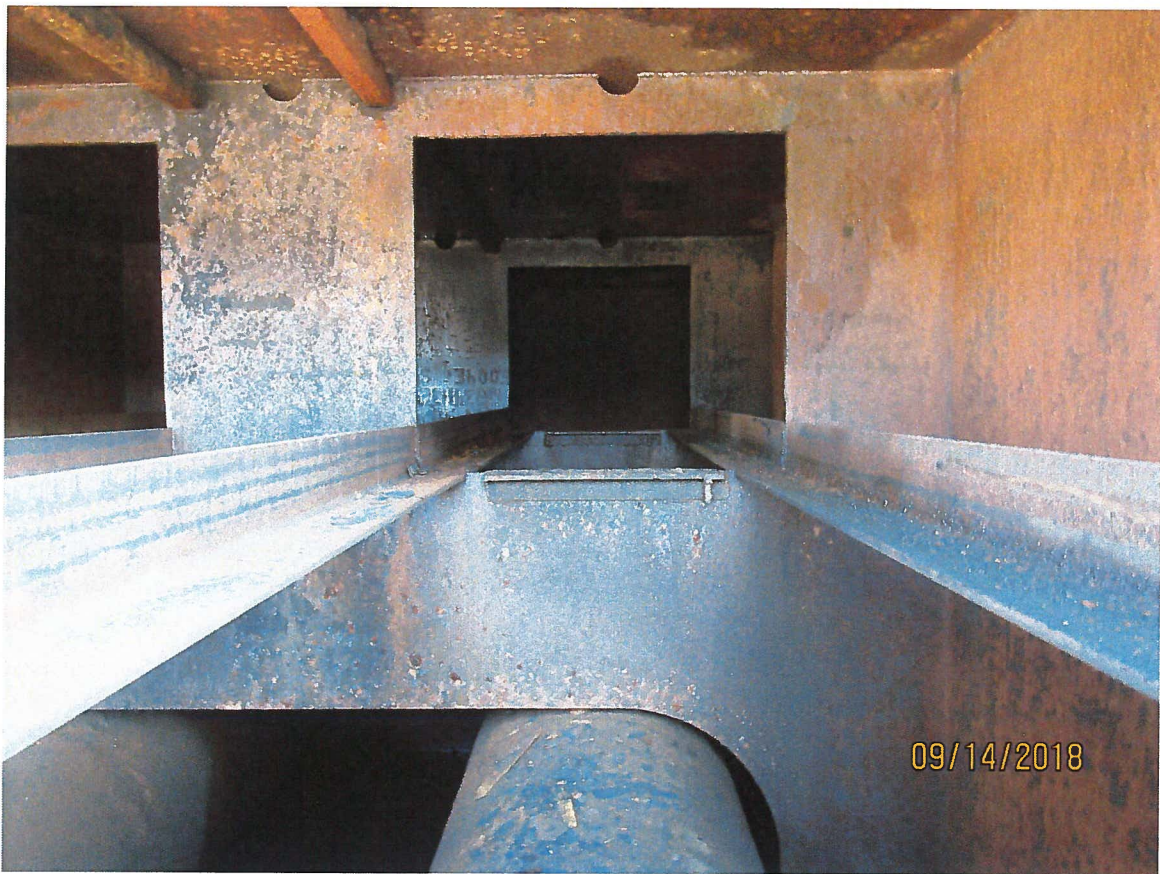
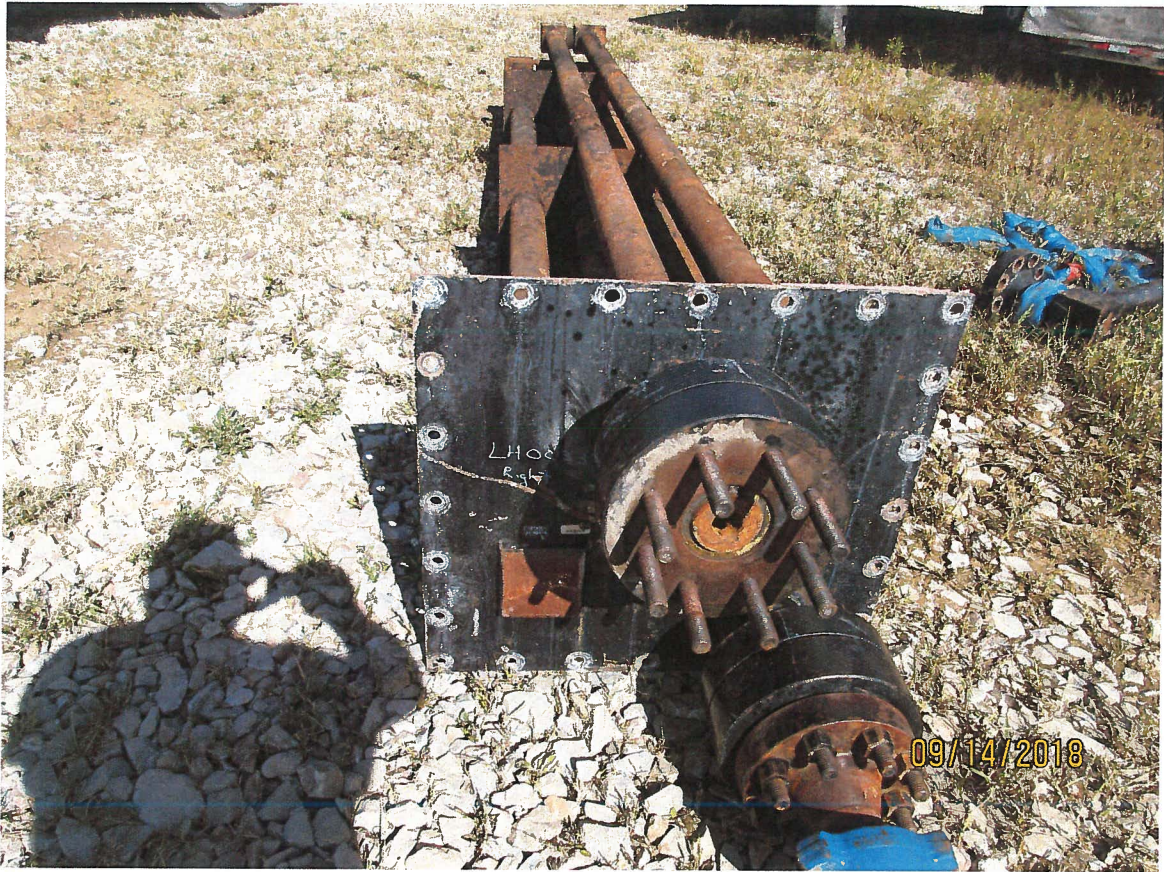
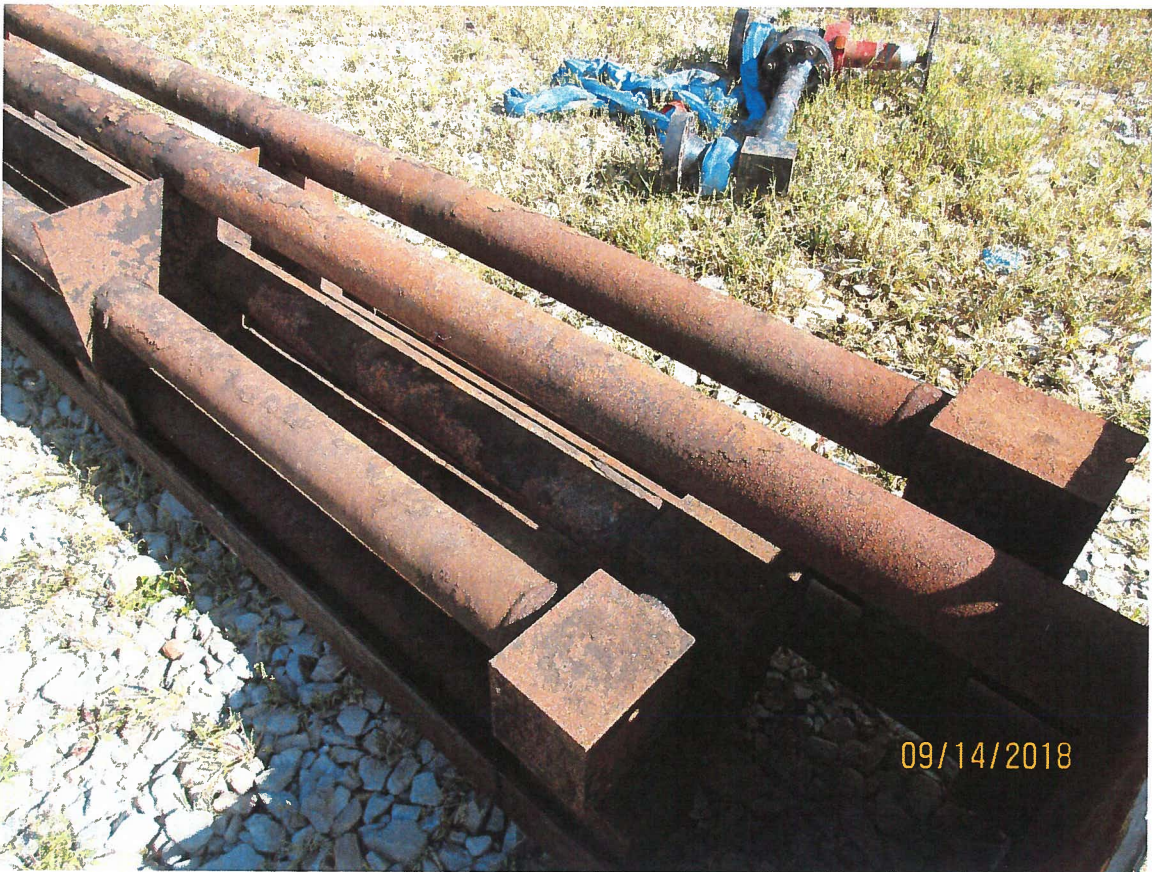
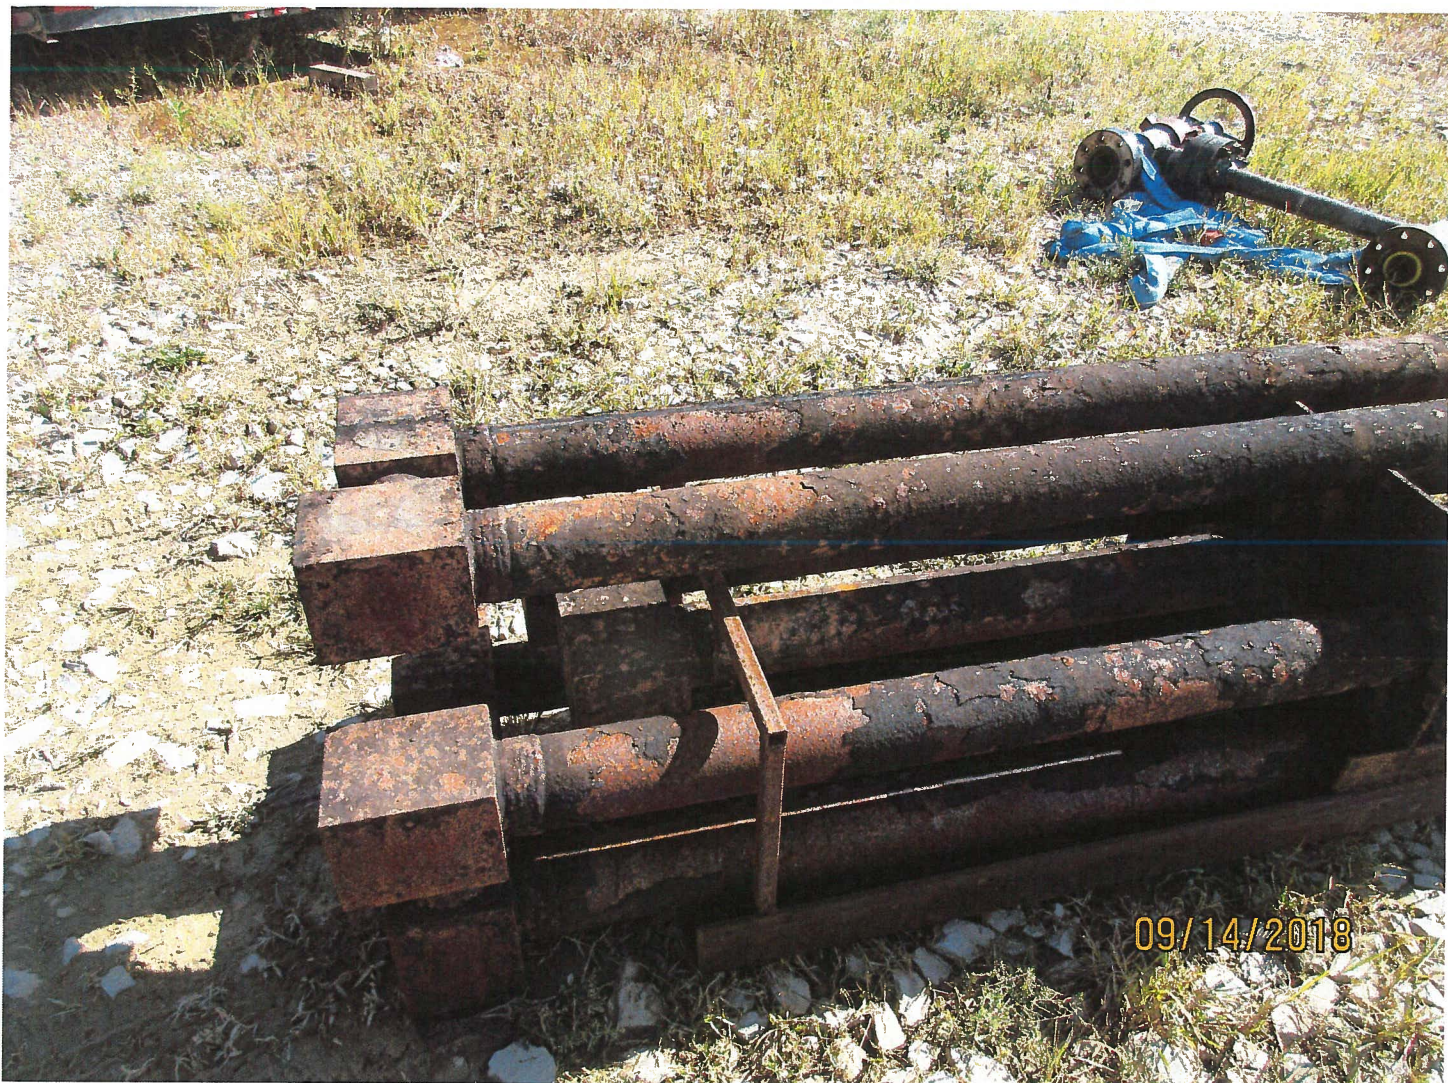
**Condition of Foundation and Anchor Bolts:** The front plate is warped with a bulge. Coating is missing on the upper right quarter. The remainder of the coating has mild surface corrosion.

**Condition of Paint and/or Insulation:** The paint is in acceptable condition with minor localized chipping and peeling.

**Condition of Nozzles, Flanges, Repads, and Weepholes:** Nozzles and flanges are in good condition. Crossover piping is in place with chipping and minor surface corrosion.

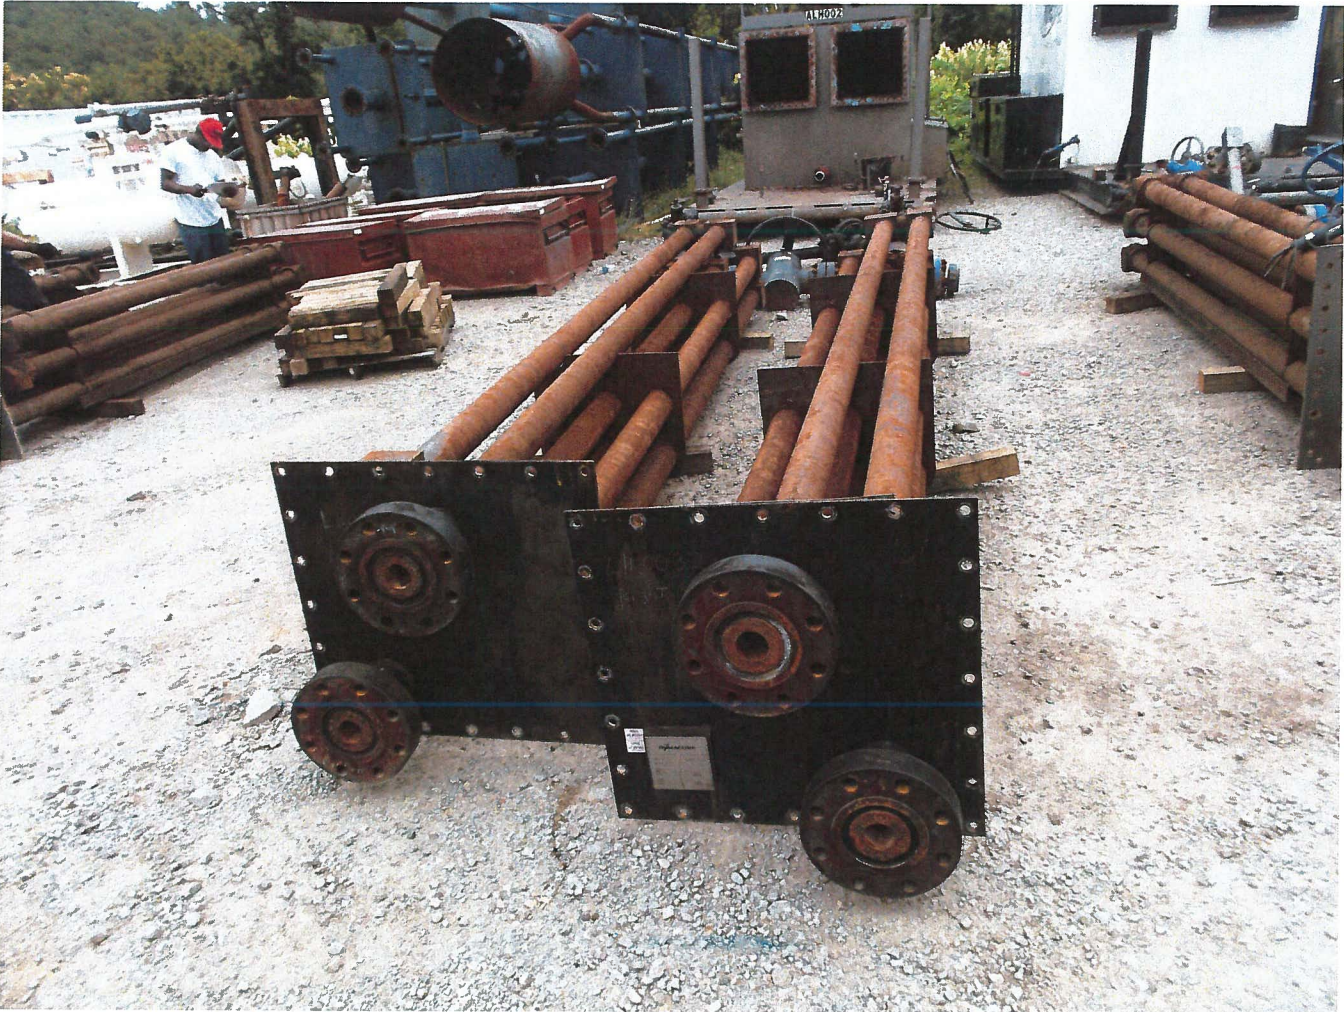
## Coil # 1 and Coil # 2

**Condition of Foundation and Anchor Bolts:** The front plate is dented in.

**Condition of Steel Supports, Saddles, and Bolting:** Angle iron supports have corrosion and scale build up.
