<b>Inspections Performed for:</b> FMC Technologies Completion – PA District	
<b>Inspection Report for:</b> LH0035-C1 Line Heater	<b>Date Last Inspected:</b> 09/11/2018
<b>Remaining Life:</b> 10.2 YRS	<b>Next UT:</b> 09/11/2021 <b>Next VT:</b> 09/11/2021
<b>Representative Corrosion Rate:</b> 52.7 MPY	<b>Mfg Serial #:</b> 4049-01
<b>Manufacturer:</b> Coral Oilfield Services Inc.	<b>Alberta Registration #:</b> 626745
<b>Year Built:</b> 2013	<b>Canadian Registration #:</b> V6716.21

**FMC Technologies Completion LH0035-C1 (Coil 1)**

# API 510 PRESSURE VESSEL EXTERNAL INSPECTION REPORT

**FMC Technologies Completion LH0035-C2 (Coil 2)**

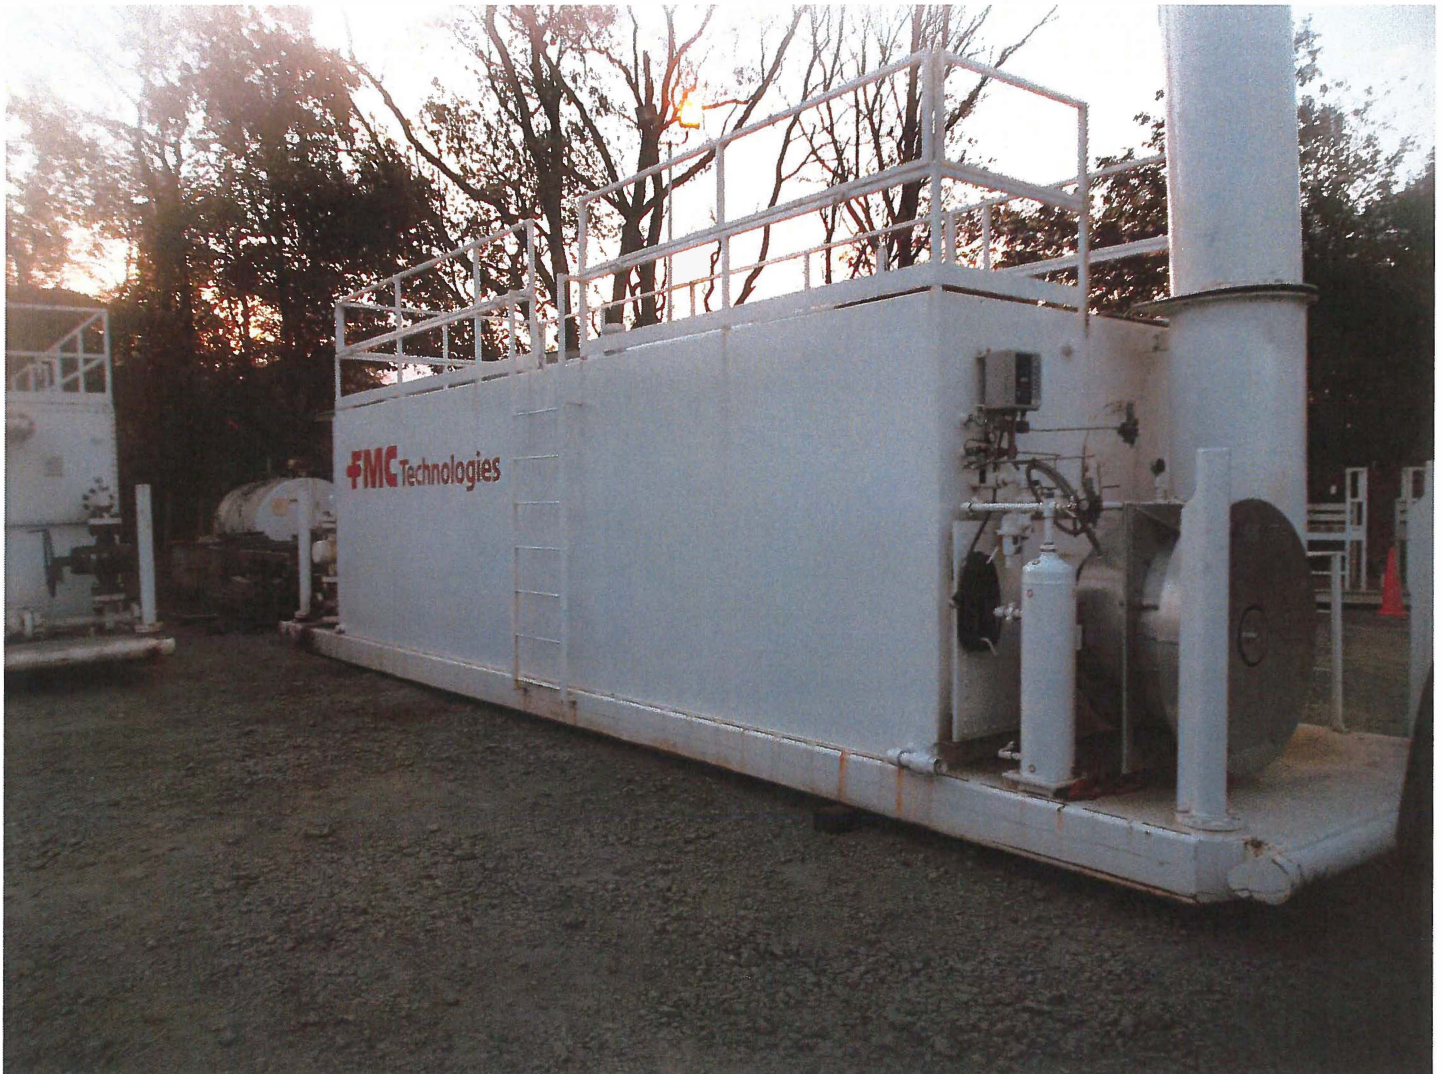
**Condition of Nozzles, Flanges, Repads, and Weepholes:** Nozzles and flanges are in good condition. Valves are removed. The outlet flanges are open and will require cleaning before reassembly. They are moderately corroded on the surface. (See attached photo)

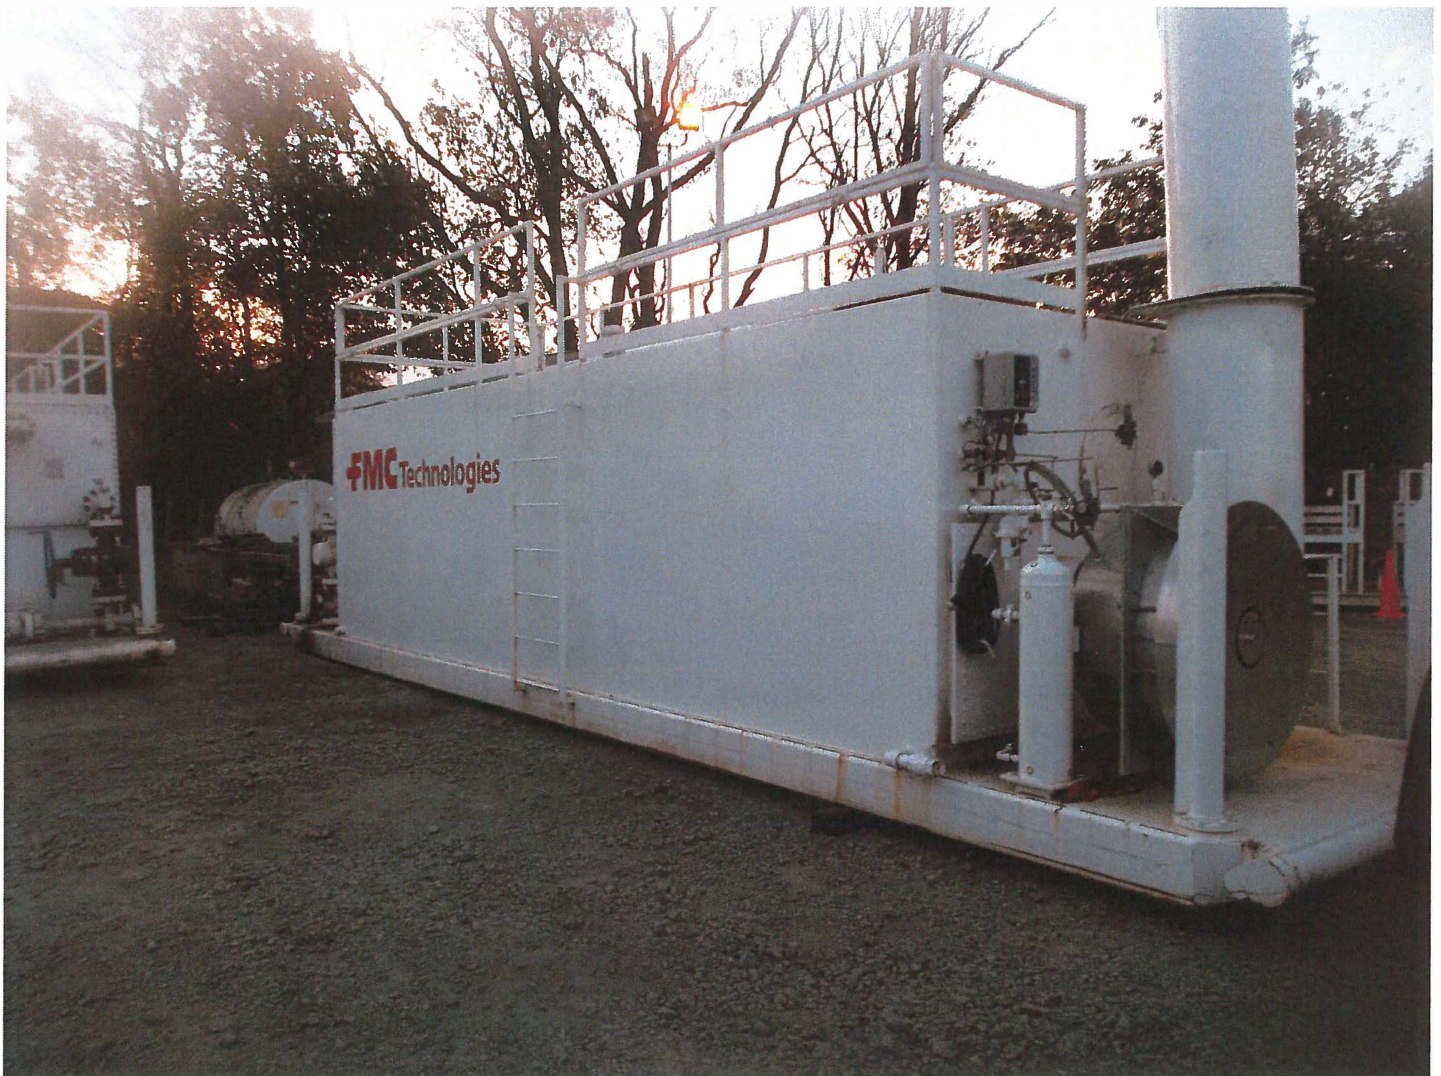
**Condition of Nozzles, Flanges, Repads, and Weepholes:** Nozzles and flanges are in good condition. Valve has been removed. The outlet flange is open. Exposed flange will require cleaning before use due to surface rust. (See attached photo)

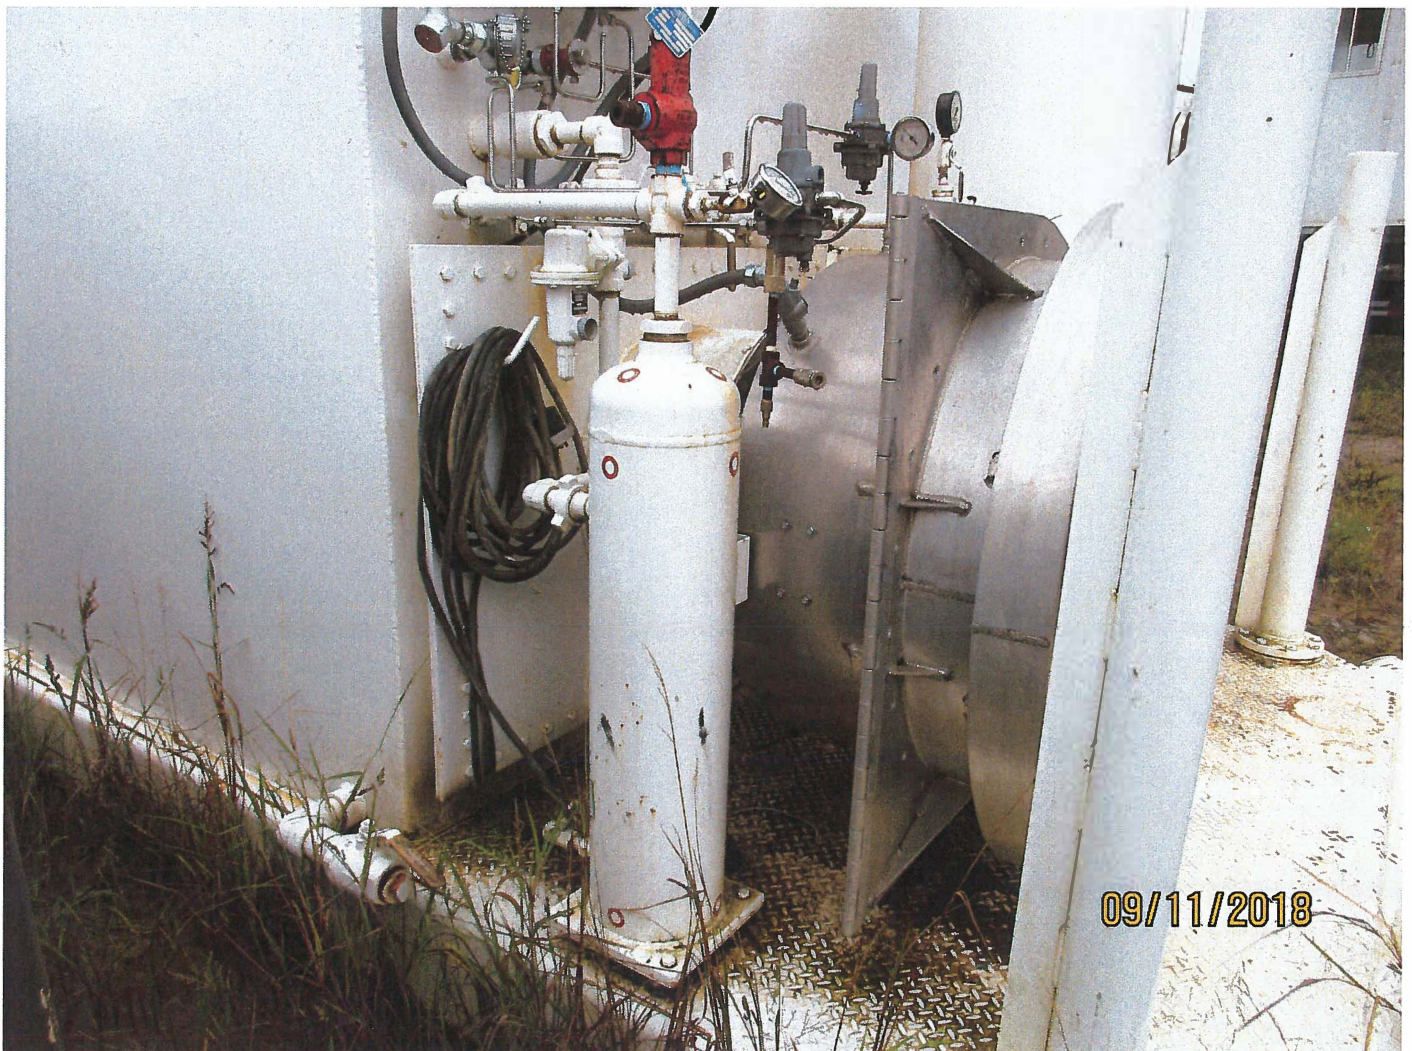
**FMC Technologies Completion LH-0035 Fuel Gas Scrubber**

There is limited access to the nameplate, due to close proximity of other equipment.

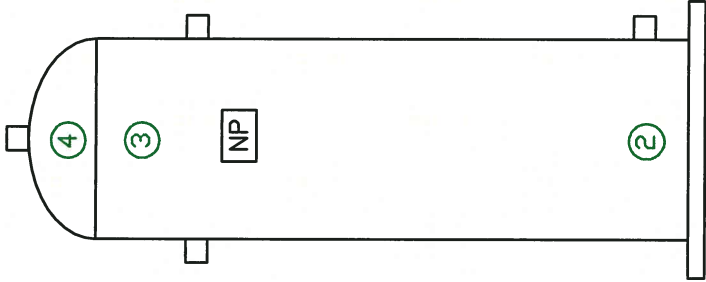
DA-501

- #2. 01- BTM SHELL-F 0. 370 DA
- #2. 02- BTM SHELL-L 0. 357 DA
- #2. 03- BTM SHELL-BK 0. 364 DA
- #2. 04- BTM SHELL-R 0. 330 DA
- #3. 01- TOP SHELL-F 0. 367 DA
- #3. 02- TOP SHELL-L 0. 356 DA
- #3. 03- TOP SHELL-BK 0. 344 DA
- #3. 04- TOP SHELL-R 0. 342 DA
- #4. 01- TOP HEAD-F 0. 323 DA
- #4. 02- TOP HEAD-L 0. 329 DA
- #4. 03- TOP HEAD-BK 0. 314 DA
- #4. 04- TOP HEAD-R 0. 314 DA
