| <b>Inspection Report for:</b> LH0035-C1 Line Heater | <b>Date Last Inspected:</b> 10/27/2016 |

**FMC Technologies Completion LH0035-C1 (Coil 1)**

# API 510 PRESSURE VESSEL EXTERNAL INSPECTION REPORT

**FMC Technologies Completion LH0035-C2 (Coil 2)**

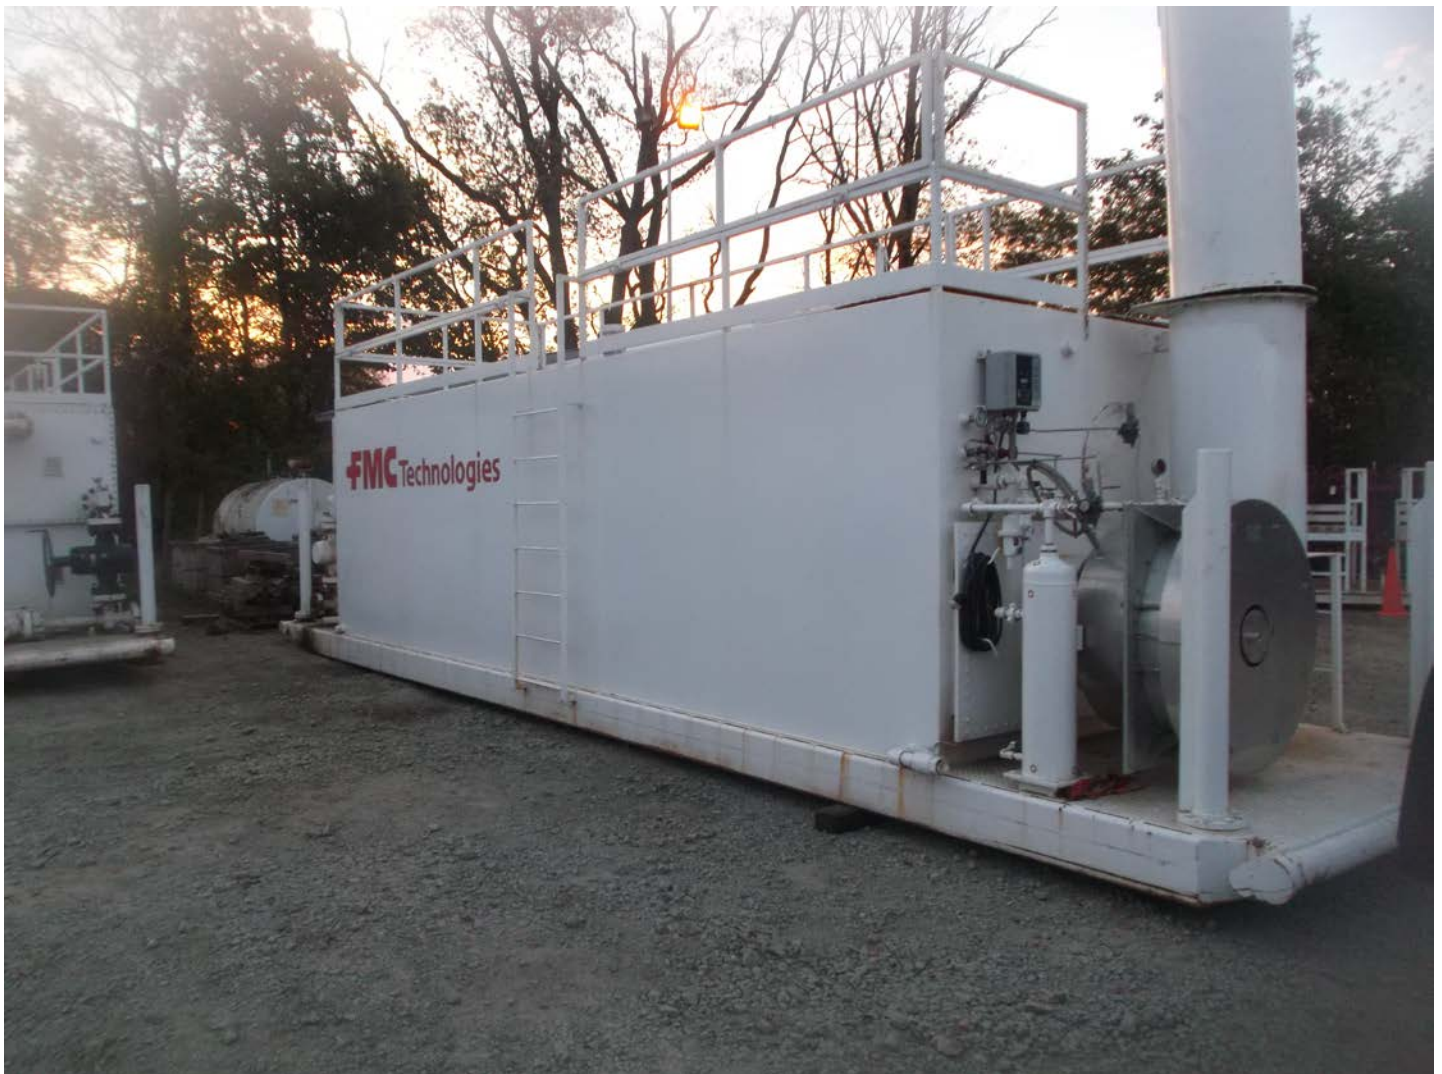
**Condition of Steel Supports, Saddles, and Bolting:** There is light corrosion on the angle iron bottom supports.

**Condition of Nozzles, Flanges, Repads, and Weepholes:** Nozzles and flanges are in good condition. There is a missing elbow on the inlet piping.

**Condition of Paint and/or Insulation:** The paint is in acceptable condition with minor localized chipping and peeling. There is light surface corrosion on the coils.

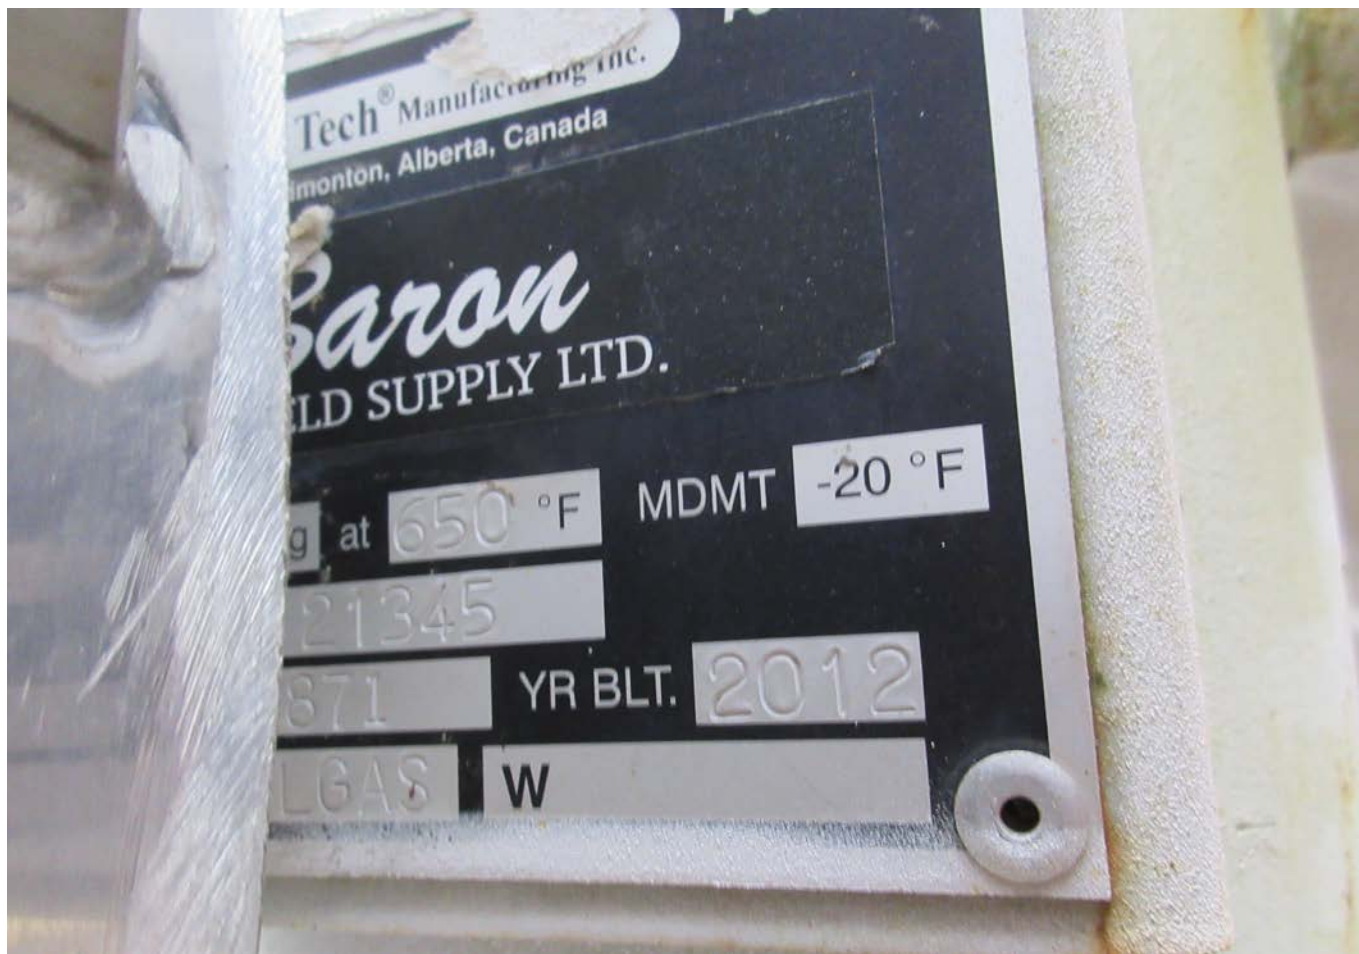
**There is limited access to the nameplate, due to close proximity of other equipment.**
