Field Inspection Report – Rare Oilfield Services

ST82253_10/06/2021_VLT_Internal

Vessel Number	ST82253	Vessel Name	AST - PRODUCTION TANK	Province	Alberta
District	INVENTORY	LSD	00-00-000-00W0	Location	INVENTORY
Method	VLT	Access	Internal	Cleaning	Good
Inspection Date (mm/dd/yyyy)	10/06/2021	Inspection Interval (months)	60	Next Inspection (mm/dd/yyyy)	10/06/2026
CRN	N/A	Skid Number	N/A	Service	SOUR
Internal Access	Entry	Internal Coating	Yes	Status	Spare
MAWP (PSI)		MAWP (kPa)		Outstanding NCRs	0
MAWT (°C)		MAWT (°F)

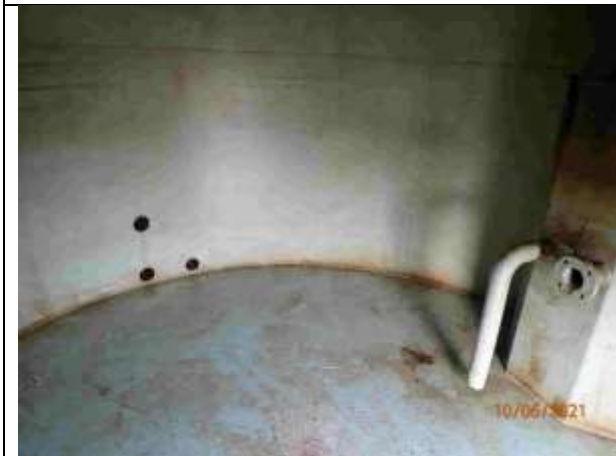
RARE-ST82253-AST-PrePurchase-Int-Overview2-10-06-2021.JPG

- Shell was washed from floor level and up 10 feet. Upper liquid level approximately 4 feet from tank roof. Oily type product staining noted on unwashed surfaces.
- Shell was internally coated, full height of tank.
- Coating was in good general condition. No chips, cracks, or peeling noted.
- welds were in good condition, as viewed through coating

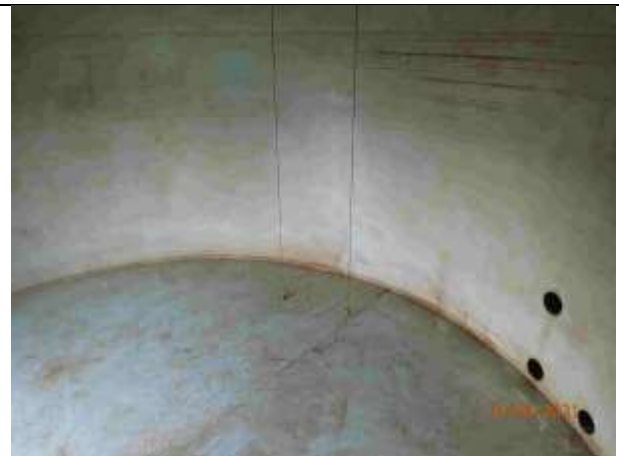
RARE-ST82253-AST-PrePurchase-Int-Overview3a-10-06-2021.JPG

- Tank floor was internally coated.
- Coating was in good condition. There were two areas of coating defects found.
- One was a crack in the coating, which was located between the manway envirovault and manway, along the floor plate weld, 24" from shell. No blistering associated with coating crack. Unable to catch edge on crack and pull on coating. Don't suspect any corrosion issues underneath coating in affected area.
- The other defect was a coating chip located 30" of shell, along floor weld, in close proximity to float floor connections. No wall loss noted in exposed area.
- minor coating repairs completed in the past. Repairs in good condition and well bonded. No issues noted.
- welds were in good condition, as viewed through coating

Tank was in good condition, and needed only minor repairs.
 -removal of external piping supports welded to transportation skid
 -spot coating repairs on identified areas.
