Client: Fuelled	Facility: CNRL Bilbo Field	Date: Sept. 8, 2025
LSD: 07-19-65-07W6M (CNRL)	Equipment Inspected: Flare Knockout Drum SN-K637	LII Job #: 14130

Job Scope: To perform external and internal informational visual inspections with Ultrasonic Testing (UT) on a horizontal Flare Knockout Drum, SN-K637. This FKOD is out of service and currently located at the CNRL 07-19-065-07W6M Bilbo location.

Visual Inspection Information – Flare Knockout Drum (SN-K637)

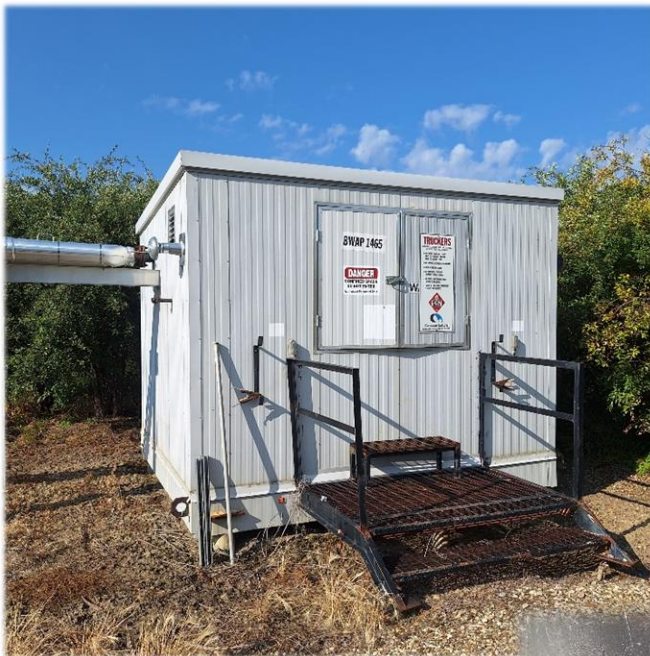
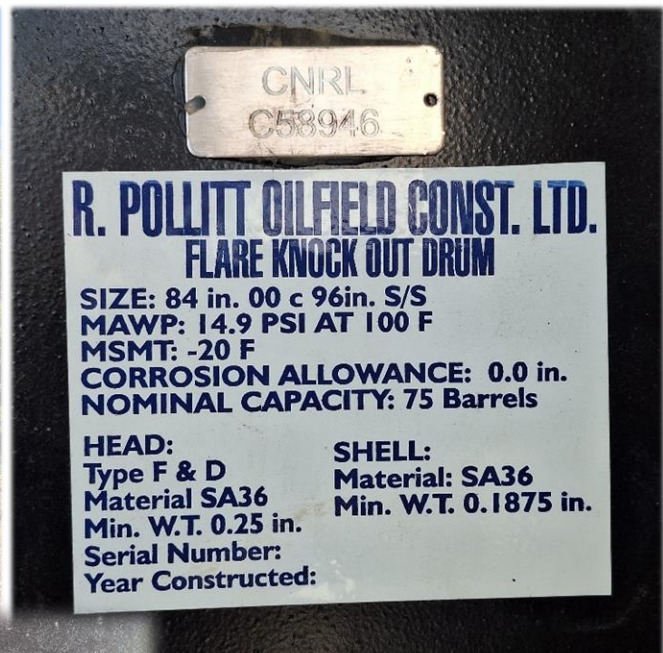
SN-K637 FKOD Skid Overview and Vessel Data Pate

- **Nameplate:** Firmly fastened and legible. Vessel serial number is welded into the manway cover.
- **Foundation/Support:** This vessel is supported by three bottom saddle supports anchor bolted to the skid floor. No visible signs of damage.

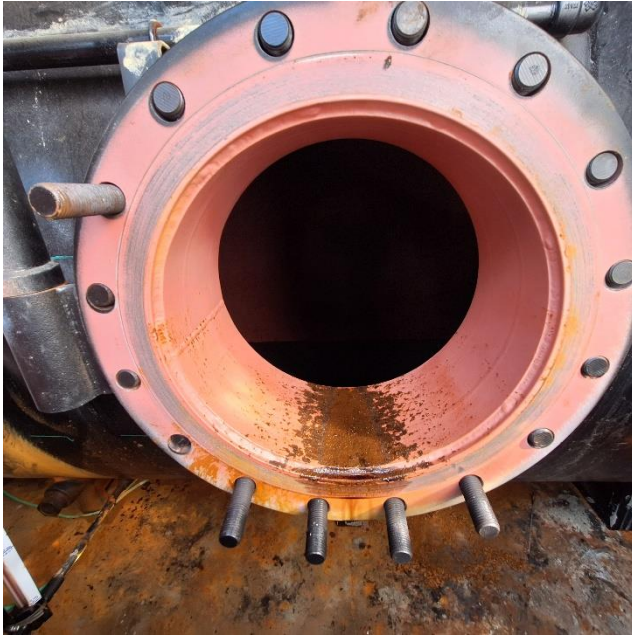
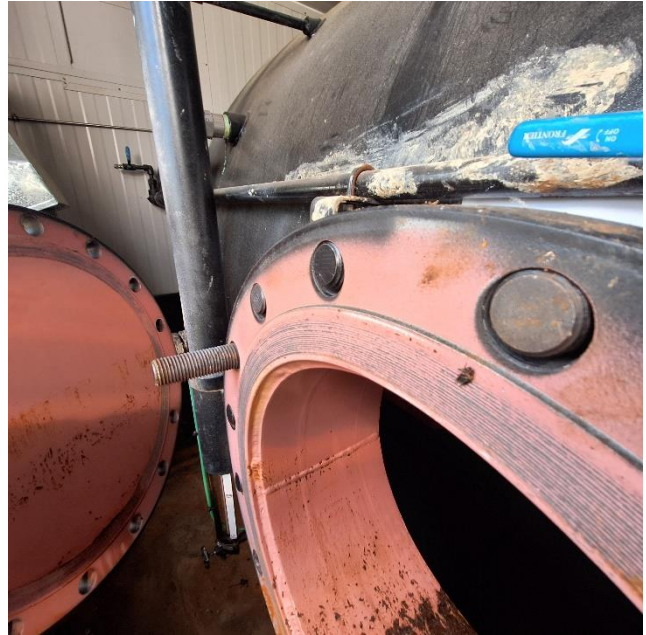
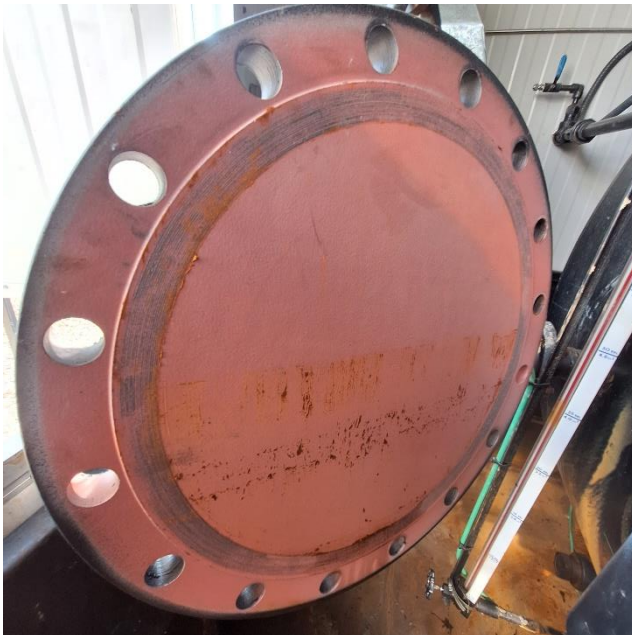
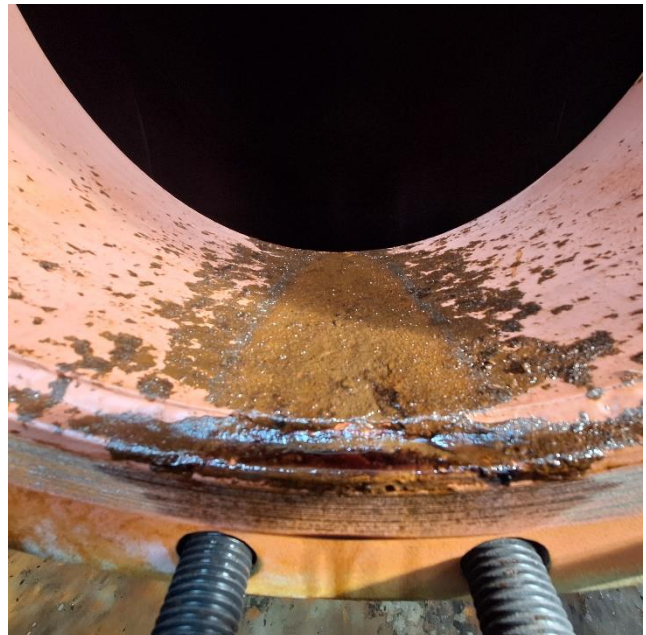
Visual Inspection Photos (Manway) – Flare Knockout Drum (SN-K637)

- **Nozzles:** All nozzles have a flange rating of 150#. No visible signs of damage or deflection.
- **Manway:** This vessel has an 18" manway with no notable external deficiencies.

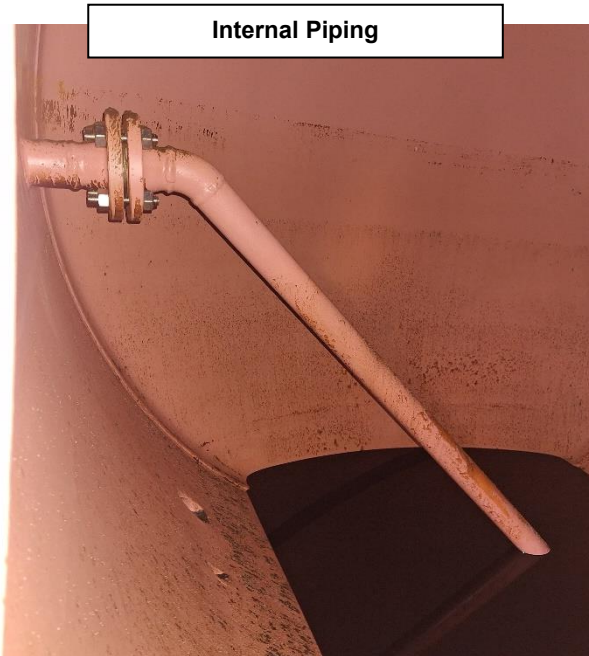
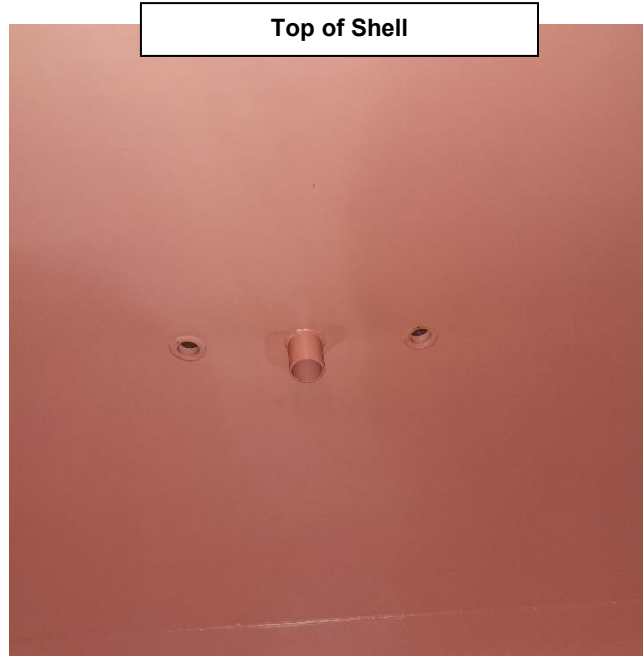
Visual Inspection Photos (Internals from Manway) – Flare Knockout Drum (SN-K637)

- **Internal Components:** Visually inspected from the manway. This FKOD is internally coated with residual product in the bottom of the vessel. No visual access to the 4 to 7 o'clock position of the vessel internals. No concerns observed in the visible internals of this FKOD.

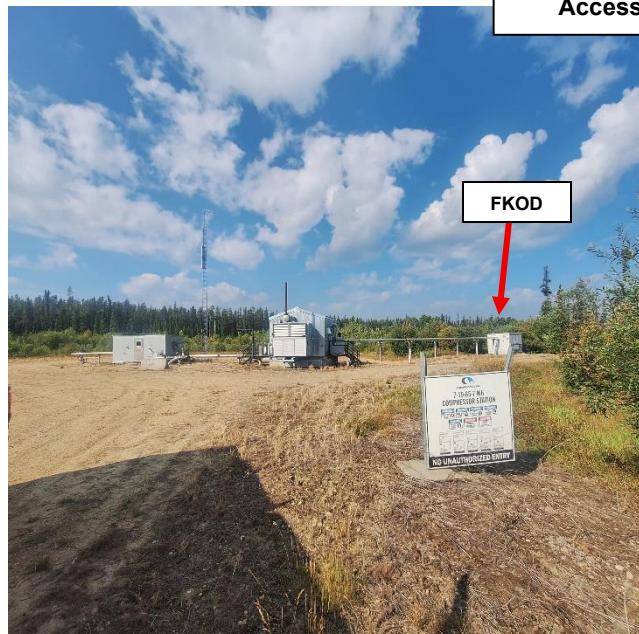
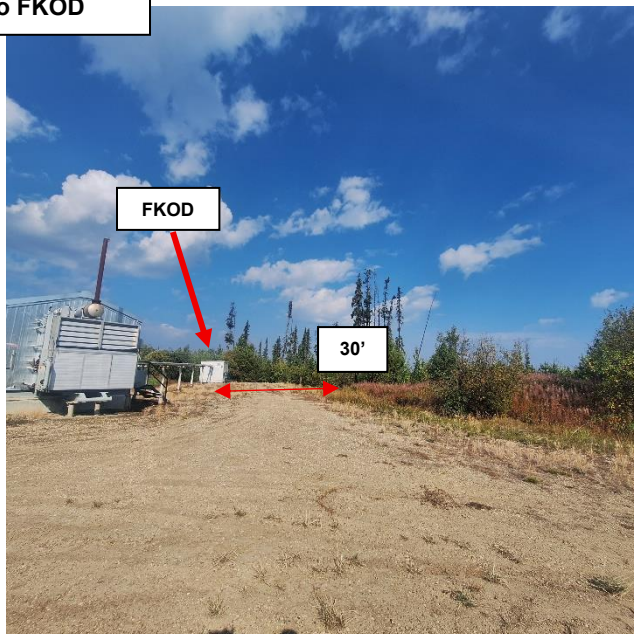
Access to FKOD

- **Insulation:** This vessel is uninsulated and inside of a utilidor building. The building appears well sealed with no visible signs of damage.
- **Ladder/Platform:** There is no ladder or platform associated with this vessel.
