Report No: IG001263

Client	Midstream Equipment	Inspection Date	Jun 6, 2025		
Prov. Reg. #	AB RAE49501	Inspection Type	VE / UT / PSV		
Equipment Type	Fuel Gas Scrubber	Location	27 DURUM DRIVE, AB (MIDSTREAM YARD)		
Tag/Equip.		LSD			
Status	Not in Service	Downhole LSD			
Manufacturer	Industrial Fabrication Corporation	Area			
Serial Number	17013-01	Year Built	2005		
CRN #	P2308.231	Service	Sweet		
Comp/Unit Id	UNIT 1029	Manway	None		
Nat.Board #		Coating	Painted		
Interim Insp'n		Interim Type			
Next Thorough Insp	2030	Next Insp Type	VE / UT / PSV		
Length		Height			
Volume	Capacity	Client Reference			
Owner	Midstream Equipment	RT	2	HT	NO
Foreman		RAE Job No.	PR0004444		
ABSA	Plant: R Vessel: Y Process: G Special: Z		ASME	Sec. VIII div. 1	
History Log	Inspection Report Complete - Inspection Date: 2025-June-06 Inspection Type: VE/UT/PSV

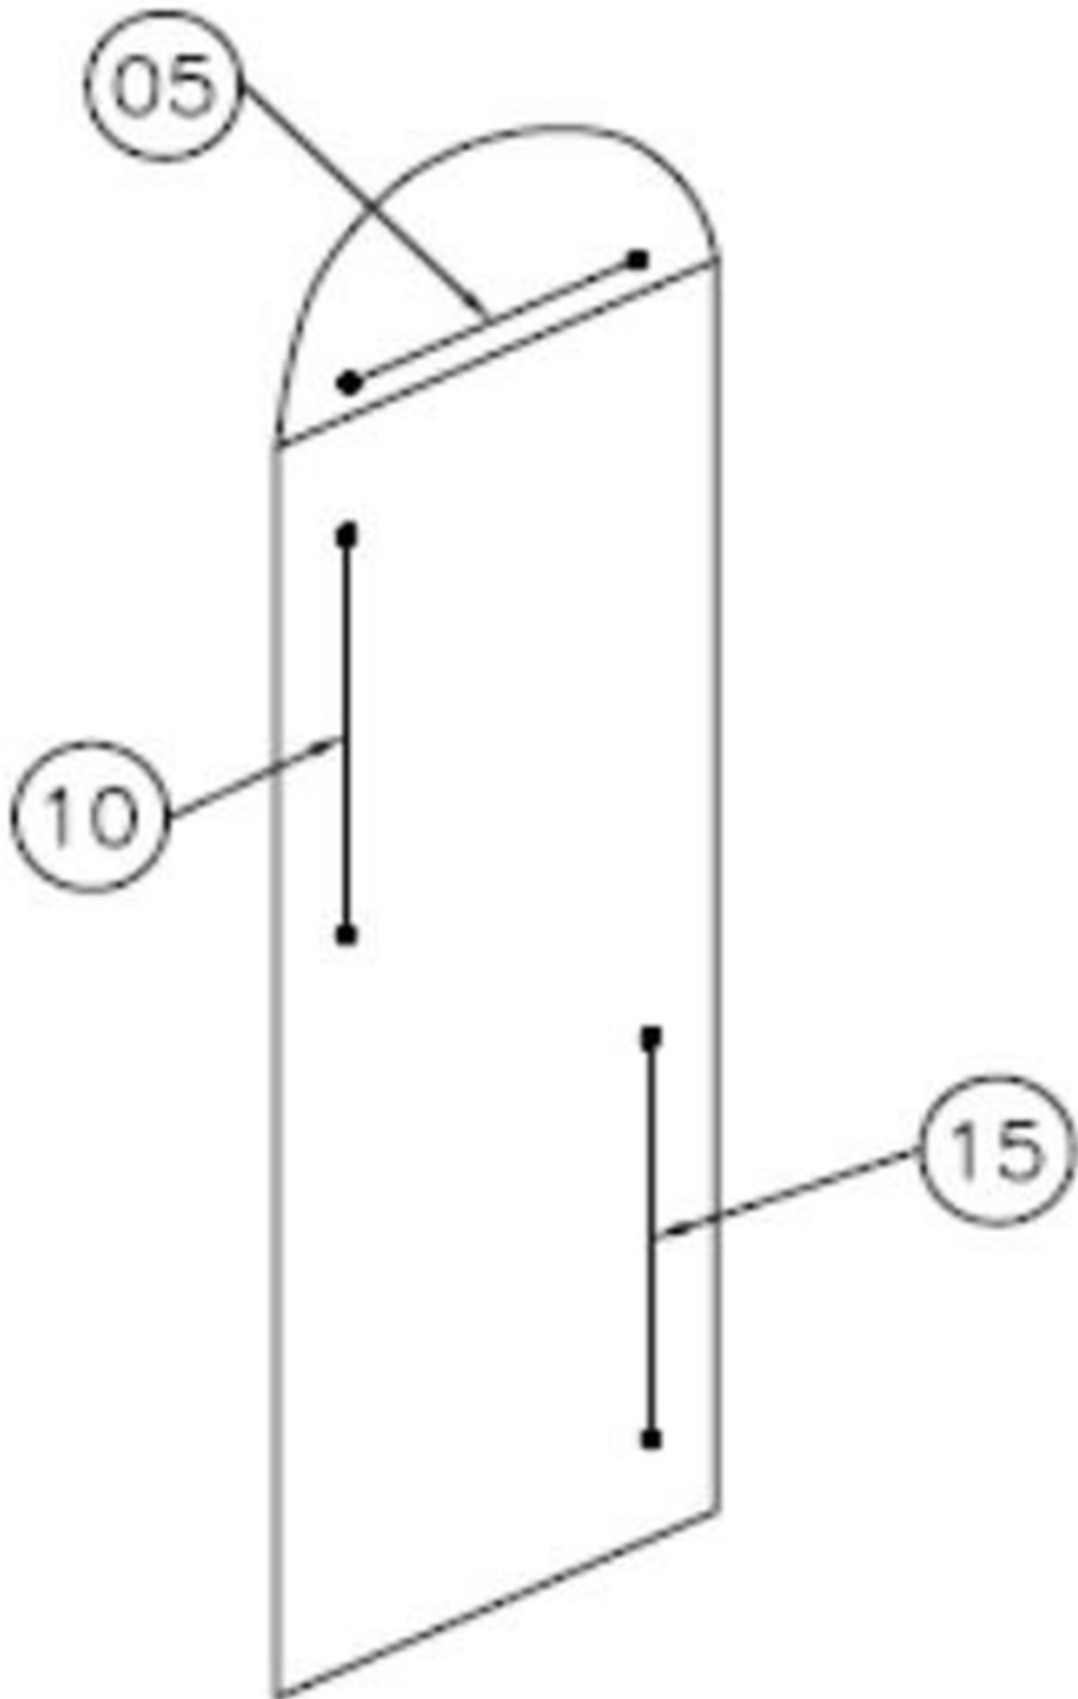
ISO

The measurements obtained from the inspection locations showed the thicknesses of all the components inspected to be at or around nominal. There were no signs of wall thinning, internal corrosion, erosion, laminations or inclusions at the time of inspection.
