Client	Midstream Equipment	Inspection Date	Jun 6, 2025		
Prov. Reg. #	AB 0514156	Inspection Type	VE / UT / PSV		
Equipment Type	Separator	Location	27 DURUM DRIVE, AB (MIDSTREAM YARD)		
Tag/Equip.		LSD	AB		
Status	Not in Service	Downhole LSD			
Manufacturer	Ifc Industrial Fabrication Corporation	Area			
Serial Number	16091-01	Year Built	2005		
CRN #	T3942.231	Service	Sour		
Comp/Unit Id	UNIT 1029	Manway	Yes		
Nat.Board #		Coating	Painted		
Interim Insp'n		Interim Type			
Next Thorough Insp	2030	Next Insp Type	VI / VE / UT / PSV		
Length		Height			
Volume	205 ft³	Client Reference			
Owner	Midstream Equipment	RT	1	HT	YES
Foreman		RAE Job No.	PR0004444		
ABSA	Plant: R Vessel: P Process: W Special: Z		ASME	Sec. VIII div. 1	
History Log	Vessel relocated as per ESR - previously at Enerflex Yard - entered March 2, 2017. Certificate of Inspection - entered March 22, 2017. AB-25 - entered March 24, 2017. AB-10 - Unit 1029 - Midstream Ownership - 2017-02-13 AB-10 - Unit 1029 Operated in BC - 2018-08-21 Inspection Report Complete - Inspection Date: 2025-June-06 Inspection Type: VE/UT/PSV

Comments

RAE Engineering and Inspection Ltd. www.raeengineering.ca Phone: (780) 469-2401 Fax: (780)-469-2

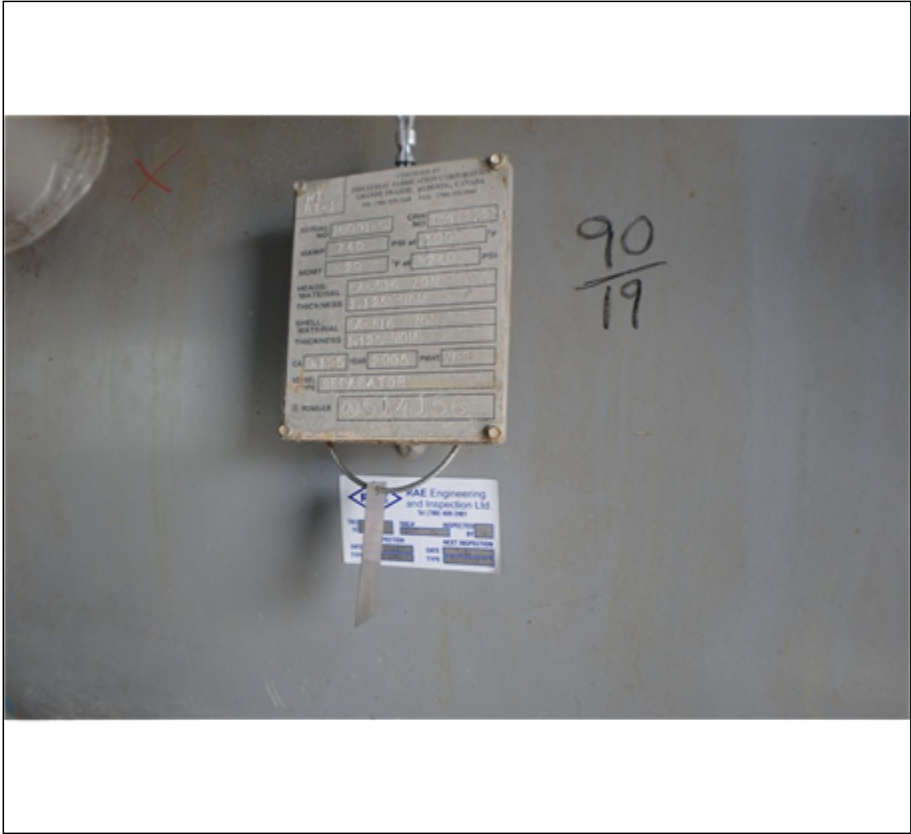
Nameplate

The vessel was identified by the Alberta Registration Number stamped on the nameplate.
The nameplate was legible and securely mounted to the vessel.
The vessel was located inside the building was ergonomically placed.
The manway was located outside the building.
The vessel was adequately supported on saddle supports and was welded to the skid floor.
The heads, shell, nozzles and bolting appeared to be in good condition.
There was no stress evident on piping or nozzle connections and there was no damage or distortion evident on the vessel surface.
The vessel was painted grey and is in acceptable condition.
The gauges were in good condition.
PSV was serviced in 2022.
