Client	Midstream Equipment	Inspection Date	Jun 6, 2025		
Prov. Reg. #	AB RAE46443	Inspection Type	VE / UT / PSV		
Equipment Type	Fuel Gas Scrubber	Location			
Tag/Equip.		LSD	AB		
Status	In Service	Downhole LSD			
Manufacturer	Aquila Fabrication & Equipment Ltd.	Area			
Serial Number	S-3120	Year Built	2014		
CRN #	0H5837.231	Service	Sour		
Comp/Unit Id	UNIT 1063	Manway	None		
Nat.Board #		Coating			
Interim Insp'n		Interim Type			
Next Thorough Insp	2030	Next Insp Type	VE / UT / PSV		
Length		Height			
Volume	Capacity	Client Reference			
Owner	Midstream Equipment	RT	2	HT	NO
Foreman		RAE Job No.	PR0004445		
ABSA	Plant: H	Vessel: K	Process: W	Special: R	ASME Sec. VIII div. 1
History Log	Inspection Report Complete - Inspection Date: 2025-June-06 Inspection Type: VE/UT/PSV

RAE Engineering and Inspection Ltd. www.raeengineering.ca Phone: (780) 469-2401 Fax: (780)-469-2401		Inspection Date:		June 06, 2025		<h1 style="text-align: center;">UT Report</h1>								
			Report Number:		IG000069										
			Page:		1 of 4										
Client:		Midstream Equipment		Job Number:		PR0004445									
Facility:		Midstream Yard		Location/LSD:		Midstream Yard									
Equipment Number:		RAE46443		Client R

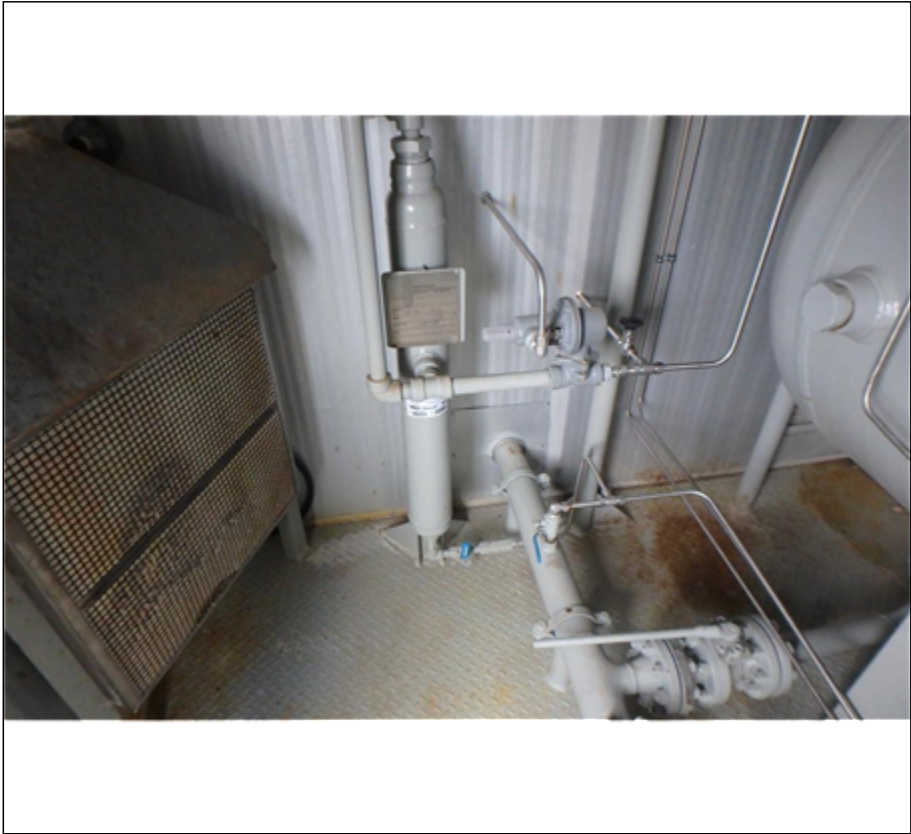
Overall View

The vessel was located inside a building.
The nameplate was legible and securely attached.
The exterior was fully painted, and the paint was in serviceable condition.
The heads and shell appeared to be in serviceable condition.
There was no damage, distortion, or stress evident on piping connections.
The vessel was adequately supported, with no makeshift structural attachments on any of the pressure containing components.

1. The vessel is fit-for-service.
2. The PSV outlet pipe needs a 90 fitting put on the end to keep rain and snow out.
3. There should be an installation inspection of the unit after being installed on site to ensure no damage occurred during shipping and to verify proper installation.
