Client: Fuelled	Facility: CNRL Wapiti Field	Date: August 22, 2025
LSD: 06-03-69-06W6M (CNRL)	Equipment Inspected: Flare Knockout Drum SN 10154B	LII Job #: 13752

Job Scope: To perform external/internal informational visual inspections, and Ultrasonic Testing (UT) on a horizontal Flare Knockout Drum (FKOD), Serial Number (SN) 10154B. This FKOD is out of service and currently located at the CNRL 06-03-069-06W6M Wapiti location.

Visual Inspection Information – Flare Knockout Drum (SN 10154B)

**Informational Visual Inspection
Report**
**Informational Visual Inspection_SN
10154B FKOD_aug2025**

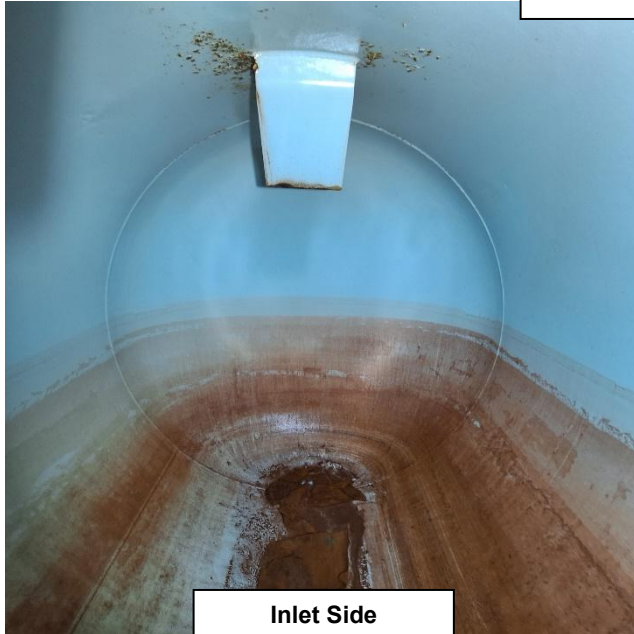
Vessel Heads

- **Internal Components:** Inspected from the manway at the top of the vessel with a light and camera. This vessel is internally coated with no visible sign of coating damage in the shells of heads. There was limited visual access to the 6:00 portion of the vessel due to product residual. Coating damage was observed in the inlet and outlet nozzles, with corrosion identified during UT.
